CW1: A Reflection on a Software Based System Failure (Boeing 737 MAX)

Samara Cunningham H00429775
Year 2 Computer Science- F28SD
Edinburgh Campus

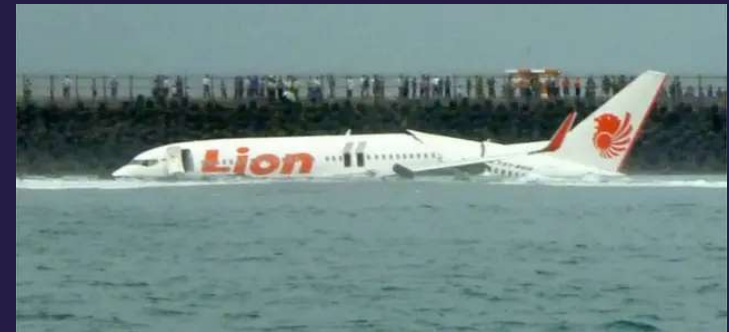
This repeatedly pushed the nose down, regardless of there being no high AoA or stall.

The MCAS falsely activated due to a faulty AoA (angle-of-attack) sensor.

Figure 6: Image showing Lion Air Flight 610 after crashing.

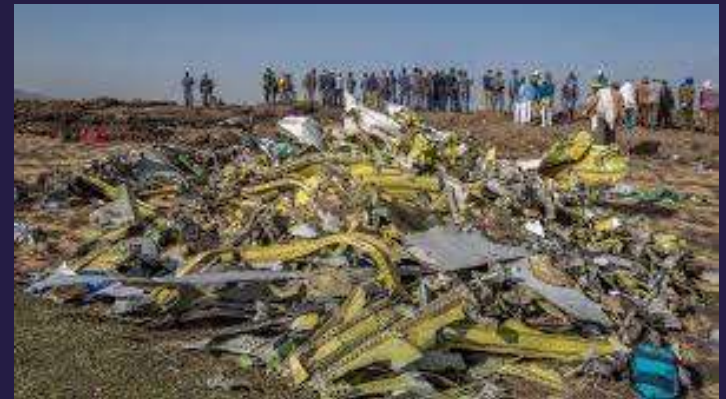
As instructed, the pilots
disabled the MCAS
system, but were unable to
regain control due to
insufficient time.

Figure 8: Image showing Ethiopian Airlines Flight 302 after crashing.

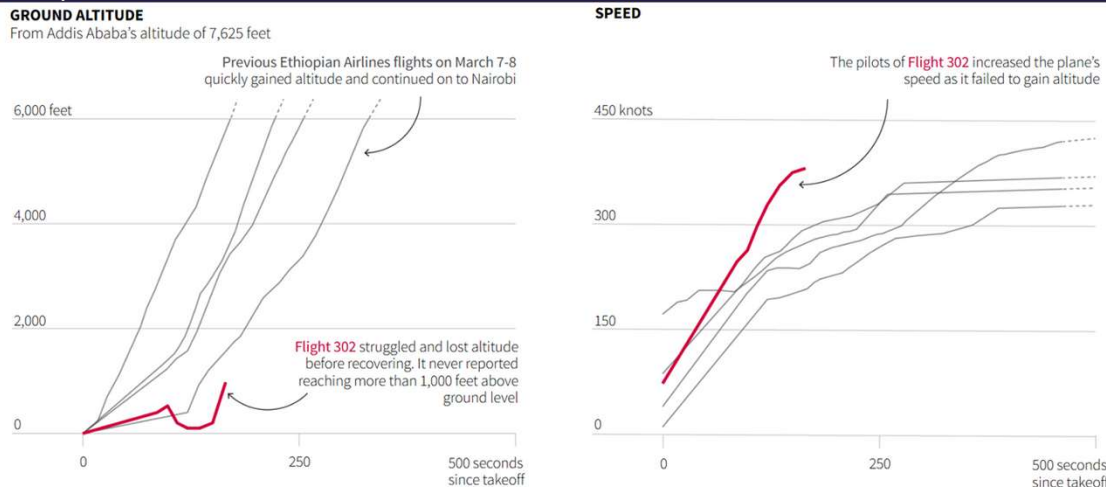
Figure 9: Data showing Ground Altitude and Speed of the Ethiopian Airlines flight 302 in comparison to the previous Ethiopian Airline Flights.

Figure 9 shows that the Ethiopian flight struggled to gain altitude compared to the previous flights.

Figure 9 also shows that the Ethiopian flight experienced fluctuation in altitude suggesting control issues.

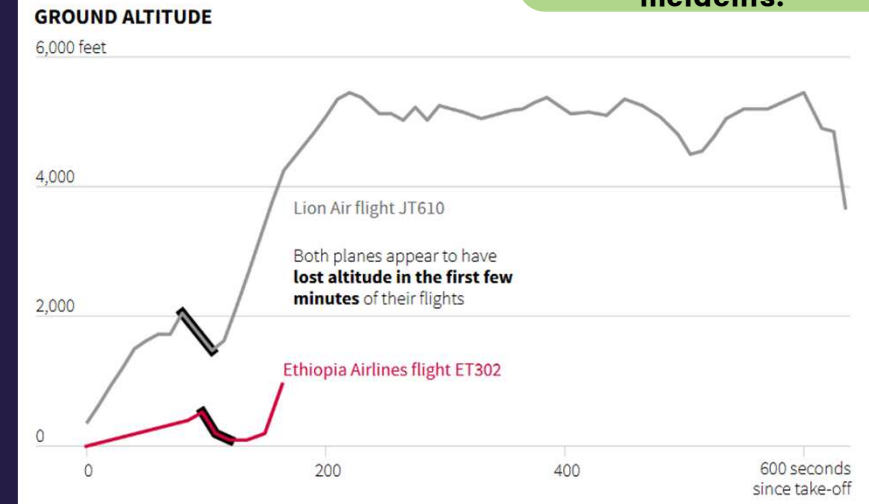
The similarities between the date for the Lion Air and Ethiopian flight (shown in Figure 10) implies a systematic issue with the aircraft rather than isolated incidents.

Figure 10 shows that both the Ethiopian and Lion Air flights experienced a loss of altitude within the first few minutes of flight.

Figure 10: Data showing Ground Altitude of the Ethiopian Airlines flight 302 in comparison to the Lion Air Flight 610.
