Netaji Subhas University of Technology

CanSat 2019

Post Flight Review (PFR)

Kinetic Autogyro Landing Aerospace Mission

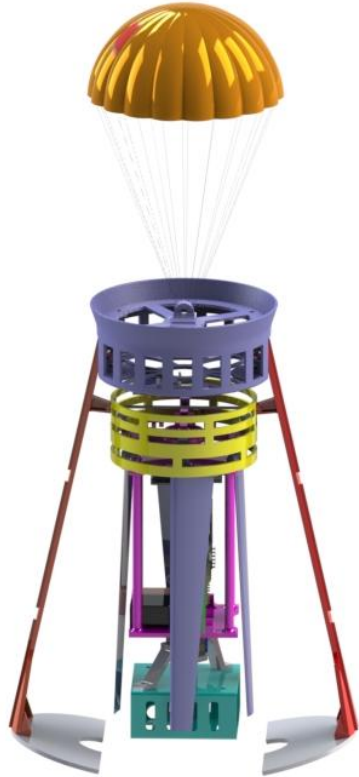
The payload starts to deploy after the container opening mechanism occurs.

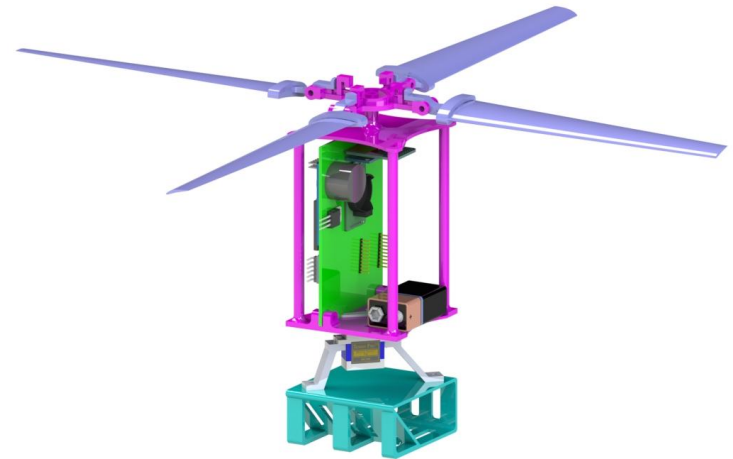
The payload is fully deployed and the autogyro starts functioning.

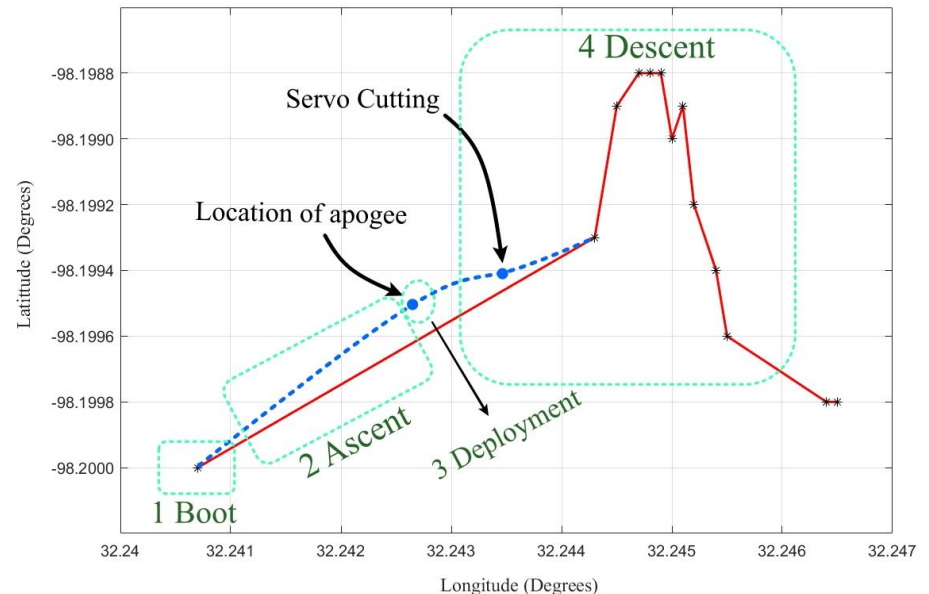
Container Separation Altitude

CANSAT released from the rocket at 771m.

The actual altitude at which separation took place was measured to be 475 m. This can be verified as the software state changed from “3” to “4”.

From the graph and the SD Card data we conclude that separation of payload from container took place at 475m as the software state changes from 3 to 4. We infer that software reset and loss of power for bluetooth and GPS occur due to turbulence faced during this separation.

Failure	Root cause	Corrective action
Received 496 packets. 87 Packets not received out of 583	For some time during launch, deployment and descent, due to power cut off ,teensy faced software reset due to which packets were not generated and transmitted	Better hardware connections and mounting of electronics may not have created this problem

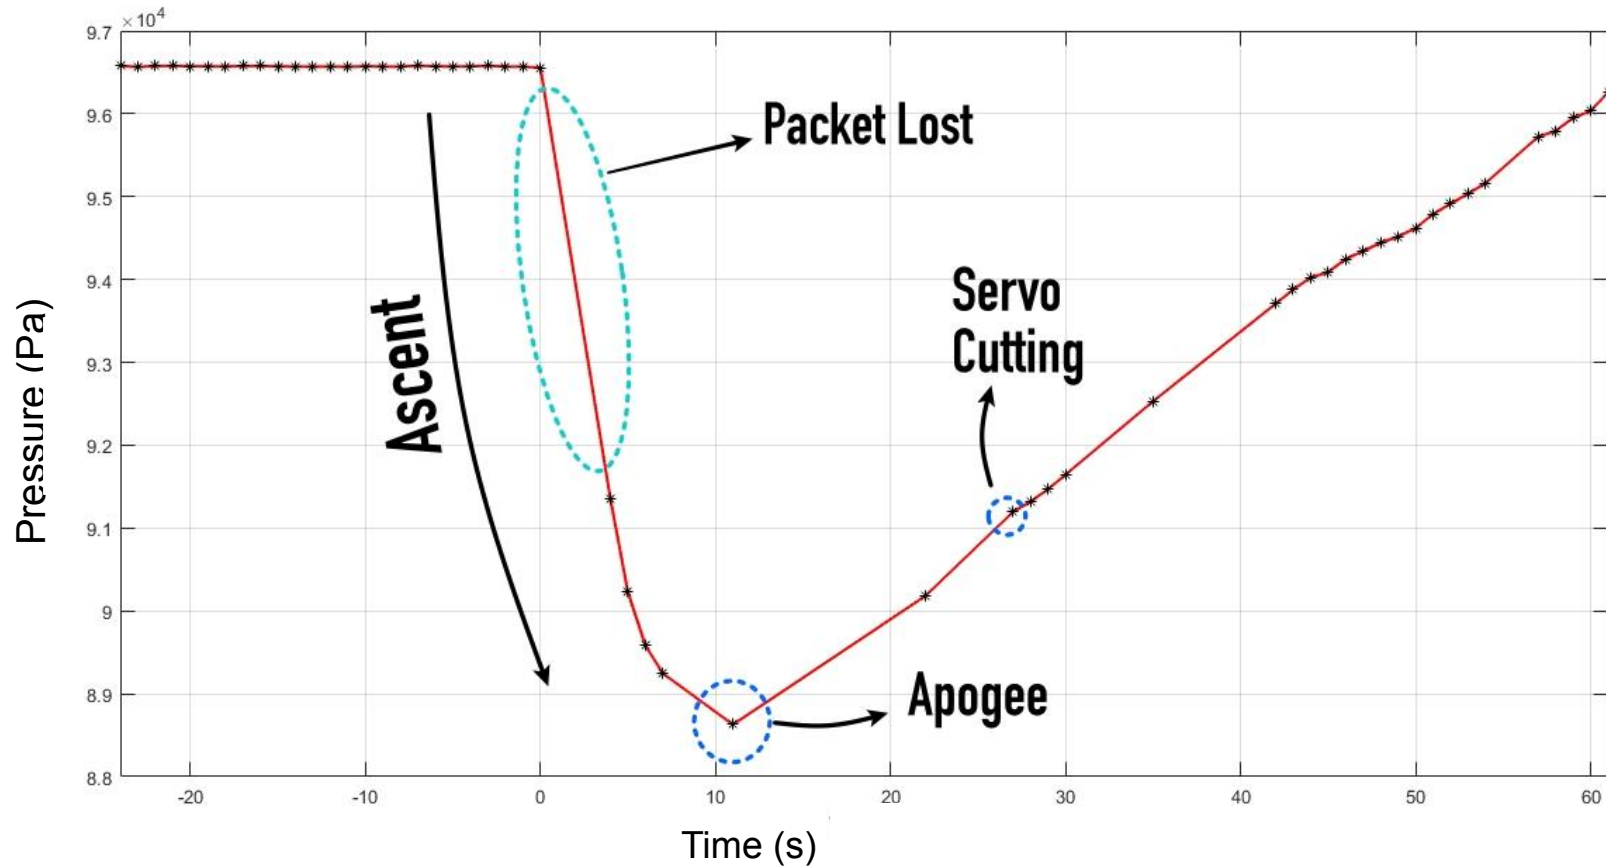
Payload pressure sensor data plot

Pressure being inversely related to altitude dips during the ascent and increases while the CANSAT descends.

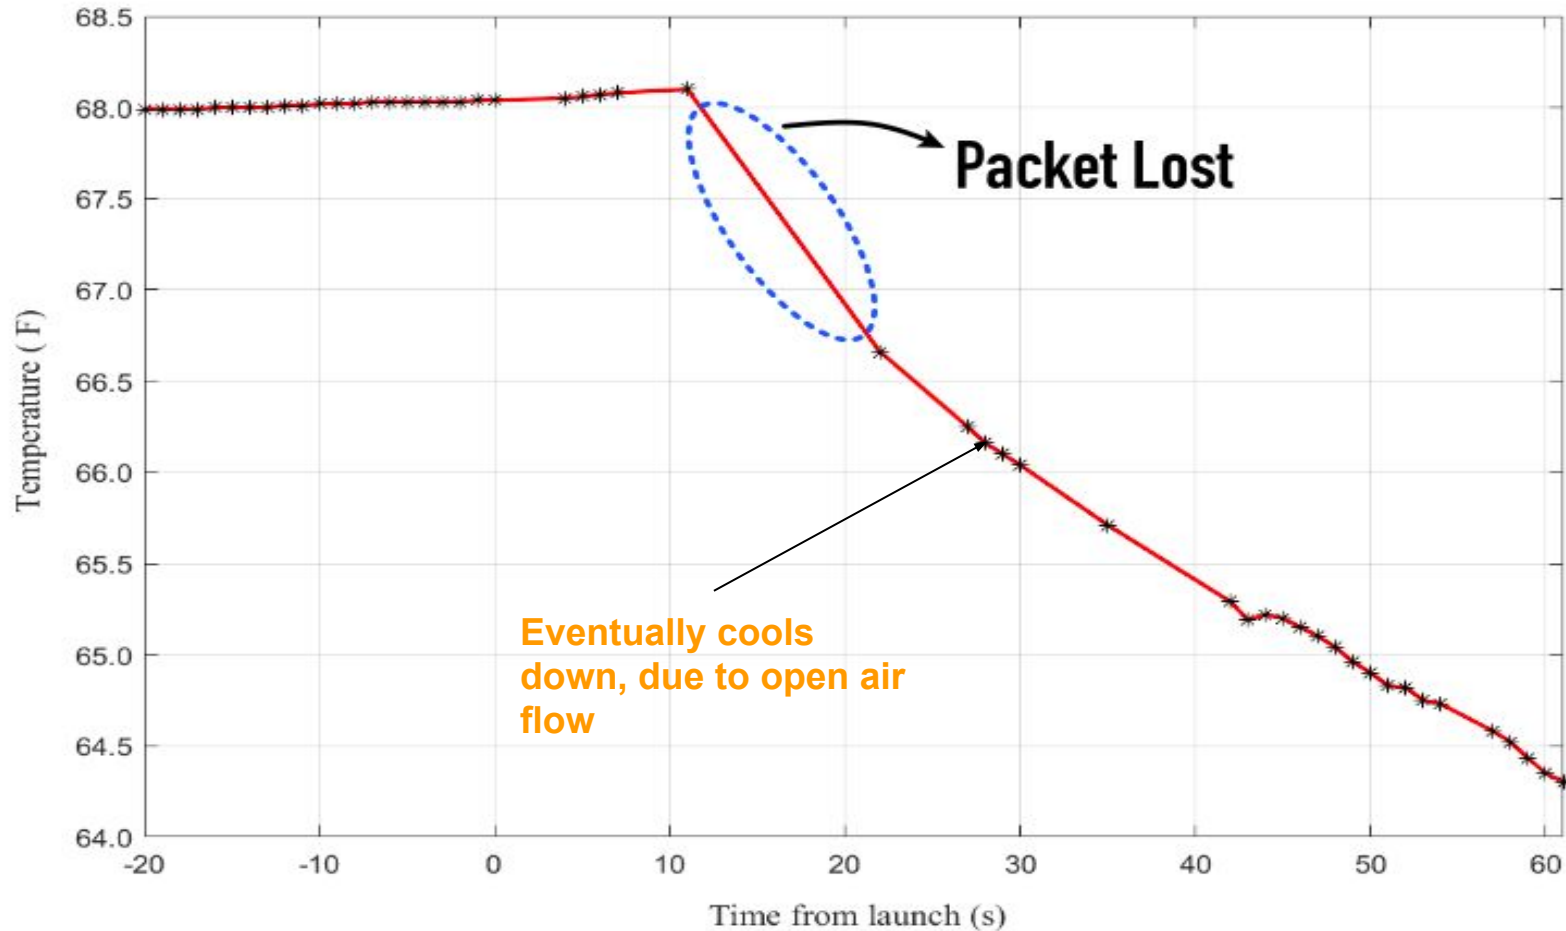
Payload temperature sensor plot

As can be seen , the temperature does not vary much during the flight but slowly decreases

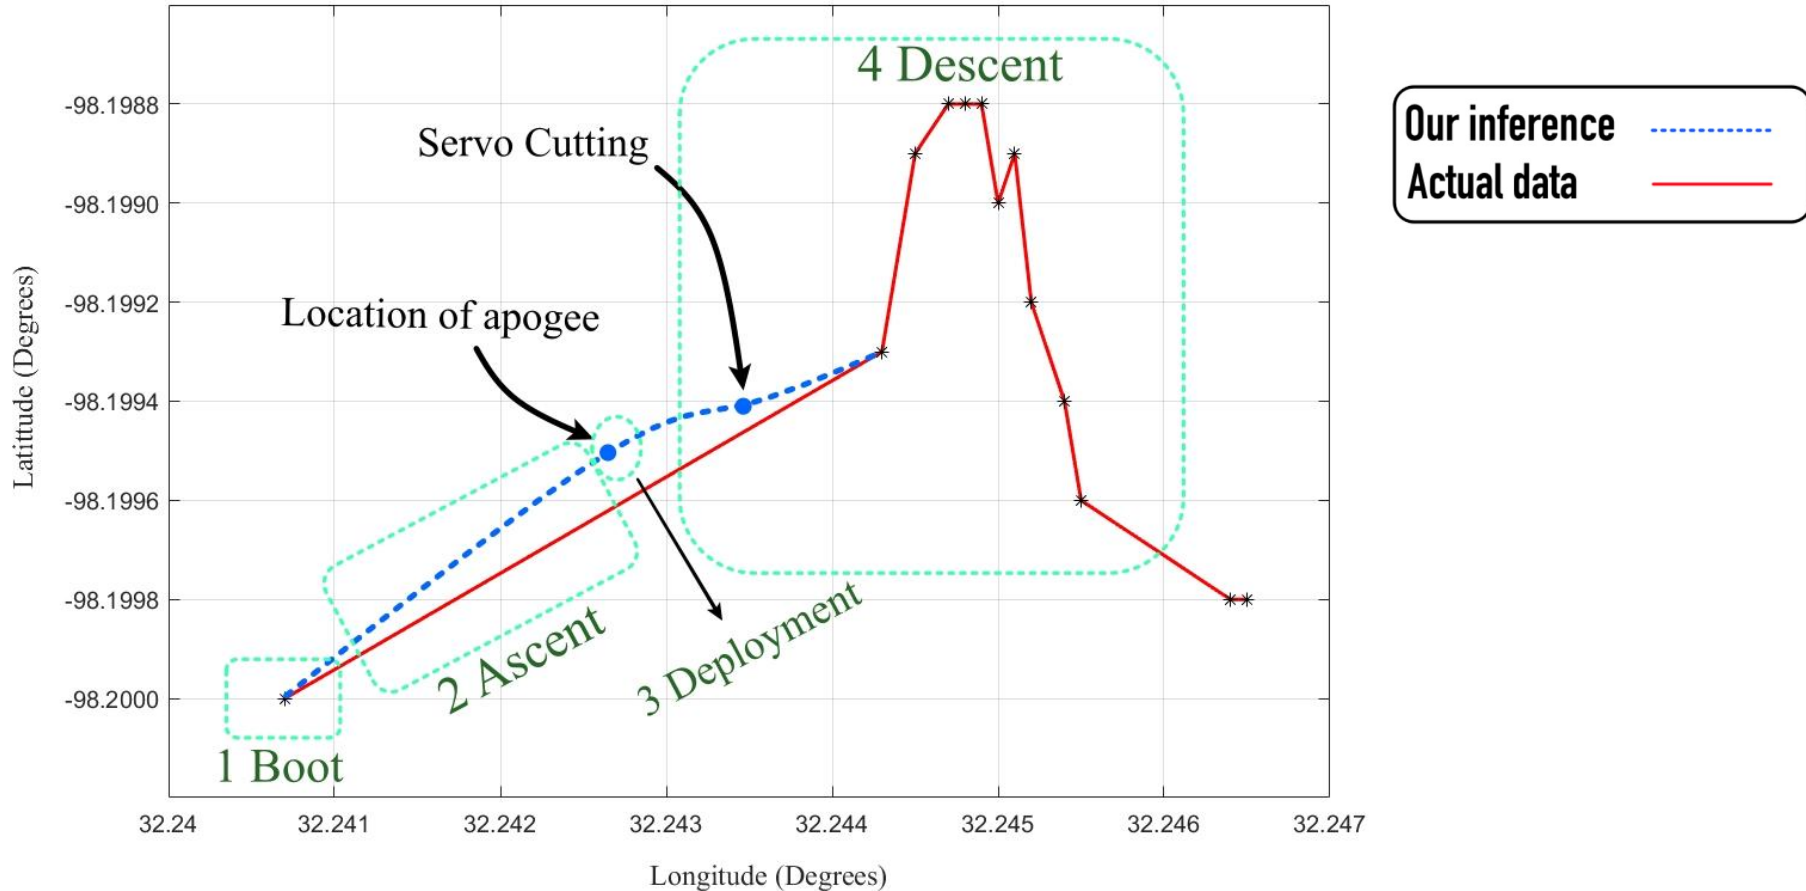
Payload GPS plot (1/2)

2 D interpolation of GPS data shows that although we missed some packets , the ones we received give us the trajectory fairly accurately . The last received packet was also close to the actual location.

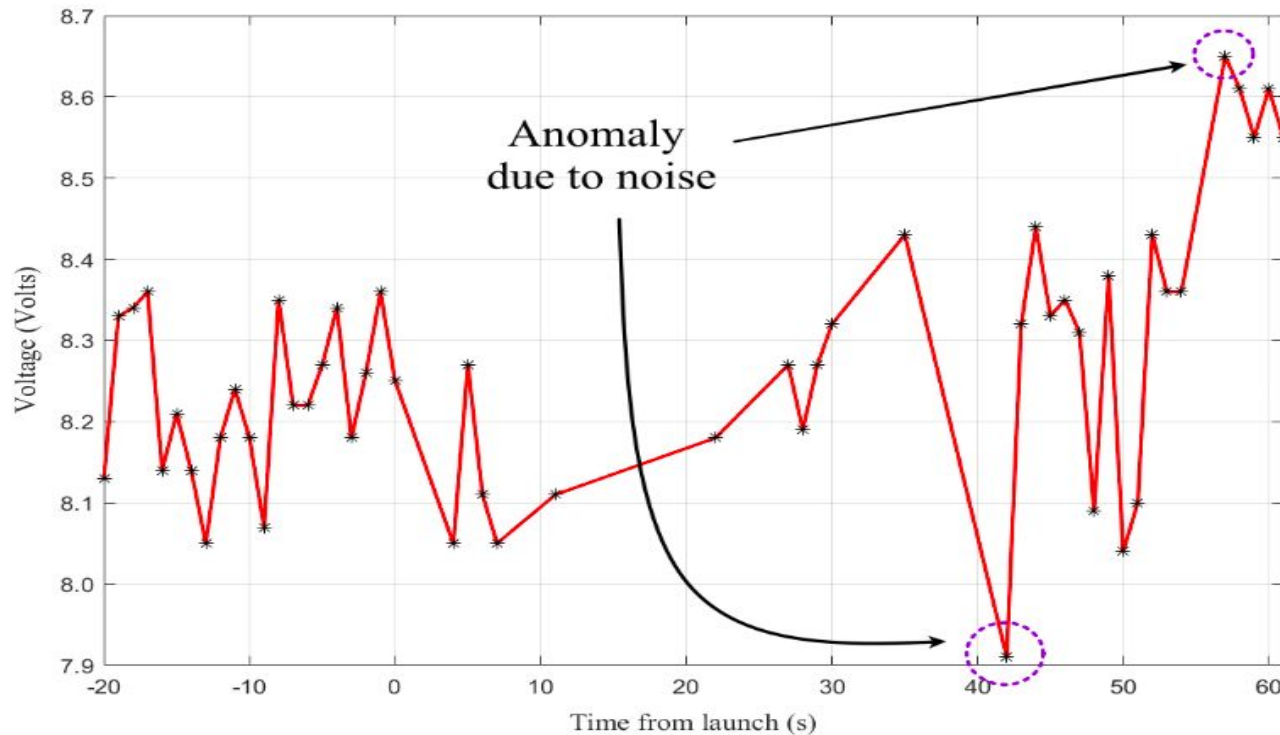
Payload battery power plot

Battery voltage almost remained constant because there was no high current drawing component.

Bigger capacitors can be used to filter out these oscillations , however they were avoided due to weight constraints .

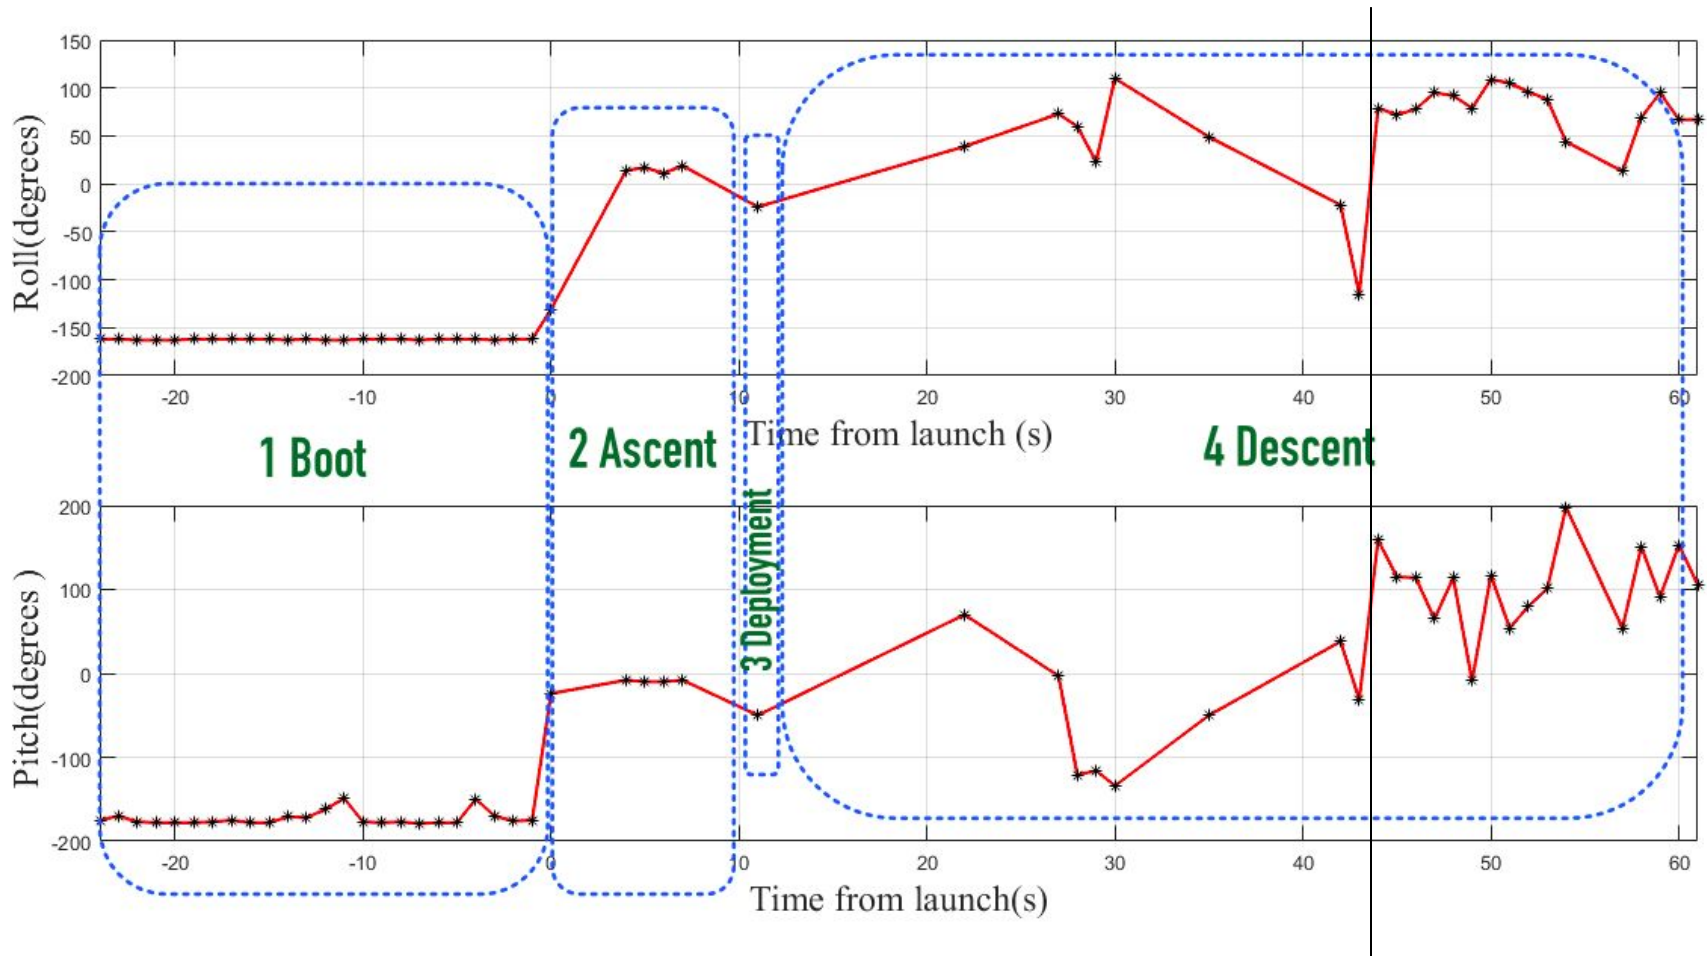
Tilt Sensor plot

An animation of the above plot shows that except for some initial turbulence , the roll and pitch move back and forth and the payload falls in the nadir direction .

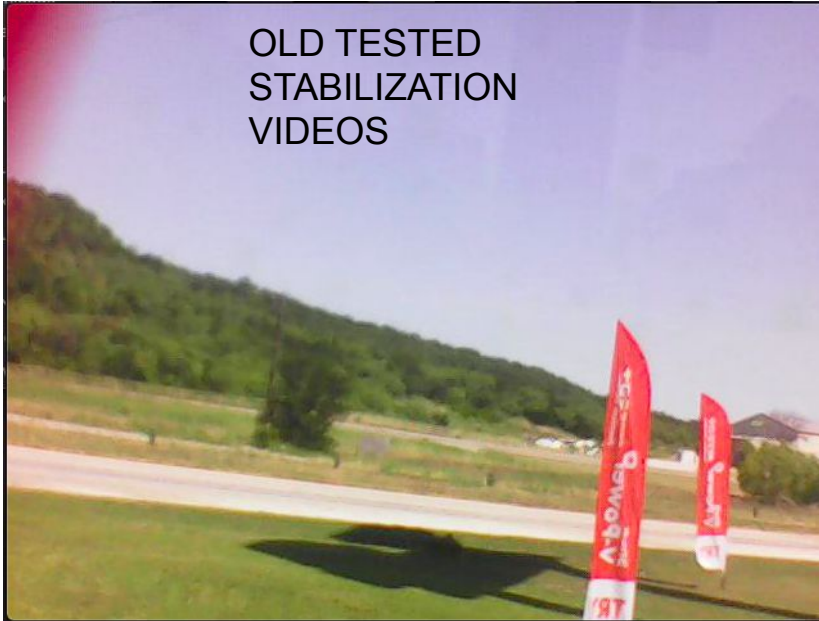
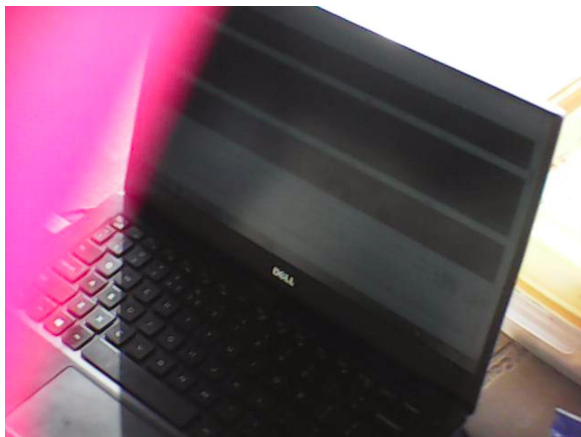
OLD TESTED
STABILIZATION
VIDEOS

Our camera didn't record anything in the SD card during flight though our stabilization system worked.

This was unexpected because camera stabilization system worked well and camera SD Card recorded video too during testing (images on left) and that's why we invested 130g weight (Current weight = 628) more by developing stabilization system in the cansat.

After the flight we found the wire that switches on/off the camera was broken. Reasons could be the jerks faced during take off or deployment.

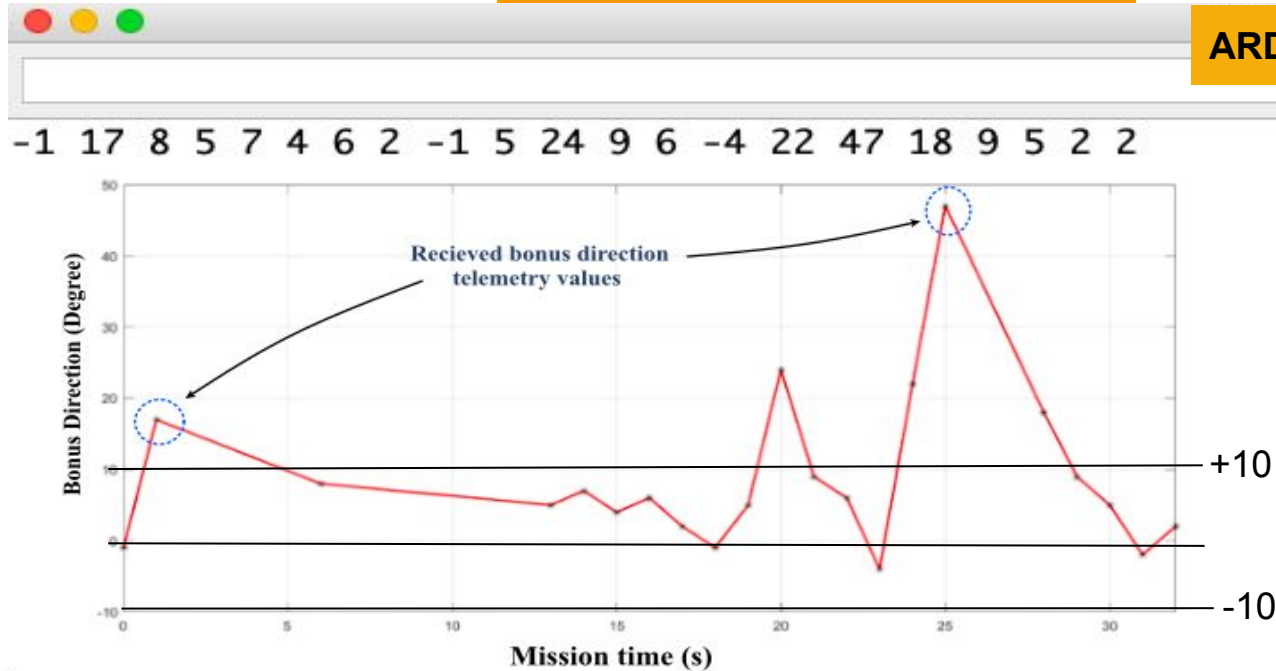
ARDUINO IDE SCREENSHOT

CAMERA STABILIZATION - SUCCESS

Most of the readings (70%) stored in the EEPROM range from -10 to 10 degree deviation. Thus, Camera Stabilization system was a major success.
