## How To Read A Damaged Piston

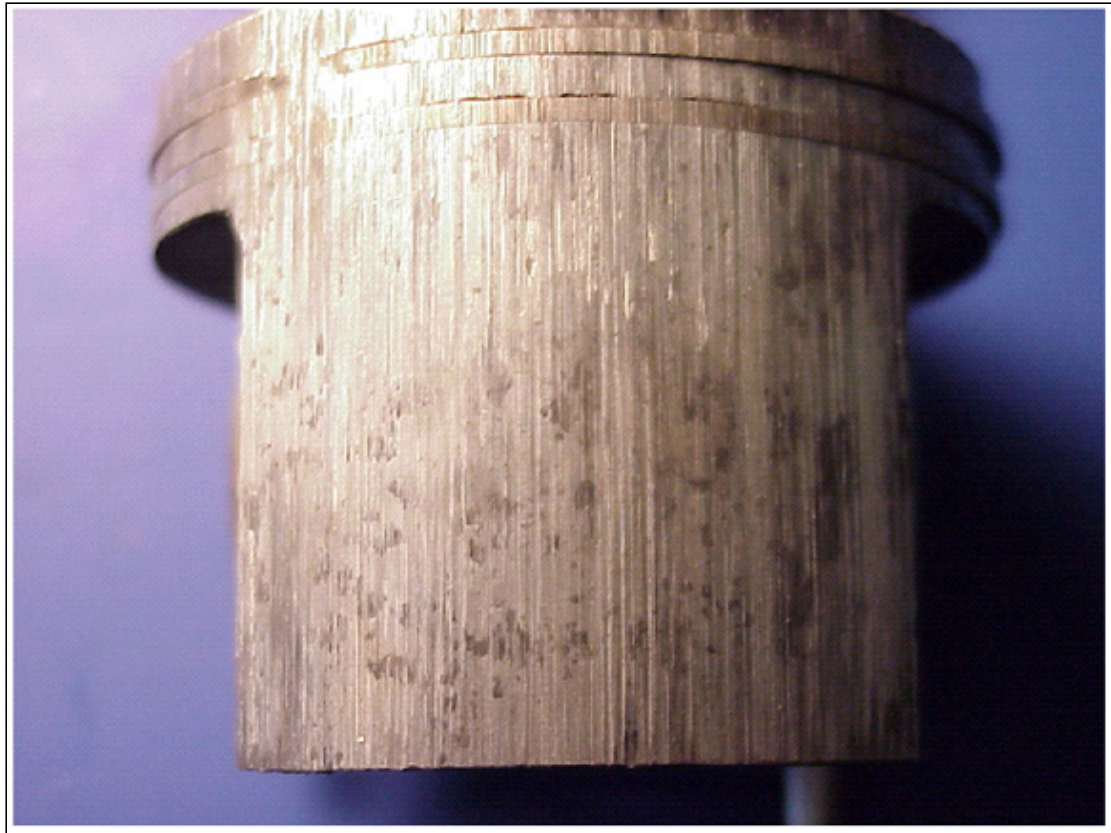
### Damage From Running Unmixed Fuel

The piston above has severe scouring on the exhaust skirt with the heaviest damage on the clutch side of the piston. All of this damage was caused from running straight fuel in a STIHL MS360. The lack of lubrication on the piston has caused it to seize to the cylinder wall. The damage you see was caused in the moments before the piston "stuck," which seized the engine.

This kind of piston damage can also be found on a saw that was run with the carburetor set too lean or one that was run with an air leak. If you didn't know this saw had been run with no oil in the fuel, how would you know it wasn't a heat seizure? To fully understand the cause of this failure, it is important to look at the rest of the piston. The photo below is of the same piston. It shows additional damage that's usually only found on a saw engine that had been run with unmixed fuel.

If you tear down a saw and find this kind of damage, don't forget to replace the fuel in the saw's fuel tank before you test run it after the repair. It is also important to check the contents of the fuel container that was last used to fill it. Since the repair required the replacement of both the barrel and piston (read: expensive,) this is a repair you don't want to do twice or on more than one saw.

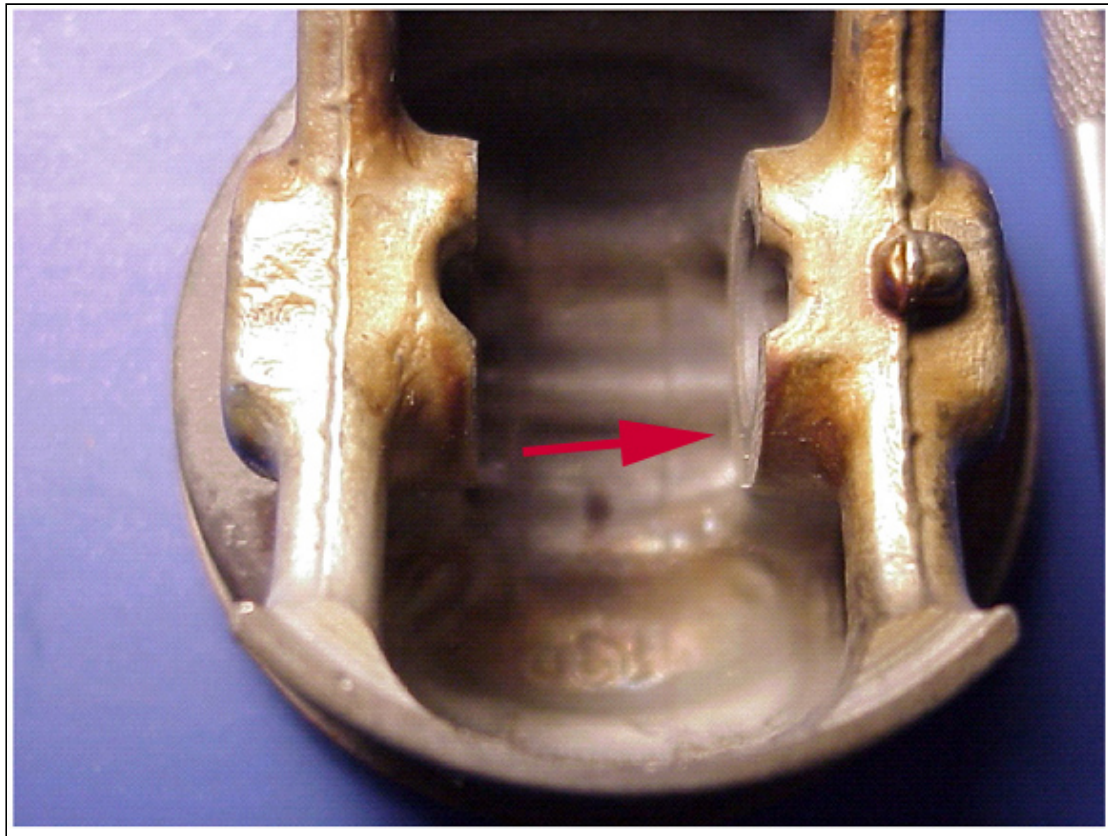
On this piston, notice the scouring in the wrist pin area. (red arrow) You can also see it is dry under the piston, in the cir clip area, under the rings, and in the transfer ports -- no oily residue. A heat seizure will show similar damage on the piston skirt (photo one), but the conditions under the piston will look normal. On this piston, the scouring and other dry conditions provide the evidence to suggest this seizure was caused by no lubricant in the fuel.

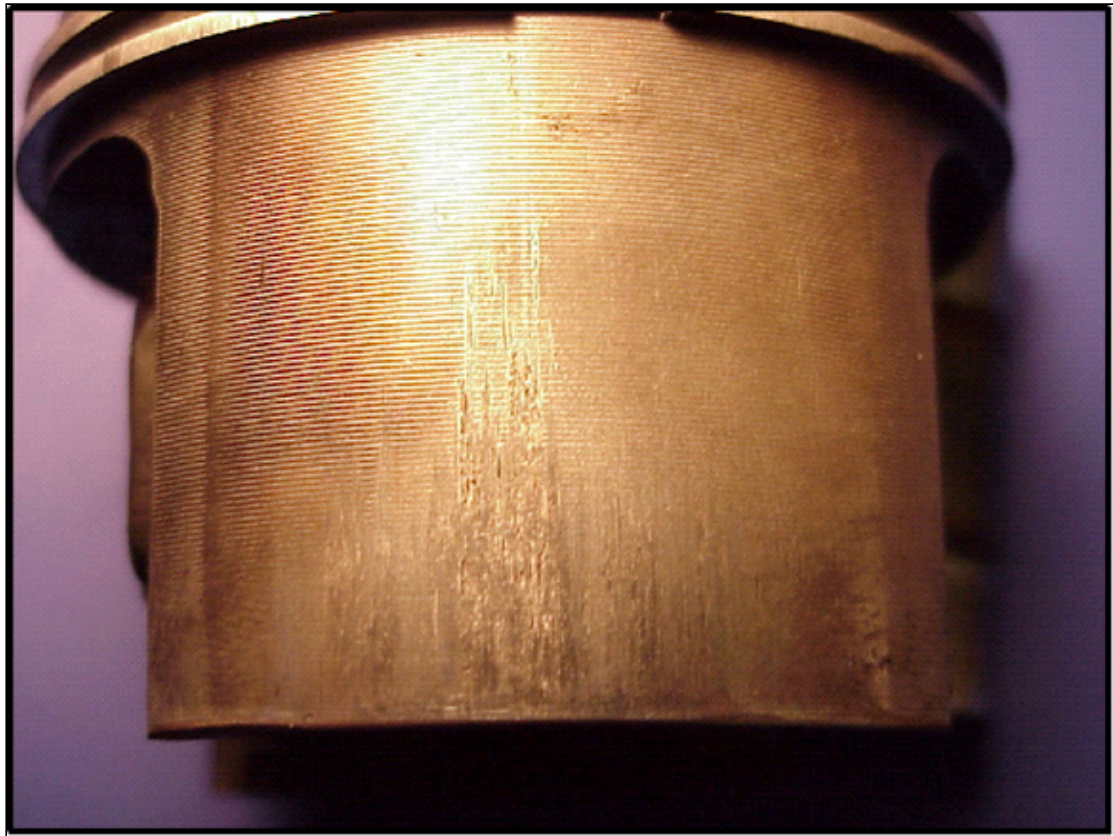
### **Damage From Debris Getting Through the Air Filter**

The damage on this piston skirt is caused by debris getting through the air filtering system. Notice the horizontal machine marks have been scrubbed off all across the bottom indicating extreme wear on the lower part of the skirt. Not shown, but the other side of the piston looked perfect. This damage was only found only on the intake side of the piston. This is typical for damage caused by intake debris. The other side of the piston is not exposed to an intake port, so it isn't affected at early stages.

What damages the intake skirt is debris from a leaking filter wedging between the piston and cylinder wall causing scuffing on the piston skirt. Since the piston is made of softer material, the damage is more pronounced on the skirt than on the cylinder bore's hard surface. This wear on the piston increases the clearance, which allows the piston to "rock" in the cylinder's bore. As the skirt becomes thinner and weaker, rocking increases. Eventually the piston will break. When it does, the engine seizes.

When a faulty air filter is replaced, this puts a temporary stop to further debris damage, but it does not reverse damage once it has occurred. This is why it is important to change air filters *before* they fail. Most pro saw manufacturers suggest changing the air filter after thirty days of use or before if a regular inspection reveals any leakage.

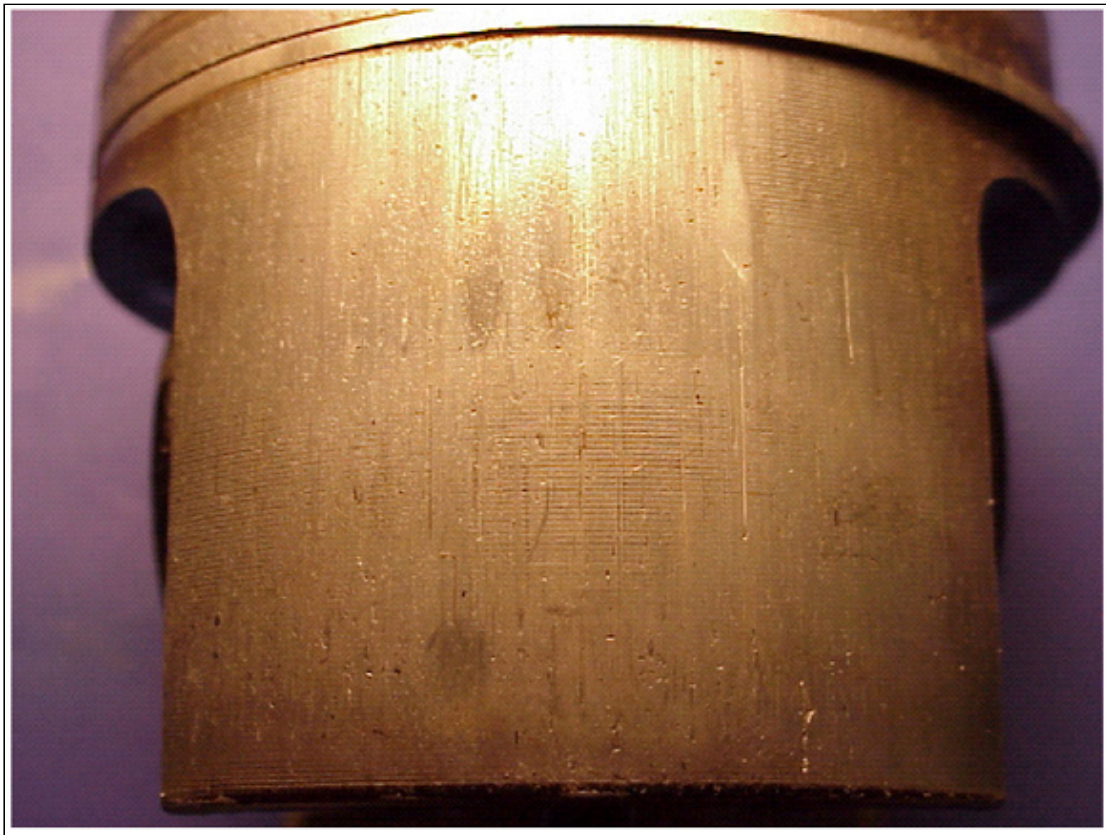
### **Damage From Bearing Failure**

These fine scratches and "peppering" on the exhaust skirt and lower intake skirt is caused by the failure of the lower rod bearing or main bearings. Small, but hard pieces of the bearings and retention cages are breaking loose, causing this piston damage. If you are lucky enough to catch a piston in this condition, stop running the saw until you find which bearing is giving up material. If you keep running the saw, eventually the bearing(s) will completely fail. This usually releases larger pieces of bearing material.

When this occurs, sometimes the crank shaft locks up. But if it keeps running, loose pieces in the bottom end will travel up through the transfer ports and into the engine. All the parts won't make the complete trip. Some won't pass through the upper transfer port and when the piston goes by, it will drive these parts into the cylinder wall, destroying both. To repair this damage, both the crankshaft assembly and the cylinder and piston must be replaced -- two very expensive components.

We typically see this kind of damage on saw engines that have been over-revved. For more information see our section on [Rod Bearing Failure](#).

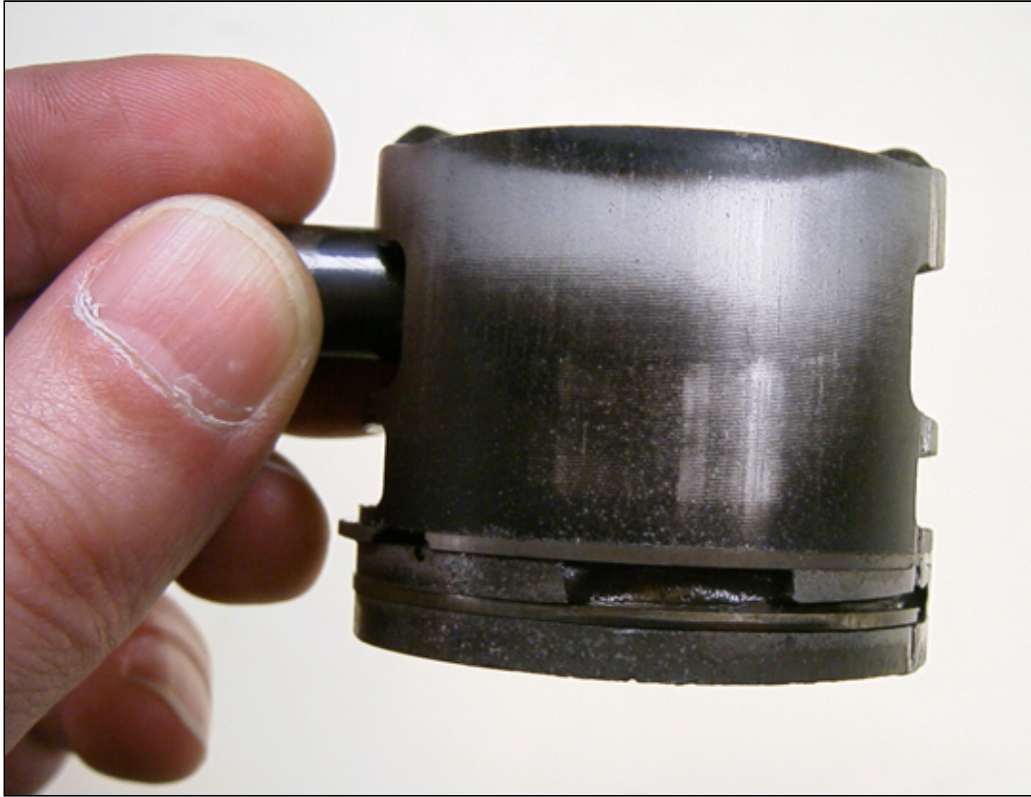
## **Damage From Over-Speeding The Engine**

The piston above has been damaged by over-speeding. Look at the piston material between the ring-lands. You can see a big chunk of it is missing and some has been "squished" thinner, creating a super-wide ring-land. Look at the top ring (bottom of photo). You can see the edge is rounded-over, a sure sign the rings were catching in the exhaust port. When this occurs, this sets off a high frequency vibration, eventually breaking the ring-land.

When operating a pro saw, don't over-rev it. Some pro saw users like the sound of a "screaming" saw, but it shortens its life and causes expensive repairs. Proper fuel mix also plays a role in both the performance and working life of a pro saw. High octane fuel and the use of properly formulated mix oil is extremely important. The way the fuel is blended and its age are also factors. Maintaining the air filter is also important. Inspect it, clean it, and replace it often. Postponing air filter and fuel filter replacement is not a good way to save money.

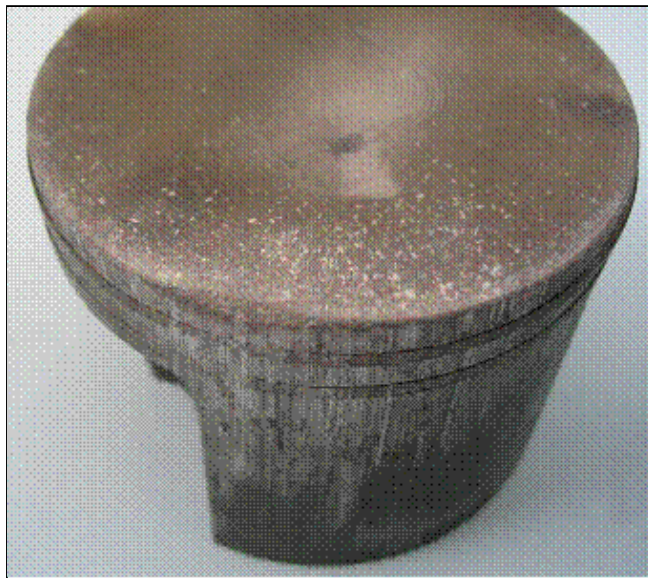
## **Damage From Detonation**

The piston above has been damaged by detonation. Notice the damage on the top and the edges of the piston. The heat caused by detonation made the piston so hot, the rings stuck and the piston seized in the cylinder. You can see the seizure marks on the side of the piston. This damage usually ruins both the cylinder and piston.

Detonation can be caused by a number of things. In this case, changing to higher octane supreme grade fuel was the answer. See our article on Fuel for more information.

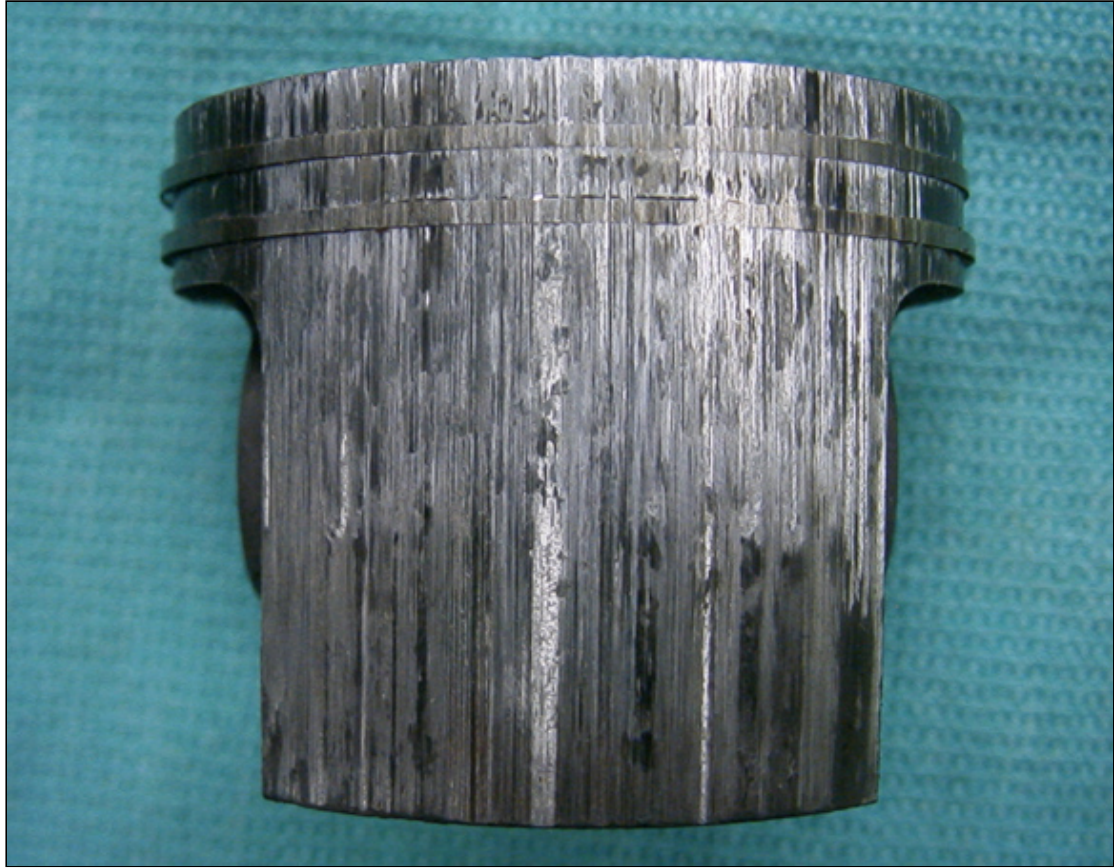
## **Damage From Heat Seizure**

The piston above shows the most common severe piston damage we see - the exhaust side has damage caused from excess heat. This damage looks similar to piston damage caused by running straight gas shown in the first image, but with this piston, conditions under the piston looked normal.

This kind of damage can be caused by over-revving the saw, running the carburetor adjustment too lean, by ignoring an air leak in the saw's engine, or a combination of factors. The best way to avoid a such a seizure is to use good quality fuel and mix oil, avoid over-revving the engine, and always stop running a saw that shows signs of a potential air leak. This kind of damage can also be caused by a partially plugged fuel filter, which is another reason fuel filters should be replaced regularly.

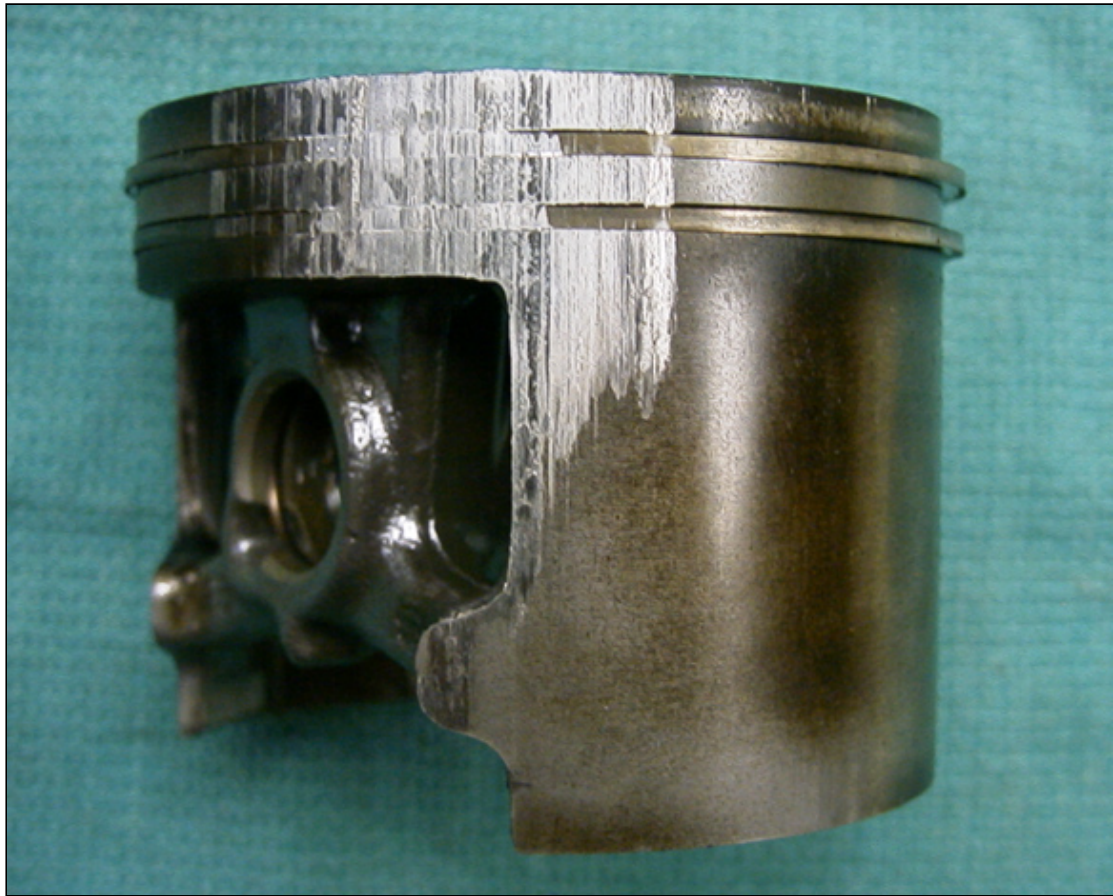
## **Damage From Heat Seizure Due to Blocked Cooling**

The piston above also shows damage from excess heat. What makes this piston damage interesting is that this damage is on the side of the piston - near the transfer port, and not on the exhaust side where heat damage is found more frequently. In this case, the damage occurred on the back side of the cylinder, where less air passes over the cylinder's cooling fins.

On all saws, the cylinder causes a sort of circulation "shadow" reducing air volume to the cooling fins behind the bore. This is one reason it is important to keep the cylinder's cooling fins clean and free from debris. When wood chips build up around the cylinder, they can block air circulation that cools a saw's cylinder. Today's pro saw engines need all the cooling they can get, especially when a saw is making a big cut in a tree on a hot day.
