Instructions to get ERP Trigger and Logging Up and Running – Bench Unit

Testing Pre-deployment – Field Unit

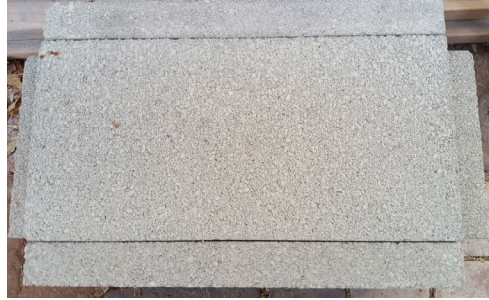
- 3) Prior to transport the the fram the unit was powered and tested in the vault again before sealing the NEMA enclosure with rs.local, ssh, and power from Solar power bank. Passed all basic tests before transport to the farm to bury.
- 4) Vault closed (lid is held in place by friction – not glued and not strapped – possible improvement), but assumption is that most force is compression rather than shear. Wrapping the valut with stapping to make sure the lid is less likely to slide out of place might be advised. See the closed vault images below.

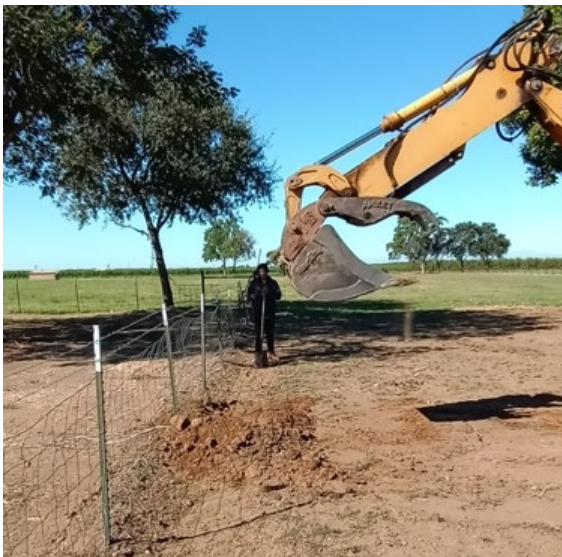
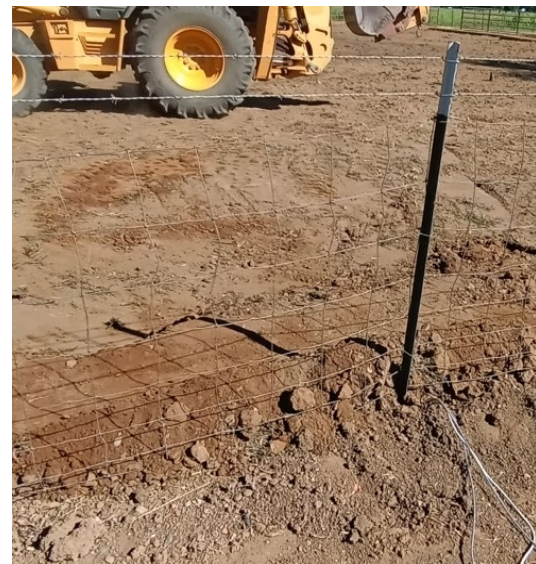
- 5) Buried inside fence near fence post (for cable run) about 3 feet in depth (top 2 feet below ground), soil mildly compacted with backhoe to be level, cables run outside the fence and ultimately protected with a PVC pipe (post bury). Vault placed on relative flat hole bottom with dirt hand packed around the sides before the backhoe replaced soil on top and compacted.

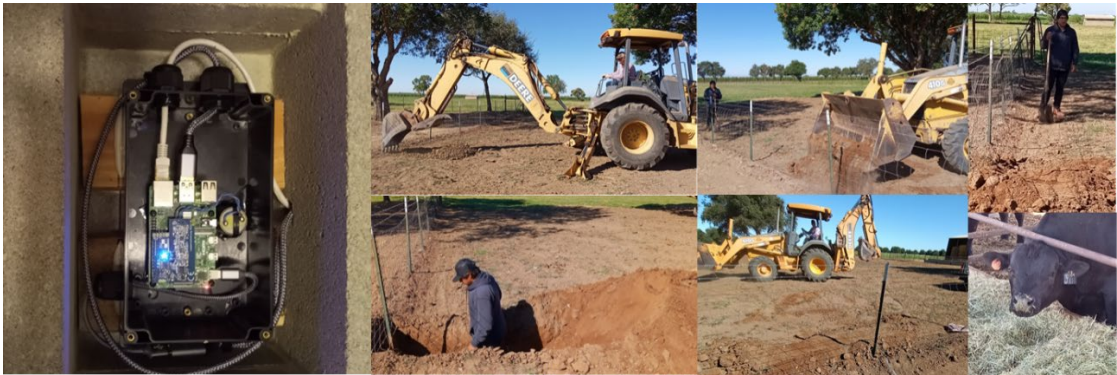
- 6) Unfortunately, computer and cables required to test immediately post install were not available. First real-power on test was on 10/14/22, almost 2 months later!
- 7) Power-on test in place on 10/14/22 failed step #3 in bench test procedure – never saw any link lights and could be due to:
 - a. Cable pull on power or networking (due to strain during burial or in-place)
 - b. Vault structural failure (soil on 10/14/22 was significantly compacted by cows/bulls)
 - c. Connector corrosion or dirty connector issues or cable failure
 - d. Procedures followed matched bench tests (repeatable), but there is always the potential for error (unlikely)
- 8) Summary – dig up, inspect for failures, re-deploy. Ideas to improve are:
 - a. Deploy outside of fence (other side) – less stress on unit
 - b. Reinforce the vault (e.g., interior wood supports)
 - c. Re-design the vault

- d. Add better cable strain relief measures
- e. Bench test thoroughly before re-deployment and fix/replace any broken hardware
