Bento Rodrigues dam collapse: quantification of the affected area

Lucas Schmutz

The goal of this small project is to use remote sensing, in this case freely available satellite images, to quantify the affected area.

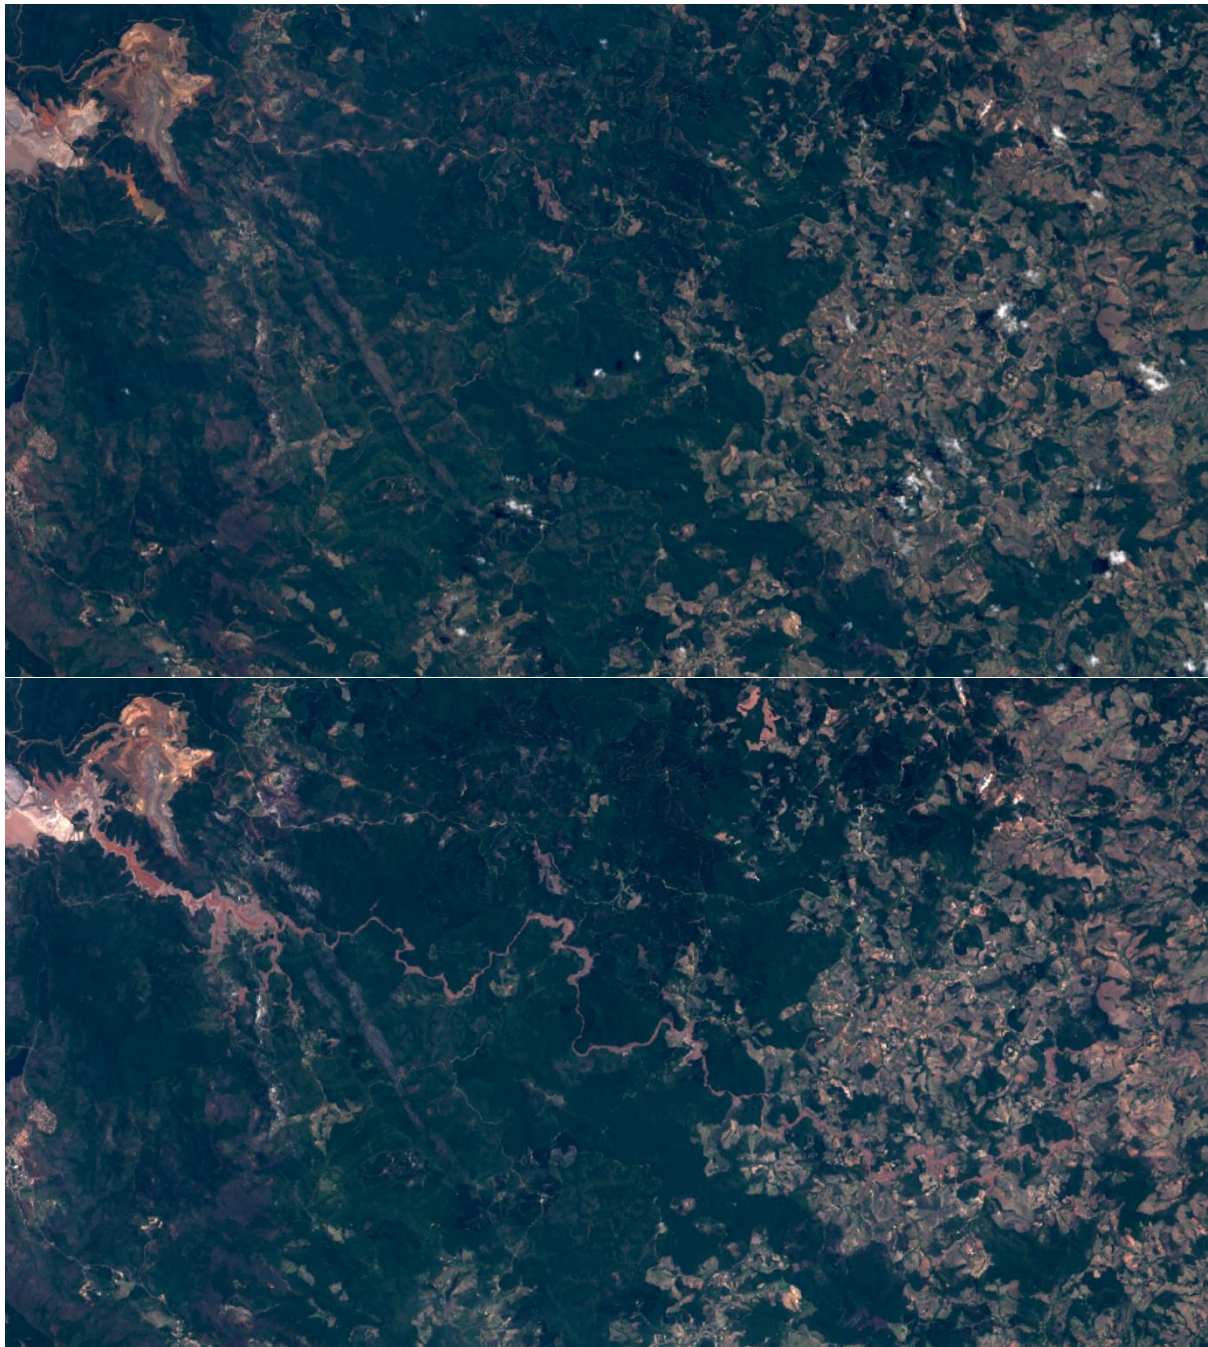
Figure 2 : Visualisation of the before (above) and after (bellow) in RGB (bands 4,3,2)

Both images are from LANDSAT 8 and I downloaded them to further process in MATLAB. On Figure 2, you can observe the extent of the flood in RGB colors.

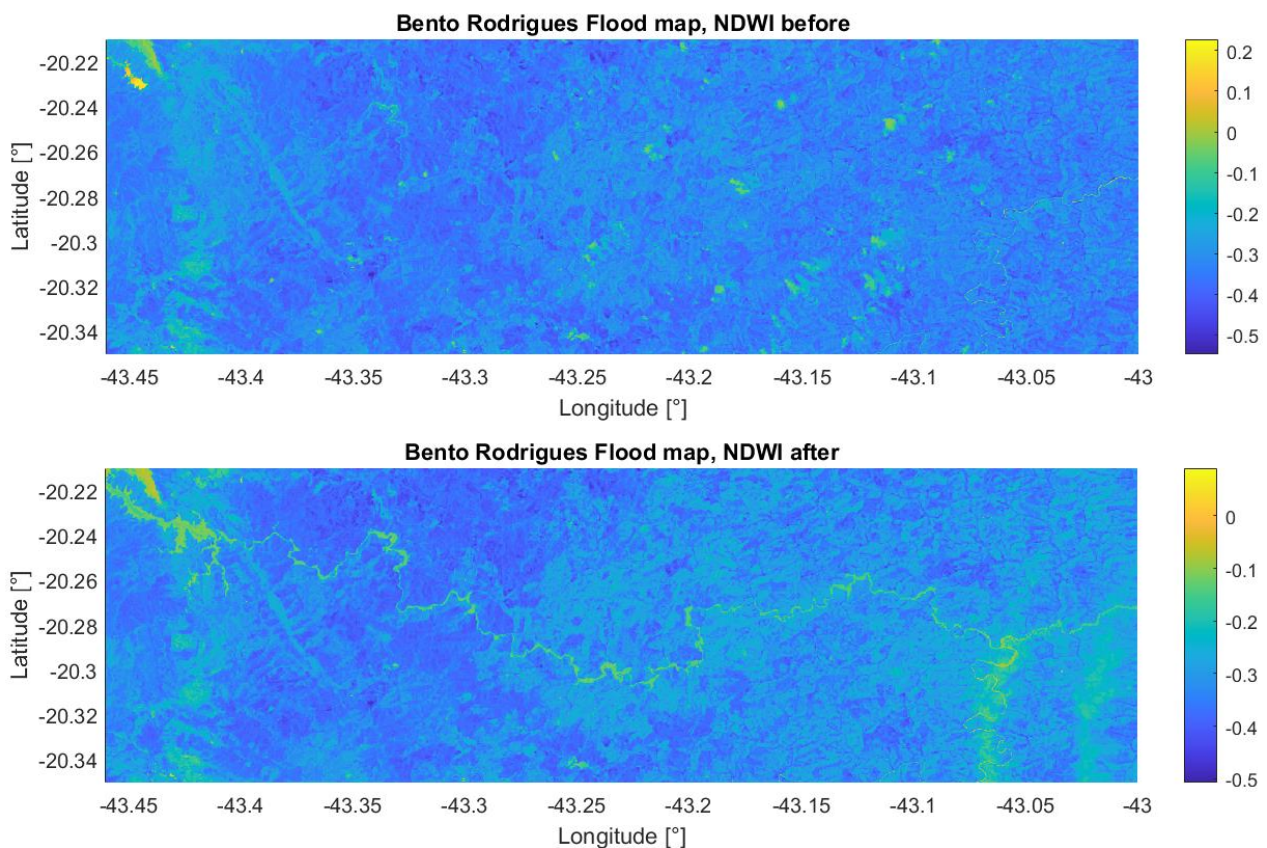
Figure 6 : NDWI before and after the flood

The Normalized Difference Water Index (NDWI) refers to at least two indexes related to water. The one suited for the detection of water bodies uses the green and NIR bands, bands 3 and 5 respectively for LANDSAT 8 (McFeeters, 1996). Figure 6 displays the NDWI before and after the event. The course of the Doce River appears a lot wider after the flood and I assume

that even if the area is not flooded anymore, the deposition of water rich sediments up to 3m high (Carmo et al., 2017) changes the reflectance significantly and allows us to visualize the event. I also tried other variation of NDWI, but they did not provide as good results as the bands 3 and 5 version. The NDWI seemed to be an appropriate way to quantify the area affected by the flood and in the next section I will develop the workflow I adopted.

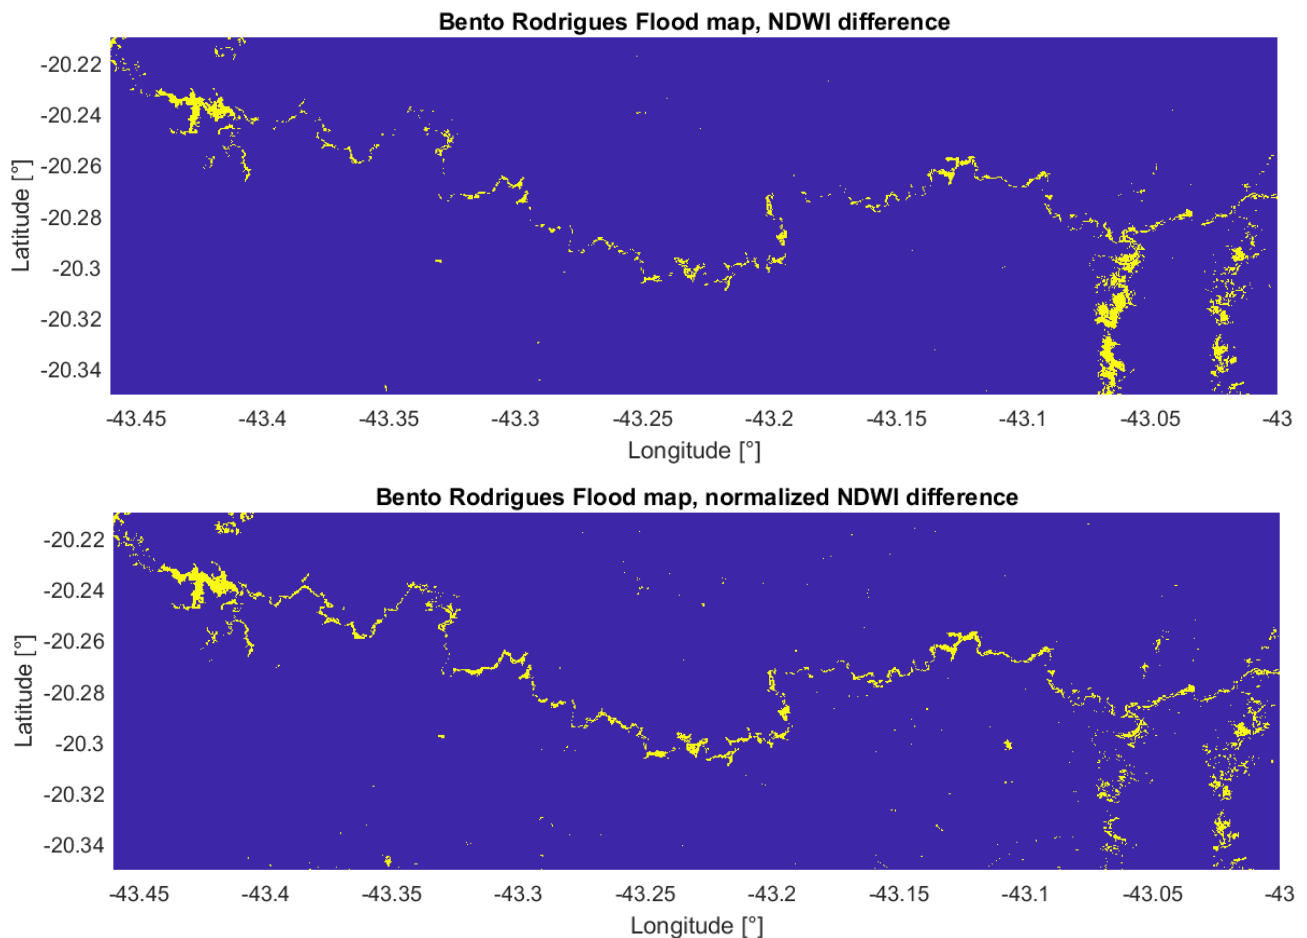
Figure 7 : Comparison of the NDWI and normalized NDWI flood map

On Figure 7, we can observe the superiority of the normalized NDWI. It is able to suppress a bit more of the clouds and cloud shadows in the lower right part of the image, and the flooded zone of the river are more in line with what can be visually observed in the corresponding zones. It is also important to note that the number on TRUE pixel is almost exactly matched between the two maps, revealing the most effective method.

Looking more closely at the normalized NDWI flood map, we see there is still a small number of false positive, and that the clouds and cloud shadows are still visible. However the flooded zone are better defined, especially in the north-west, where the flood originated, and the flooding was the most substantial.

An important thing to note is that with this method of difference, the before river course is subtracted in the resulting the flood map, it is correct in terms of flooding, but it omits the fact the riverbed itself has been polluted by the toxic sediments.

In the end, the flooded area I was able to compute is 18.5km^2 . Which is in the neighborhood of other estimation of the disaster that range from 15km^2 to 22km^2 (Carmo et al., 2017; Instituto Brasileiro do Meio Ambiente e dos Recursos Naturais Renováveis [IBAMA], 2015; Segura et al., 2016).
