Bento Rodrigues dam collapse (2015)

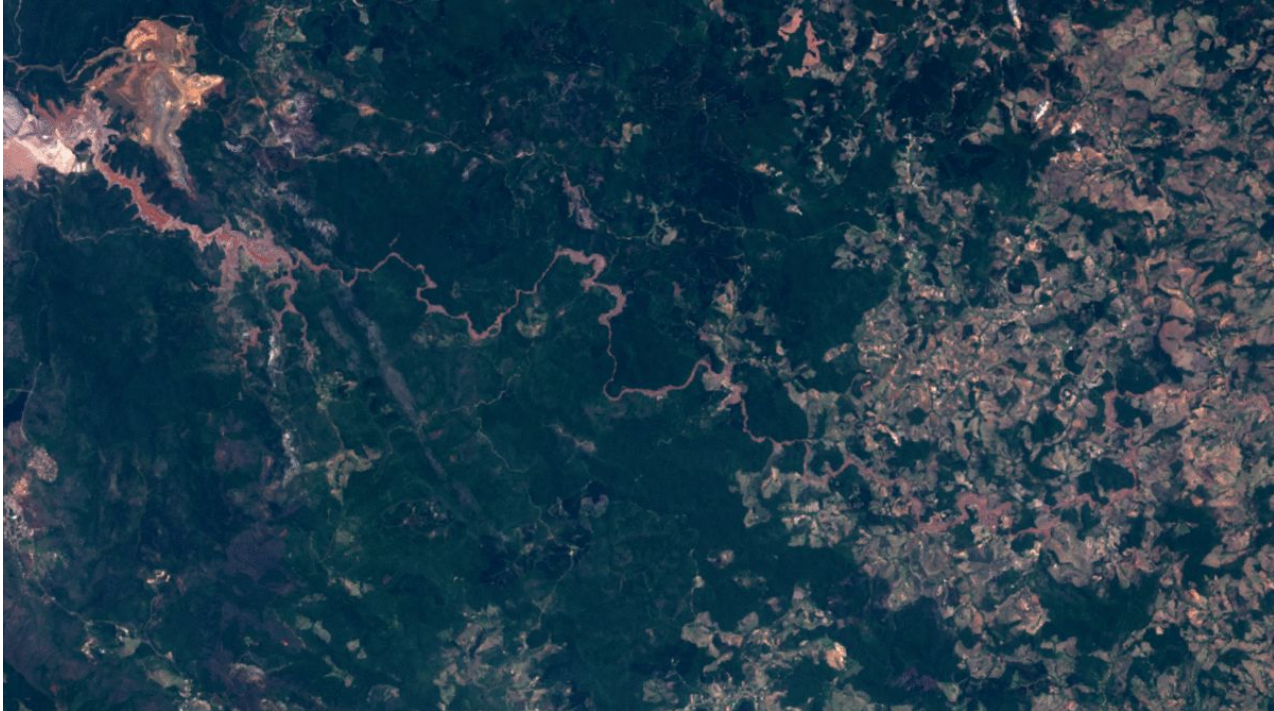
Bands 4, 3, 2

- ❖ The mudflow is brown and is deposited by the flooding
 - Changes in reflectance in bands 4,3,2
- ❖ The mudflow is mostly water
 - Strong absorbance in IR, bands 5, 6, 7

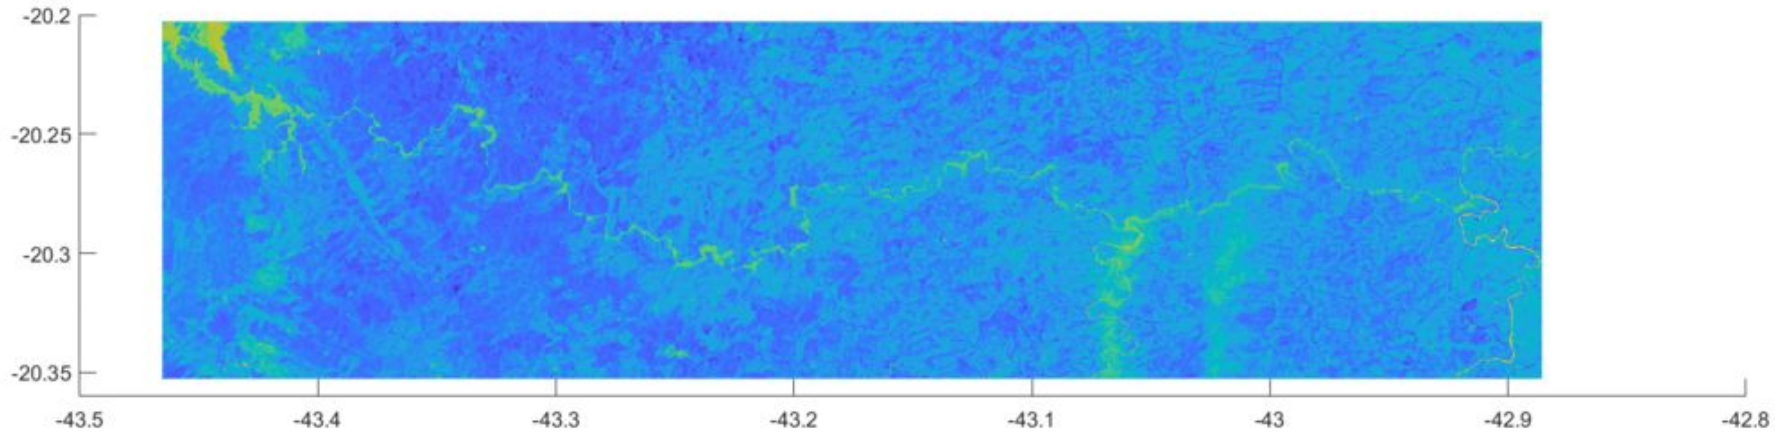
- NDWI using bands 5 and 3

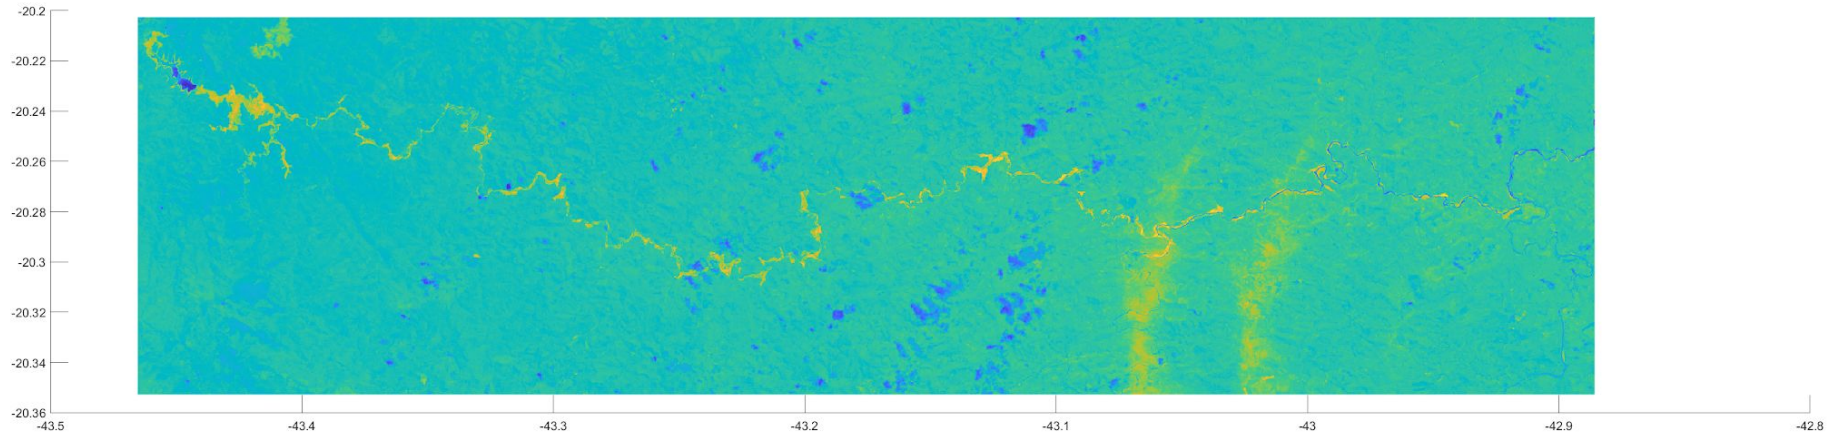
- Difference on NDWI (B5, B3)

- Merging the difference on the NDWI with a DEM
- Adding per pixel constraints
 - Threshold on the NDWI difference +
 - Changes in B5 reflectance $\rightarrow B5_{after} < B5_{before}$
 - Manually selecting the zone of study
 - ...
