Static and Dynamic Testing Featuring Current Signature Analysis

A Conservative Investment With Immediate Payback

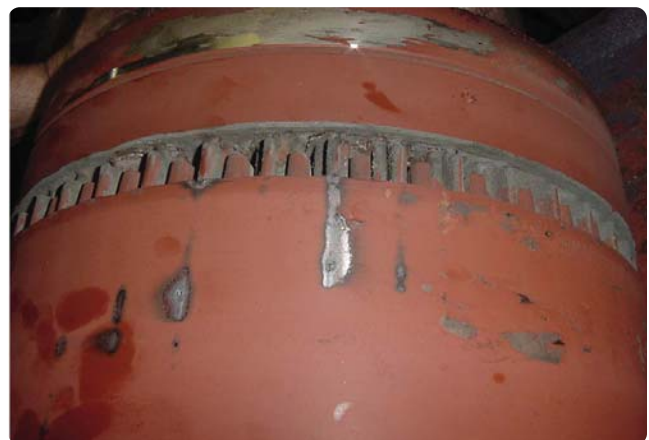
■ PdMA Case Study – 1250 HP Air Compressor Motor

The rotor below had at least five broken rotor bars, a situation that was worsening over a two year period. The test data showed alarm level side-bands, indicative of a failing rotor. The motor was pulled during a planned outage, avoiding costly downtime and preventing complete failure and a likely rewind.

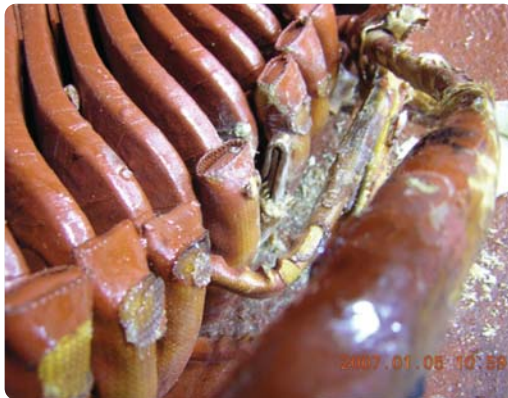
■ PdMA Case Study – Bare Connection in New Winding

This problem was found during a QA check in a motor repair shop prior to being shipped. Test results showed erratic phase to phase resistance readings. During the investigation that followed, a bare winding connection was found (no solder). The connection was repaired immediately, saving the shop a warranty rewind and sparing the customer unnecessary labor and downtime.

418			
View Condition Code Test Show / Hide			
AC Standard	Polarization Index		
Test Date	01/04/2007	01/05/2007	01/05/2007
Test Time	12:06:06 PM	07:58:59 AM	10:35:22 AM
	Baseline		
Frequency	1200	1200	1200
Mohm Ph 1 to Gnd			
Charge Time	60	60	60
Voltage	5000	5000	500
Motor Temp	22	48	22
Measured Mohm	24240.0	1776.0	16270.0
Corrected Mohm	7000.0	3100.0	4700.0
pF Ph 1 to Gnd	32750	33000	30250
ohm Ph 1 to 2	1.00950	1.25900	1.00050
ohm Ph 1 to 3	1.44400	1.40450	1.00150
ohm Ph 2 to 3	1.43600	1.40200	1.00100
mH Ph 1 to 2	126.600	44.270	44.030
mH Ph 1 to 3	128.400	44.280	44.040
mH Ph 2 to 3	126.600	44.300	44.060
Avg. Inductance	127.200	44.283	44.043
% Res. Imbalance	22.14	7.10	0.05
% Ind. Imbalance	0.94	0.04	0.04
\$ Power Loss	764.41	255.98	1.76
Test Location	Motor Leads	Motor Leads	Motor Leads
MCE #	030888HV	030888HV	030888HV
User			
Notes	No	No	Yes

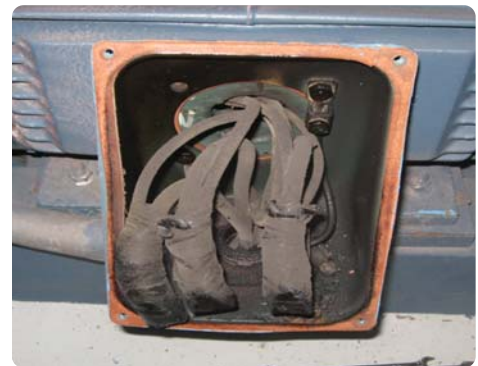
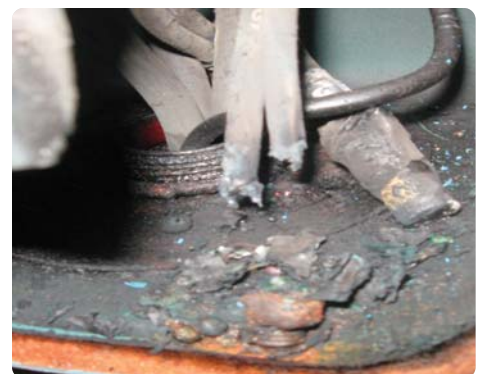
■ High Resistance Connection, 460 VAC 50 HP

During a planned test outage, a significant resistive and inductive imbalance was found. Step by step troubleshooting led to the junction box. After un-taping the leads, the completely burnt connection below was found. The problem was corrected, saving what would have resulted in a blown winding.

MCEGold - (Todd-Vista\PC\MCEGold_EE\MCEGold_Local) Validate - (Test History - 004			
File Options Asset Manager Message Data Windows Help			
Site Navigator Asset Summary Name Plate Add Asset Site Condition Test History W			
File Edit View Test Warning Settings Show/Hide Options			
MCE All Tests			
Site	AC Standard	Polarization Index	RIC Step Voltage
	A	B	C
Test Date	1/12/2009	1/12/2009	1/28/2009
Test Time	11:00:56 AM	11:05:57 AM	9:18:51 AM
Test Location	T-Leads	T-Leads	OH Fuses Local Disc
User	Administrator	Administrator	Administrator
Frequency	1200	1200	1200
Charge Time	60	60	60
Voltage	1000	1000	1000
Motor Temp	23	23	23
Measured Mohm	3082.00	2997.00	214500.00
Corrected Mohm	950.00	920.00	66000.00
pF Ph 1 to Ground	16500	16500	10500
ohm Ph 1 to 2	0.30500	0.30500	0.24050
ohm Ph 1 to 3	0.30400	0.30400	0.24000
ohm Ph 2 to 3	0.53900	0.53800	0.47800
mH Ph 1 to 2	11.480	11.670	13.360
mH Ph 1 to 3	12.840	12.960	12.110

mH Ph 2 to 3	16.960	17.090	17.170
Average Inductance	13.760	13.907	14.213
% Res. Imbalance	40.88	40.71	49.61
% Ind. Imbalance	23.28	22.89	20.60
