# Chamoli Disaster, Himalayas

## 7 Feb 2021 by massive ice and rock avalanche

D. H. Shugar et al. 2021

This disaster severely damaged two hydropower projects and over 200 people were killed or are missing.

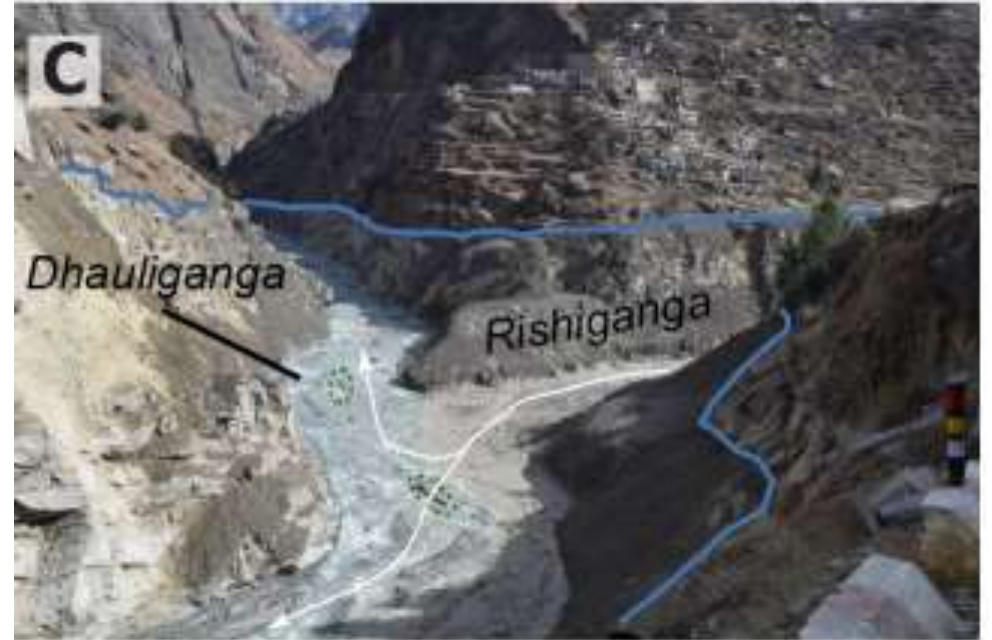
- At junction of Ronti Gad and Rishi Ganga river, a 40m thick deposit of debris blocked the Rishi Ganga Valley.
- Due to deceleration of mass flow at sharp turn
- lake of 700m formed behind these deposits in Rishi Ganga valley upstream of its confluence with Ronti Gad. DEM images estimate deposit volume ~ 8e6 cubic meter.
- It require careful monitoring as there is now risk of GOLF, if ice melt.
- A flood warning system has been installed 400 m upstream of Raini Village.

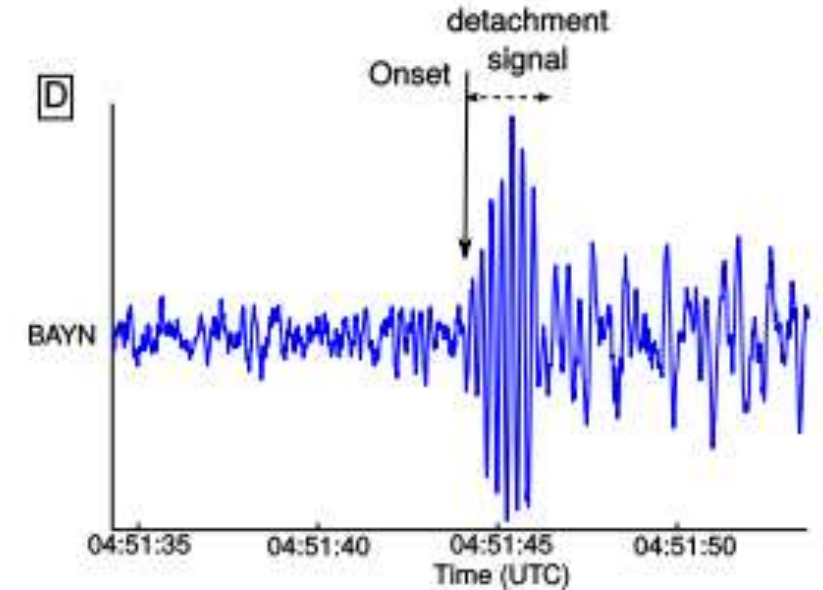
The wave propagation travel time is consequently estimated at between 24.2 and 30.3 seconds at station BAYN

- So, the onset time of the rockslide detachment between 4:51:13 UTC and 4:51:21 UTC
- i.e., 10:21:13 IST to 10:51:21 IST

\* Error on the physical origin of the detachment signal included.

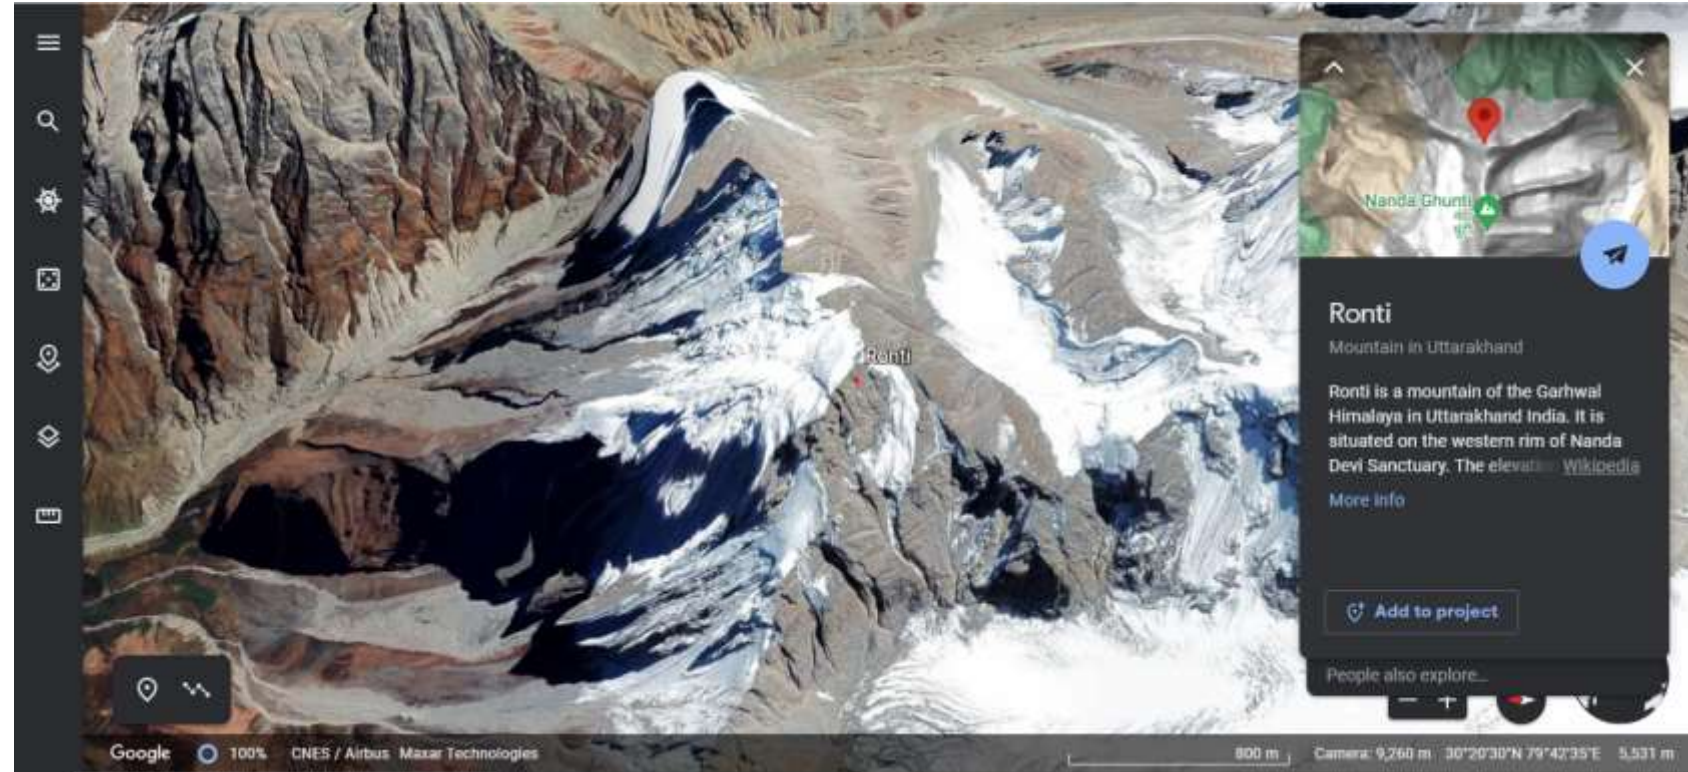
Thermal reason- According to Gruber et al 2017, most of the south faces in central and eastern Hindu Kush Himalaya are permafrost free due to radiation.

- ❑ South face of Ronti Peak is certainly warmer with rock temperature around or above zero degree Celsius.
- ❑ Rock on the north face of Ronti peak likely contains cold permafrost with rock temperature several degrees below zero degree.
- ❑ This causes strong south to north lateral heat flow.

- ❑ Increase in ground temperature would have reduced strength of the frozen rock mass by altering the rock hydrology and the mechanical properties of discontinuities and the failed rock mass.
