Apollo 13 Disaster

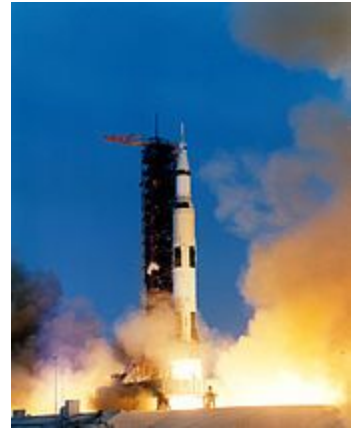
Immediately after the bang, Lovell reported a "main B bus undervolt", a temporary loss of operating voltage on the second of the spacecraft's main electrical circuits. Oxygen tank 2 immediately read quantity zero. About three minutes later, the number 1 and number 3 fuel cells failed. Lovell reported seeing out the window that the craft was venting "a gas of some sort" into space. The number 1 oxygen tank quantity gradually reduced to zero over the next 130 minutes, entirely depleting the SM's oxygen supply.

Because the fuel cells generated the Command/Service Module's electrical power by combining hydrogen and oxygen into water, when oxygen tank 1 ran dry, the remaining fuel cell finally shut down, leaving the craft on the Command Module's limited-duration battery power and water. The crew was forced to shut down the CM completely to save this for re-entry, and to power up the LM to use as a "lifeboat." This situation had been suggested during an earlier training simulation, but had not been considered a likely

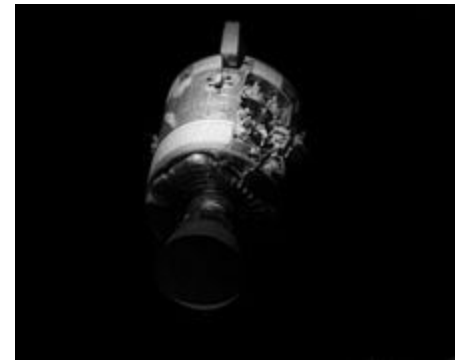
Within the service module were two tanks of liquid oxygen. Oxygen from these tanks was used not only for the astronauts to breathe, but to help run three fuel cells that provided electrical power to run the command ship's many systems.

Inside each oxygen tank was a thermostat which, along with a heater, was used to regulate the temperature inside the tank. It was the manufacturer of this thermostat that never learned of the need to accept 65 volts of electricity.
