# Space Shuttle Columbia disaster

## Introduction

In this project we will analyze the whole incident of The Space Shuttle Columbia disaster which occurred on February 1, 2003, when Columbia disintegrated over Texas and Louisiana as it re-entered Earth's atmosphere, killing all seven crew members.

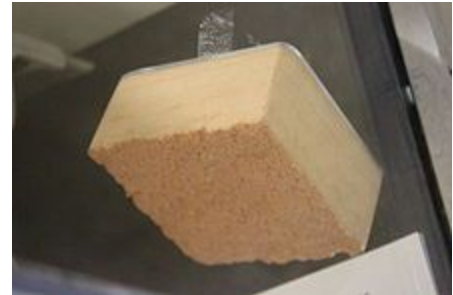
The Left Bipod Foam Ramp is an approximately three-foot (one-meter) aerodynamic component made entirely of foam. The foam, not normally considered to be a structural material, is required to bear some aerodynamic loads. Because of these special requirements, the casting-in-place and curing of the ramps may be performed only by a senior technician. The bipod ramp (having left and right sides) was originally designed to reduce aerodynamic stresses around the bipod attachment points at the external tank, but it was proven unnecessary in the wake of the accident and was removed from the external tank design for tanks flown after STS-107 (another foam ramp along the liquid oxygen line was also later removed from the tank design to eliminate it as a foam debris source, after analysis and tests proved this change safe).

Bipod Ramp insulation had been observed falling off, in whole or in part, on four previous flights: STS-7 (1983), STS-32 (1990), STS-50 (1992) and most recently STS-112 (just two launches before STS-107). All affected shuttle missions completed successfully. NASA management came to refer to this phenomenon as "foam shedding". As with the O-ring erosion problems that ultimately doomed the Space Shuttle Challenger, NASA management became accustomed to these phenomena when no serious consequences resulted from these earlier episodes. This phenomenon was termed "normalization of

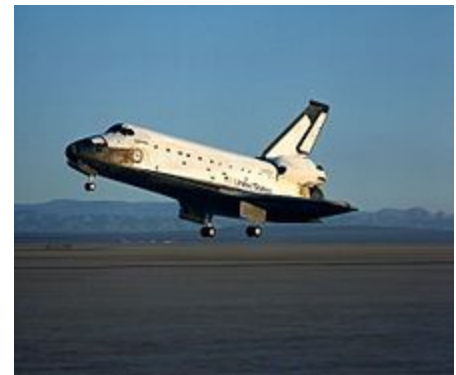
Another unique external feature, termed the "SILTS" pod, was located on the top of Columbia's vertical stabilizer, and was installed after STS-9 to acquire infrared and other thermal data. Though the pod's equipment was removed after initial tests, NASA decided to leave it in place, mainly to save costs, along with the agency's plans to use it for future experiments. The vertical stabilizer was later modified to incorporate the drag chute first used on Endeavour in 1992.
