Control points flood analysis

Tochigi No. 1

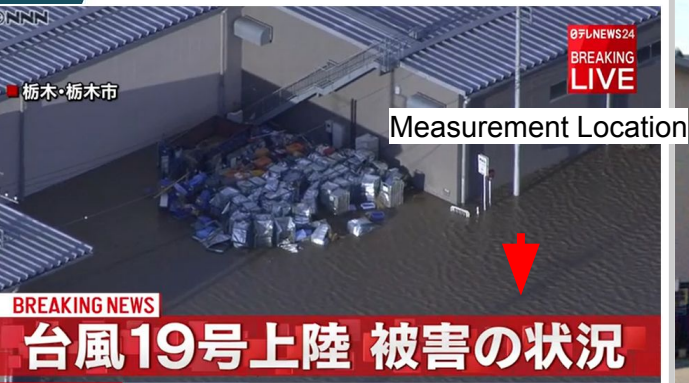
Point_1

GE measurement = 14.31m

Photo measurement = 8.68cm

Water depth in photo = 0.48cm

Estimated water depth = 0.73m

Video frame at 1:19

water depth measured from photo with good confidence

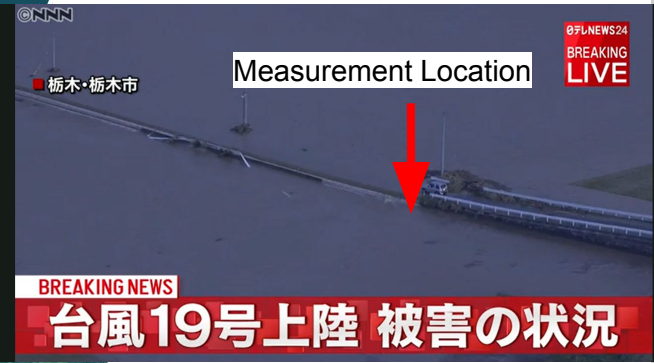
Point_3
GE measurement = 50m
Photo measurement = 10.05cm
Water depth in photo = 0.3cm

Estimated water depth = 1.48m

Video frame at 1:50

Depth measured close to the middle of the bridge where we see lots of flooding

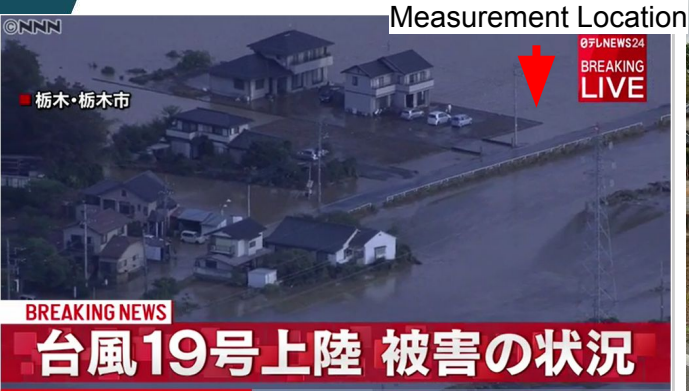
Area	Tochigi
Point ID	4
Time (JST)	10/13/2019 6:49:00
gid	40644
Water depth (m)	0.4
Location confidence	High
Water depth confidence	Low

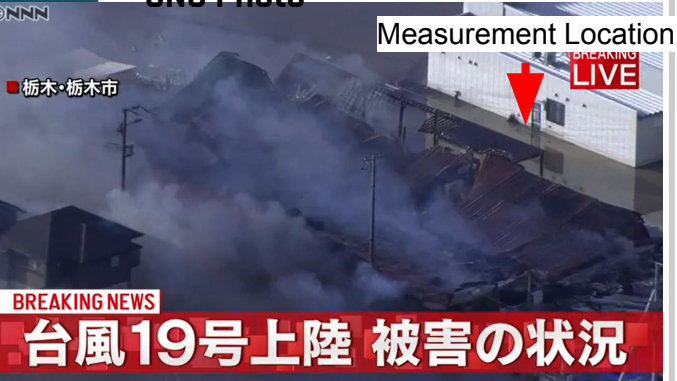
Area	Tochigi
Point ID	6
Time (JST)	10/13/2019 6:49:00
gid	40646
Latitude	36.382914
Longitude	139.734684
Water depth (m)	0.39
Location confidence	High
Water depth confidence	High

Remarks:
Video frame at 0:10

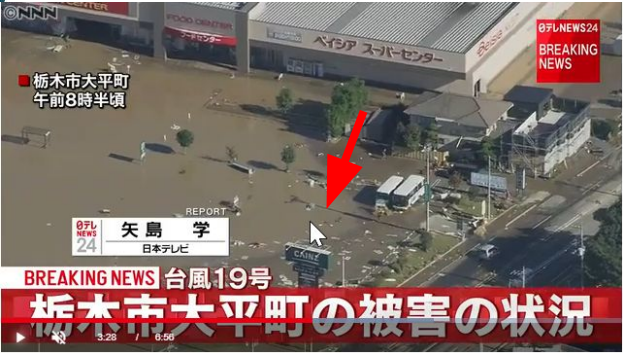
Area	Tochigi
Point ID	
gid	46318
Time (JST)	09:25AM 10/13/2019
Water depth	0.20
Location confidence	High
Water depth confidence	Low

video frame at 3:30

The waterlevel at this time has receded very much after the peak of the flood (at 01:00 am)and I will estimate the depth here to be about 0.2m. Mindful that water depth (gid: 40641) on
