Air Reservoir Tank fixation issue 8D#223232

Project : United Arab Emirates - Dubai Metro Route 2020
Platform : Turnkey Systems
Customer :
Supplier :

Title :	Air Reservoir Tank fixation issue
----------------	-----------------------------------

Air tank support issue

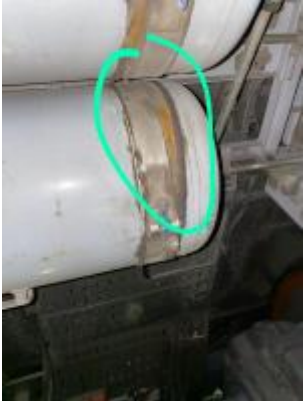
D1	Description
	Created by MOJ Adam on 2021-10-21
What, Where, How detected	Fixation bands found loosen with potential transversal misplacement of the tank
Why is it a problem	Potential issue with tank fixation / location
How Many	2 tanks confirmed
Objective to be reached	
Impacted Product (PBS)	1. Trainset/Vehicles 1.Q. Pneumatic/Hydraulic Equipment 1.Q.A. Pneumatic/Hydraulic Equipment
FBS

<p>Picture showing the problem</p>	
--	--

Start Date (D4-KPI)	Two main actions: 1. re-tighten the screw for nominal 25 Nm, 2. apply additional visual marking for detect potential tank displacement
Target start Date	2021-10-24
Start Date (D4-KPI)	2021-11-01
End of deployment	
Progress / result / next steps for deployment	<p><i>Update by JERRY KLINTON on 2021-11-07T00:00:00</i></p> <p>07/11/2021: Fleet wise check has started based on the procedure received. 10 trains contained so far. Steps to follow & check: 1. RE-TIGHTEN SCREWS AND APPLY TORQUE 25 Nm. 2. MEASURE CURRENT DISTANCE FROM AIRTANK TO CONNECTION PIPE (DIMENSION 210±2 mm). 3. MARK 10 mm INDICATION ON ALL PIPES CONNECTED DIRECTLY TO THE TANKS (USE PERMANENT MARKER) FOR MONITORING. 21-10: instruction prepared</p>

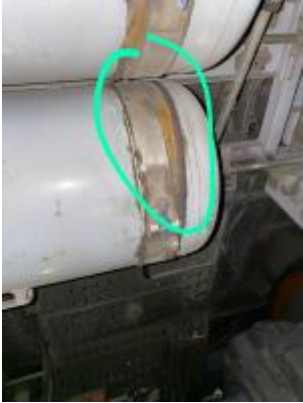
D1	Description
	Created by MOJ Adam on 2021-10-21
What, Where, How detected	Fixation bands found loosen with potential transversal misplacement of the tank
Why is it a problem	Potential issue with tank fixation / location
How Many	2 tanks confirmed
Objective to be reached	
Impacted Product (PBS)	1. Trainset/Vehicles 1.Q. Pneumatic/Hydraulic Equipment 1.Q.A. Pneumatic/Hydraulic Equipment
FBS

<p>Picture showing the problem</p>	
--	--

Start Date (D4-KPI)	Two main actions: 1. re-tighten the screw for nominal 25 Nm, 2. apply additional visual marking for detect potential tank displacement
Target start Date	2021-10-24
Start Date (D4-KPI)	2021-11-01
End of deployment	
Progress / result / next steps for deployment	<p><i>Update by JERRY KLINTON on 2021-11-07T00:00:00</i></p> <p>07/11/2021: Fleet wise check has started based on the procedure received. 10 trains contained so far. Steps to follow & check: 1. RE-TIGHTEN SCREWS AND APPLY TORQUE 25 Nm. 2. MEASURE CURRENT DISTANCE FROM AIRTANK TO CONNECTION PIPE (DIMENSION 210±2 mm). 3. MARK 10 mm INDICATION ON ALL PIPES CONNECTED DIRECTLY TO THE TANKS (USE PERMANENT MARKER) FOR MONITORING. 21-10: instruction prepared</p>

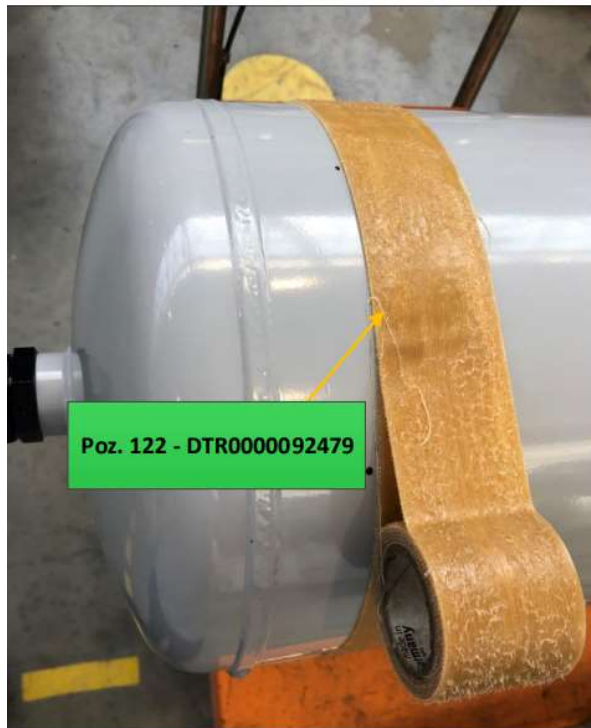
60 Montaż pierwszego zbiornika wyrównawczego

Następnie należy zamontować taśmy oraz unieść zbiornik w taki sposób, aby taśma z klejem wystawała po obu stronach.

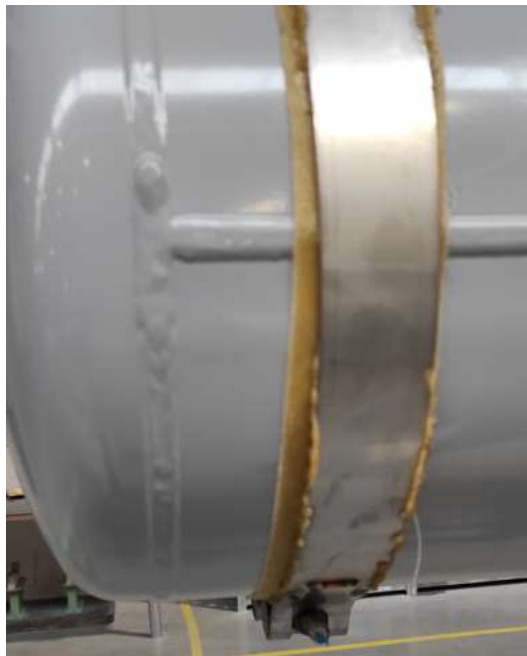
2TS in KTW

Founding on Metro Dubai

- Keep on containment (retightening) check for fleet in Dubai – Jerry
- Set up a call to review containment check for tank misplacement – Adam
- Review of the assembly definition - Quentin
