# HY-DIV268N-5A Stepper Driver

*These are my engineering notes when evaluating the HY-DIV268N-5A stepper driver. The performance of the driver was not what was expected. Therefore I did some reverse engineering and modifications to see if I could rectify the situation. The bottom line is that this stepper driver is a bit of junk. But with some persistency and work it is possible to make it work correctly.*

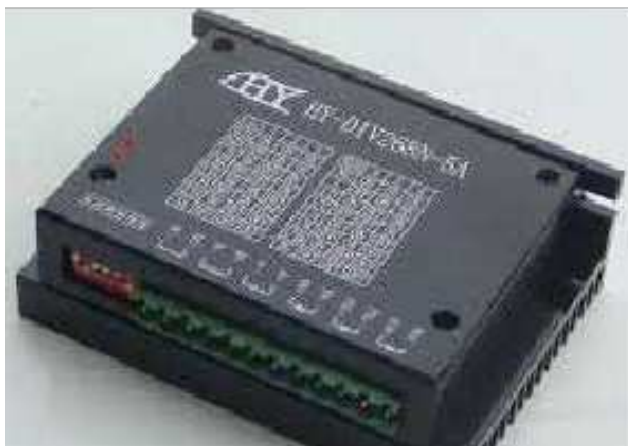
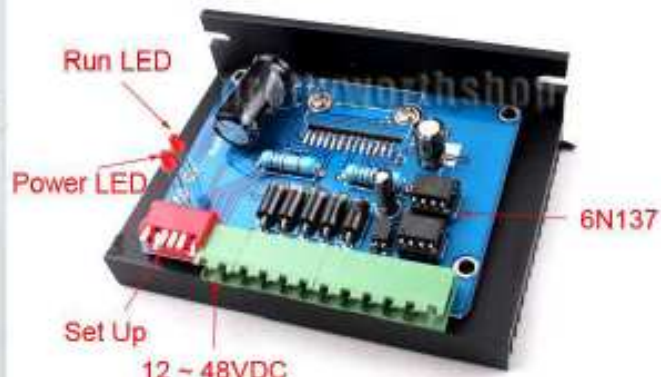
The HY-DIV268N-5A can be seen in figure 1. The driver is based on the TB6600HG IC from Toshiba. See reference 1. The device can be purchased from eBay and Amazon among other sources.

TB6600HG. I did measure the on pin 8 of the 6N137 opto coupler for the step circuit (the lower one in figure 1, right).
