Webcam Teardown

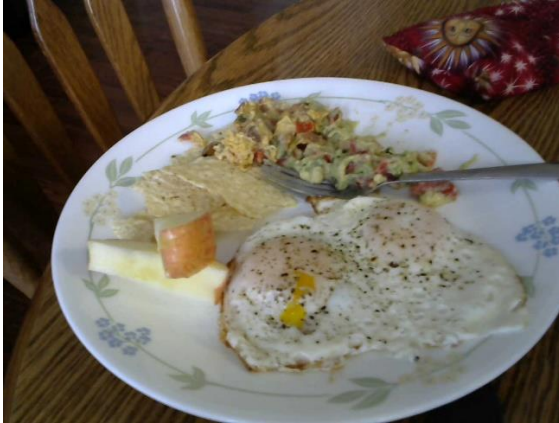
1. Initially I followed the webcam UV filter removal guide in *UV Detection via Webcams [5]*, but the Logitech camera that I was investigating (model unknown) does not have a discrete UV filter.
2. Below is a picture taken from the webcam without any modification.

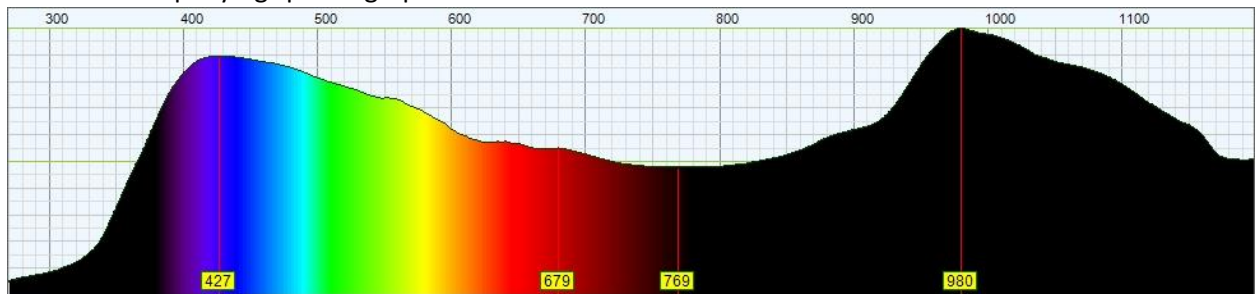
And its accompanying spectrograph.

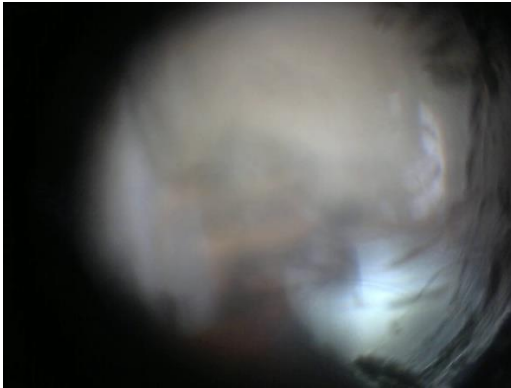
4. The lens housing contained 3 lenses. There was no apparent UV-filter on the housing, so I removed the lenses individually to see if there was one responsible for filtering UV-light.

Unfortunately, the lenses were damaged in this process and no longer properly focus the image, as seen below.

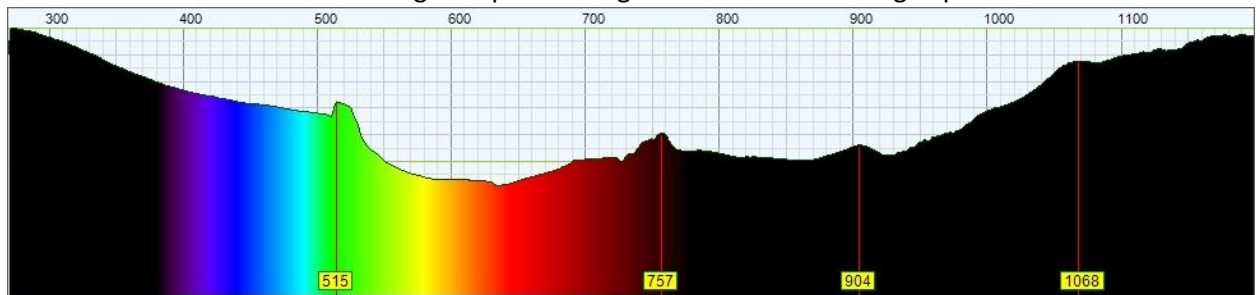
5. Somehow, without the lens housing, the webcam allows UV light to pass through. I believe the lenses are collectively filtering out the light which is why no discrete UV filter was discovered, but the camera did not allow UV light to pass through with the lens housing in place.
