Property Name: Sample Gardens

123 Sample Street
Mid City, OH 23445

PREPARED BY:
GENERIC ENERGY CONSULTING

I. EXECUTIVE SUMMARY

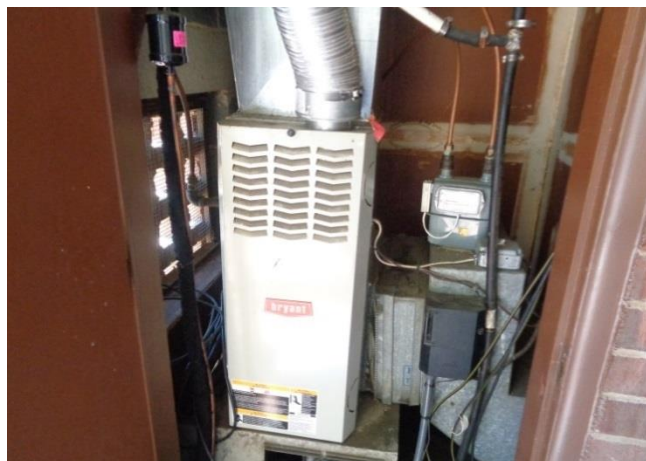
Figure 6: Typical Furnace in Sample Gardens

2. The furnaces and condensing units which heat and cool Sample Gardens are inefficient and approaching the end of their useful life.
3. The domestic hot water piping that serves the Sample Gardens is uninsulated in central mechanical rooms. This situation results in heat loss through the pipes.

Improvement Summary:	Install high efficiency heat pumps (minimum 10 HSPF, 16 SEER) in Sample Gardens to replace existing furnaces and AC units. Equipment must be ENERGY STAR-certified.
Benefits Attained:	While replacing heating and cooling units for Sample Gardens is an expensive measure, many of the units will need replacement in the coming years as they are reaching the end of their useful life. Replacing now with high efficiency alternatives provides significant cost savings and comfort benefits and reduces large future capital expense.
Assumptions:	To calculate heating and cooling savings, we assumed an improvement in efficiency from 75% AFUE to a HSPF of 10 for heating and from 12 to 16 SEER for cooling units. We used existing system specifications and historical fuel usage data for heating and cooling to calculate the estimated run-hours for existing equipment and true-up to existing utility consumption.

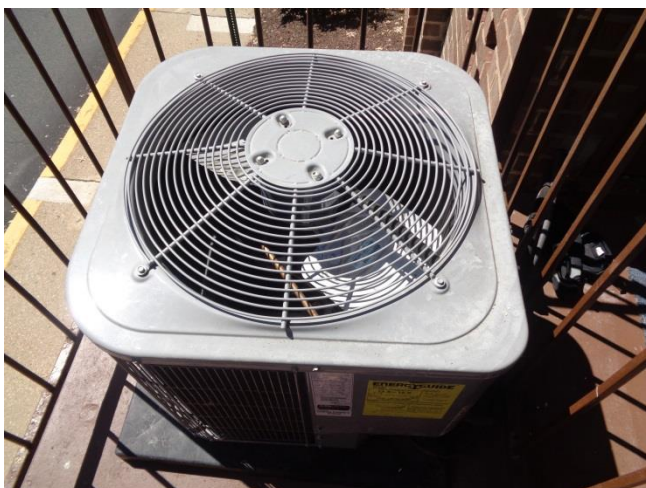
Figure 8: Typical Condensing Unit for Sample Gardens

Cooling to units is provided by a dedicated condensing unit. The air conditioning system tempers the outdoor air to provide conditioned air to the space based on the thermostat settings. The condensing units serving the Sample Gardens have a 2-Ton cooling capacity and use R-22 refrigerant. Due to their lower efficiency, these units should be replaced.

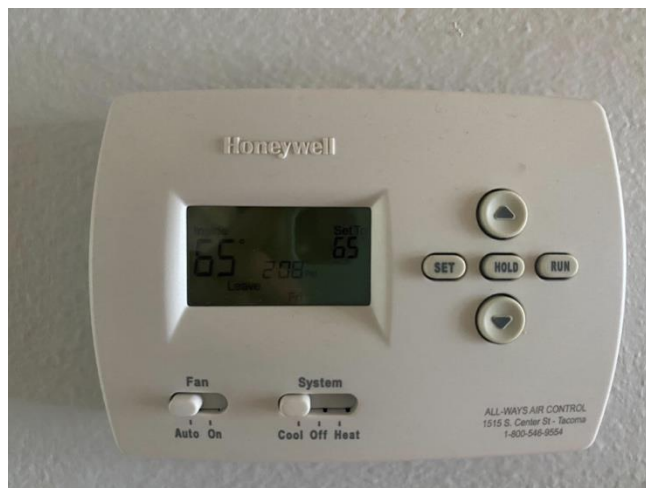
Figure 9: Typical Thermostat in Apartment

1. The furnaces in Sample Gardens are controlled using programmable thermostats. There are opportunities to upgrade existing programmable thermostats to smart thermostats.

A dedicated thermostat is installed in the common spaces in the Sample Gardens to control heating and cooling. The thermostat allows the occupant to choose the mode of conditioning and choose a temperature setpoint. The existing thermostats have simple programming capabilities.

Improvement Summary:	<p>Install one (1) ENERGY STAR certified Smart thermostat to control the operation of the furnace within the living room of each tenant apartment. Thermostats shall be selected based upon the units’ electrical ratings.</p> <p>Thermostats shall be located:</p> <ul style="list-style-type: none">• 4 to 6 ft. above finished floor (AFF)• On an interior wall, away from direct sunlight, furniture, shelves, doors, windows, skylights, drafts, fixtures, and any heat-generating or radiating appliances• In a location where natural room air currents occur (i.e., away from supply diffusers and exhaust areas, such as kitchens and bathrooms).
Benefits Attained:	<p>Replacing the existing thermostats with ENERGY STAR smart thermostats will reduce overheating or overcooling of the Sample Gardens. They will allow the residents to control the heating and cooling in their Sample Gardens more closely, improving comfort. Many devices can also sense when a space is empty, reducing heating and cooling when occupants are away.</p>

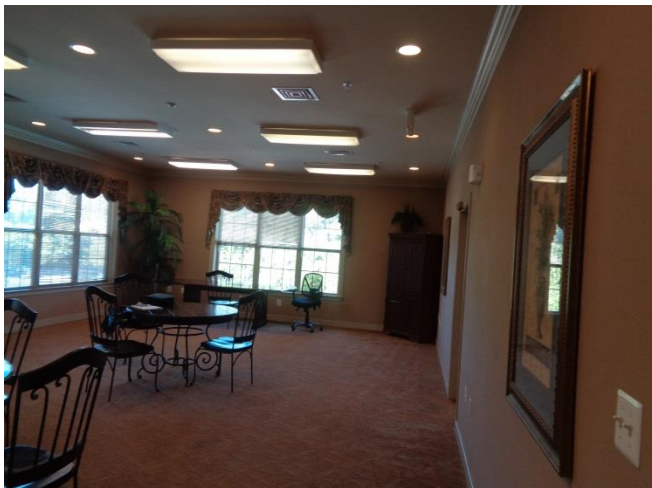
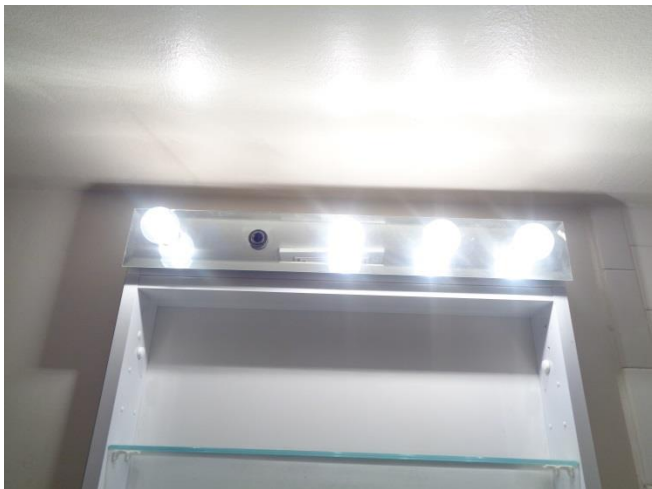
4. Owner-maintained interior lighting in the Sample Gardens and common areas comprise incandescent, compact, and linear-fluorescent fixtures. Exterior lighting fixtures include halogen technology lamps. There are opportunities to upgrade existing light fixtures to LED technology.

Owner installed and maintained fixtures in the Sample Gardens include fixtures with incandescent bulbs in the kitchen, apartment entrance, and bathroom. The facility maintenance staff has been replacing burnt out bulbs with CFL lamps in the kitchen and living room fixtures.

Improvement Summary:	<p>Implement a lighting retrofit project in Sample Gardens with the following major items:</p> <ul style="list-style-type: none">• Retrofit existing linear fluorescent T12 fixtures with 15-watt LED lamps.• Retrofit existing 60-watt incandescent lamps and 13-watt CFLs with 8-watt LED lamps in the Sample Gardens.
Benefits Attained:	<p>See Tables 14 and 15 for detailed lighting descriptions and recommendations.</p> <p>Installing high-efficiency lighting will significantly reduce tenant electrical consumption while maintaining equivalent or better light levels. Also, many of the recommended bulbs and fixtures have longer lifespans. This measure will reduce the number of bulbs replaced at the property as well as maintenance costs.</p>
Assumptions:	<p>GEC modeled this improvement using spreadsheet-based calculations. Light runtime hours were based on observations from the site visit and on discussions with property staff and residents.</p>

Improvement Summary:	<p>Implement a lighting retrofit in building common areas and exterior, including the following major items:</p> <ul style="list-style-type: none"> • Retrofit existing incandescent, compact, and linear-fluorescent technology fixtures with LED technology lamps. • Retrofit the exterior lighting fixtures with LED technology fixtures. Halogen lamps shall be replaced with LED lamps with similar or higher wattage output. <p>Property staff shall be trained on the operation and maintenance of the new high-efficiency lighting systems.</p>
Benefits Attained:	<p>Installing high-efficiency lighting will significantly reduce the property's electrical consumption while maintaining equivalent or better light levels. In addition, many of the recommended bulbs and fixtures have longer lifespans, which will reduce the number of bulbs replaced at the property.</p>
Assumptions:	<p>GEC modeled this improvement using spreadsheet-based calculations. Light runtime hours were based on observations made on site and discussions with property staff.</p>

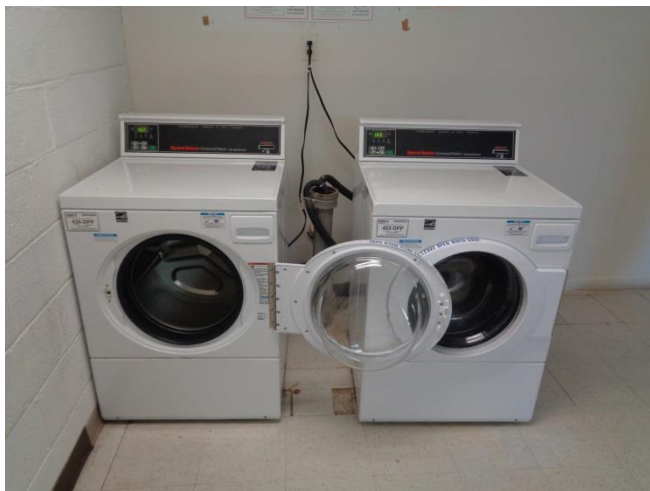
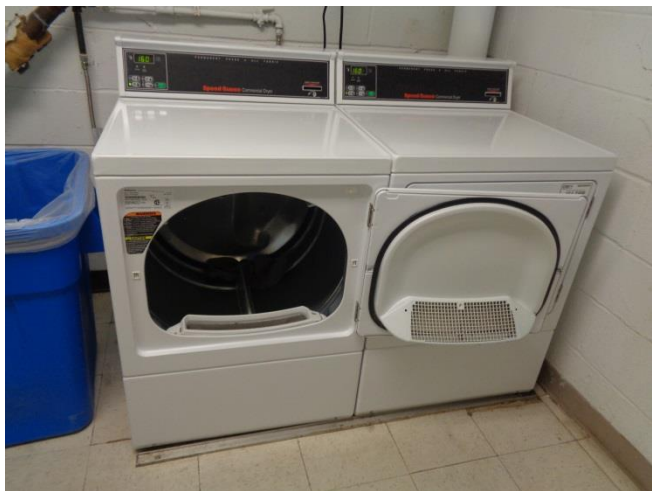
Laundry service at the property is provided through dedicated leased laundry equipment in the property's laundry facility. Based on the age of the equipment, they do not warrant replacement. The dryers use natural gas.

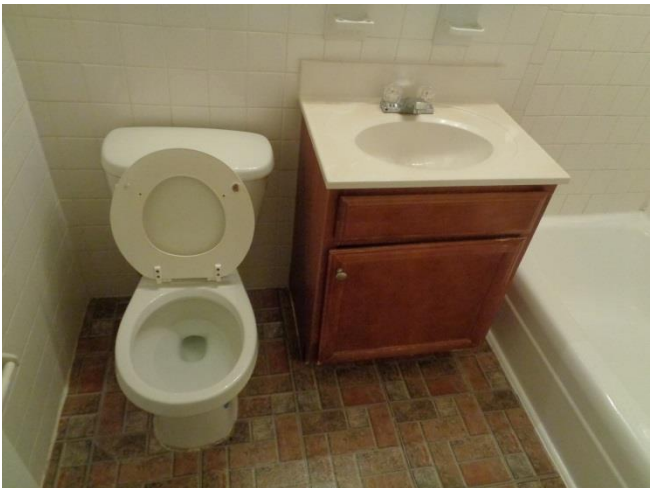
GEC found the plumbing fixtures in all sampled Sample Gardens to be identical. The kitchen and bathroom faucets are rated at 2 gallons per minute (GPM) but their average flowrates were measured by GEC to be 2.4 GPM and 2.04 GPM, respectively. The showerheads are rated at 2 GPM, but the average flowrate was measured to be 2.25 GPM. The toilets in the apartment are rated to flush 1.6 gallons per flush but were measured to flush about 2.54 gallons per flush, which contributes significantly to the high water usage at the property. A sample of volumetric flowrates at the faucets and showerheads as well as toilet flush rates can be found in the Exhibit D.

Improvement Summary:	Retrofit 235 bathroom faucets at the property with a 1.0 GPM low-flow WaterSense-certified aerator. Both the aerator and aerator housing should be replaced.
Benefits Attained:	Aerators mix air and water to reduce volumetric flowrate while maintaining a similar perceived flowrate as existing fixtures. This measure will reduce the amount of hot and cold water used by the plumbing fixtures. The reduction in hot water usage will result in energy savings by reducing the hot water load on the domestic hot water heaters.
Assumptions:	For the savings calculation, GEC assumed that each bathroom faucet is used for 2 minutes per occupant per day. GEC also assumed an adoption rate of 75% in the analysis.

Improvement Summary:	Retrofit 129 kitchen faucets at the property with a 1.5 GPM low-flow aerator. Kitchen faucet aerators should be of a similar quality to WaterSense-certified fixtures. Both the aerator and aerator housing should be replaced.
-----------------------------	---

Improvement Summary:	Replace 181 showerheads with 1.5 GPM low-flow WaterSense-certified showerheads.
Benefits Attained:	This measure will reduce the amount of hot and cold water used by the plumbing fixtures. The reduction in hot water usage will result in energy savings by reducing the hot water load on the domestic hot water heaters.
Assumptions:	For the savings calculation, GEC assumed that each shower is used for 8 minutes per occupant per day. GEC also assumed an adoption rate of 75% in the analysis.

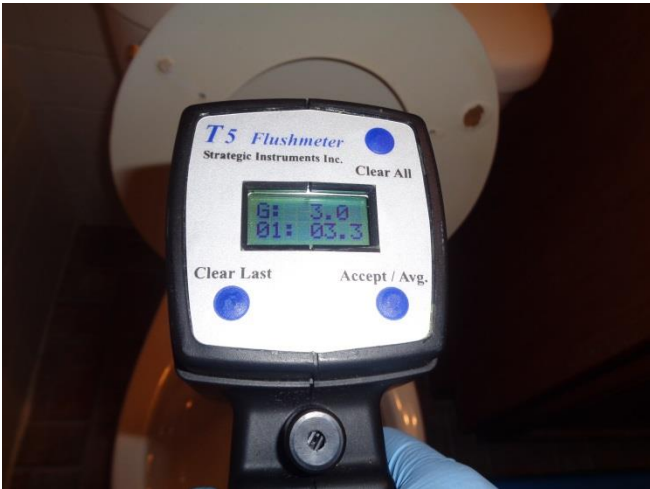
Figure 29: Typical Test Result for Toilet Flush Test

Assumptions:	GEC modeled water savings as a reduction in toilet flow rates per flush from the average flow rates measured on site to the recommended flow rate, specified above. GEC assumed that toilets are flushed five (5) times per day per occupant and 100% of the toilets will be replaced.

Improvement Summary:	<p>Replace 235 existing toilet fixtures with 0.8 GPF pressure-assisted toilets. Pressure-assisted toilets are hybrids of gravity and flush-valve toilets. A pressurized tank, placed inside the porcelain tank, compresses a pocket of air and releases pressurized water into the bowl and out the trap way at high velocity, creating a vigorous flushing action that whisks away waste and cleans the bowl. The flushing action of these toilets is quieter than common pressure-assisted toilets.</p> <p>GEC observed that the piping configuration at the property should allow for 0.8 GPF toilets to be installed without extensive replacement of plumbing. An experienced plumbing contractor should be engaged to assess requirements prior to installation.</p>
Benefits Attained:	<p>Replacing old model toilets with new low-flow toilets will immediately reduce the water consumption at the property. Water-efficient pressure-assisted toilets also reduce the pressure demand on the water supply. These toilets require less maintenance because they have fewer moving parts.</p> <p>Moreover, with a pressure-assisted system, the flush water is contained in a plastic tank inside the ceramic tank, which eliminates the potential for condensation (sweating) on the outside of the tank. This design prevents water from dripping onto the floor, which may result in mold growth and damage to the flooring.</p>

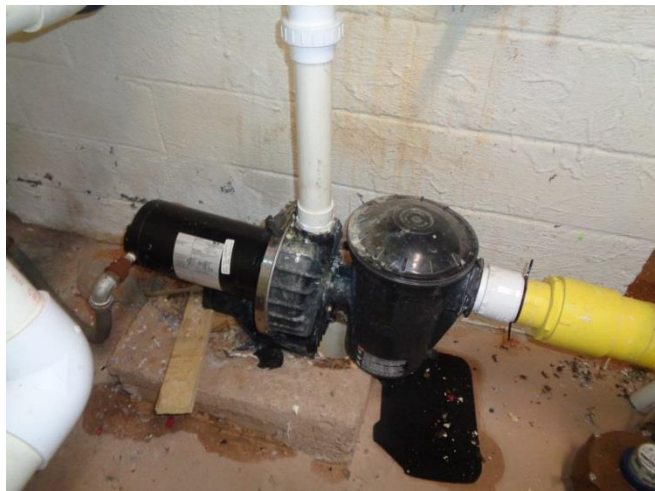
Figure 26: Pool Pump

7. The property has a pool that is open to residents during the summer. The pump serving the pool operates at constant volume, which results in excess consumption of electrical energy.

Swimming Pool: The property houses a non-heated, outdoor swimming pool located behind the rental office building. The pool is open from Memorial Day weekend through Labor Day weekend. A single 5-HP pump circulates water through the pool and operates on constant flow.

Improvement Summary:	GEC recommends replacing the existing 5-HP continuous-speed pool pump with a variable frequency drive (VFD)-controlled pool pump. VFDs will take advantage of the varying pool water circulation demand to reduce the speed of the pool pump. The drive allows the pump to unload, which saves energy by delivering only the amount of water required by the operating heat pumps.
Benefits Attained:	Installing VFD-controlled pool pumps will result in savings through reduced electrical consumption when the pumps operate at lower speeds. The VFD-controlled pool pumps also have additional ancillary benefits. By avoiding hard start/stop of the pumps every day with manual controls or timer controls, the pumps will last longer and require less maintenance and repair. Additionally, pumps are often oversized, which results in sediment forcing through the filter, which may cause damage to the pump and chemical systems. With VFDs, this damage can be reduced, therefore resulting in a longer useful life for the pump.
