Sample Gardens

1258 Blake Ave
Mid City, OH 23445

PREPARED BY:
GENERIC ENERGY CONSULTING

Generic Energy Consulting, INC (GEC) conducted an energy and water audit for Sample Gardens Apartments in Mid City, OH. A site visit was conducted on November 1, 2023. This report has the following purposes, summarized below:

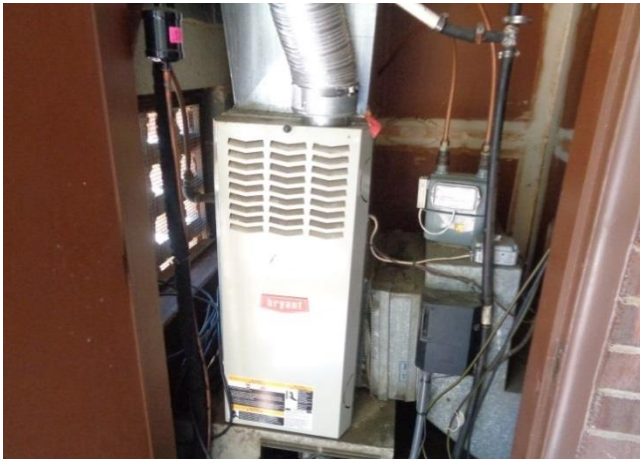
Figure 6: Typical Furnace in Apartments

2. The furnaces and condensing units which heat and cool apartments are inefficient and approaching the end of their useful life.
3. The domestic hot water piping that serves the apartments is uninsulated in central mechanical rooms. This situation results in heat loss through the pipes.

Improvement Summary:	Install high efficiency heat pumps (minimum 10 HSPF, 16 SEER) in apartments to replace existing furnaces and AC units. Equipment must be ENERGY STAR-certified.
Benefits Attained:	While replacing heating and cooling units for apartments is an expensive measure, many of the units will need replacement in the coming years as they are reaching the end of their useful life. Replacing now with high efficiency alternatives provides significant cost savings and comfort benefits and reduces large future capital expense.
Assumptions:	To calculate heating and cooling savings, we assumed an improvement in efficiency from 75% AFUE to a HSPF of 10 for heating and from 12 to 16 SEER for cooling units. We used existing system specifications and historical fuel usage data for heating and cooling to calculate the estimated run-hours for existing equipment and true-up to existing utility consumption.

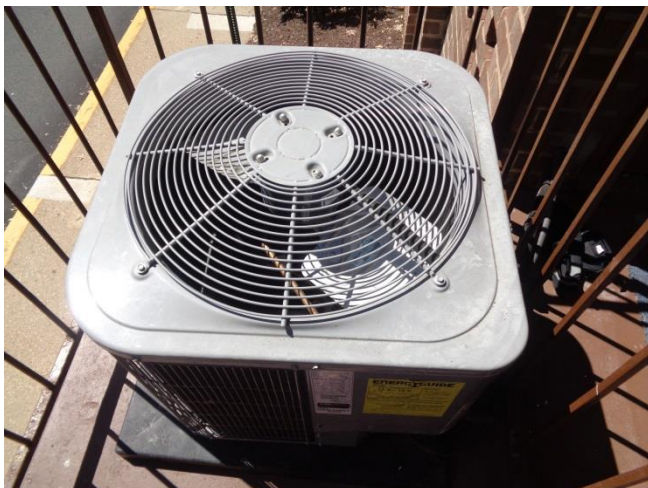
Figure 8: Typical Condensing Unit for Apartments

Cooling to units is provided by a dedicated condensing unit. The air conditioning system tempers the outdoor air to provide conditioned air to the space based on the thermostat settings. The condensing units serving the apartments have a 2-Ton cooling capacity and use R-22 refrigerant. Due to their lower efficiency, these units should be replaced.

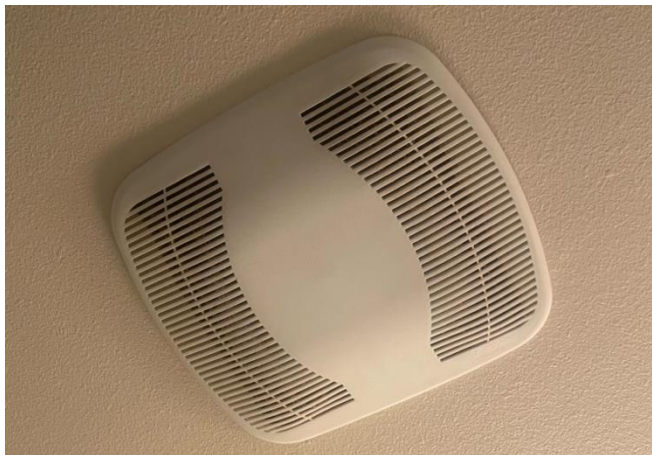
Figure 10: Typical Exhaust Fan in Apartment Bathroom

Ventilation: Apartment kitchens and bathrooms are ventilated mechanically. Each bathroom is equipped with a ceiling-mounted exhaust fan. Each kitchen is equipped with a ductless range hood. The ventilation systems are intermittent and turn on when the residents turn the switch on.

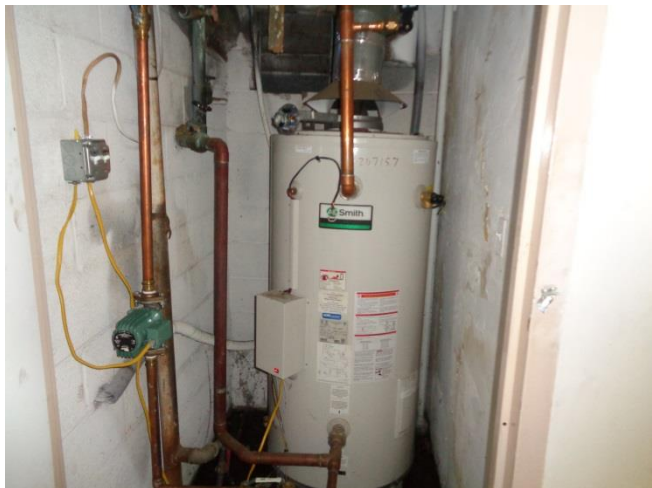
Figure 14: Typical Domestic Hot Water Heater

Eight (8) natural gas water heaters with integrated storage tanks provide domestic hot water (DHW) to the apartments. These heaters are located in eight (8) different locations and have a combined input capacity of 300,000 BTU/hr. A natural gas-fired water heater with an input capacity of 78,000 BTU/hr serves the rental office building. The heaters are controlled based on a hot water temperature setpoint. The temperature setpoints observed during our visit appeared to be appropriate for the property and hot water was measured in units at reasonable temperatures. A recirculation pump serves each heater to ensure hot water is available at all fixtures.

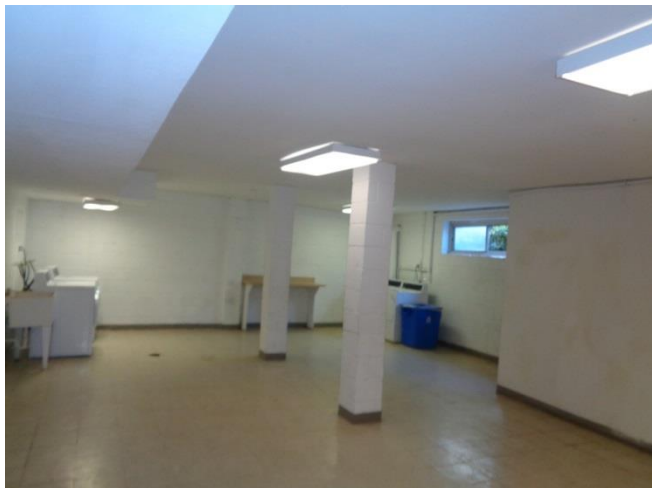
Figure 16: Typical Laundry Fixtures

4. Owner-maintained interior lighting in the apartments and common areas comprise incandescent, compact, and linear-fluorescent fixtures. Exterior lighting fixtures include halogen technology lamps. There are opportunities to upgrade existing light fixtures to LED technology.

Improvement Summary:	<p>Implement a lighting retrofit in building common areas and exterior, including the following major items:</p> <ul style="list-style-type: none"> • Retrofit existing incandescent, compact, and linear-fluorescent technology fixtures with LED technology lamps. • Retrofit the exterior lighting fixtures with LED technology fixtures. Halogen lamps shall be replaced with LED lamps with similar or higher wattage output. <p>Property staff shall be trained on the operation and maintenance of the new high-efficiency lighting systems.</p>
Benefits Attained:	<p>Installing high-efficiency lighting will significantly reduce the property's electrical consumption while maintaining equivalent or better light levels. In addition, many of the recommended bulbs and fixtures have longer lifespans, which will reduce the number of bulbs replaced at the property.</p>
Assumptions:	<p>GEC modeled this improvement using spreadsheet-based calculations. Light runtime hours were based on observations made on site and discussions with property staff.</p>

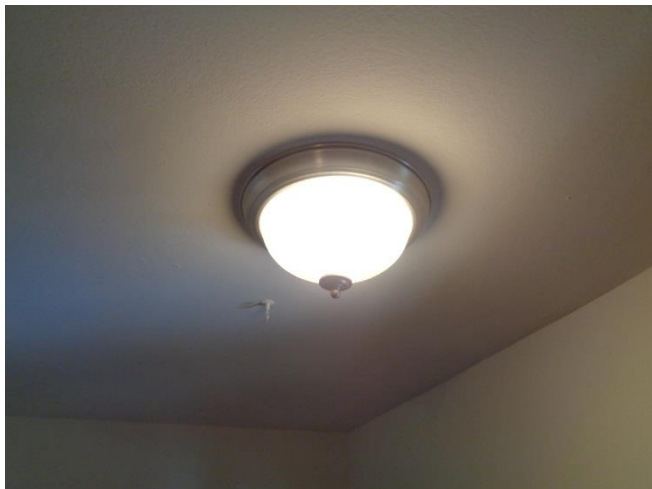
Figure 18: Typical Apartment Fixture

Owner installed and maintained fixtures in the apartments include fixtures with incandescent bulbs in the kitchen, apartment entrance, and bathroom. The facility maintenance staff has been replacing burnt out bulbs with CFL lamps in the kitchen and living room fixtures.

Improvement Summary:	<p>Implement a lighting retrofit project in apartments with the following major items:</p> <ul style="list-style-type: none">• Retrofit existing linear fluorescent T12 fixtures with 15-watt LED lamps.• Retrofit existing 60-watt incandescent lamps and 13-watt CFLs with 8-watt LED lamps in the apartments. <p>See Tables 14 and 15 for detailed lighting descriptions and recommendations.</p>
Benefits Attained:	<p>Installing high-efficiency lighting will significantly reduce tenant electrical consumption while maintaining equivalent or better light levels. Also, many of the recommended bulbs and fixtures have longer lifespans. This measure will reduce the number of bulbs replaced at the property as well as maintenance costs.</p>
Assumptions:	<p>GEC modeled this improvement using spreadsheet-based calculations. Light runtime hours were based on observations from the site visit and on discussions with property staff and residents.</p>

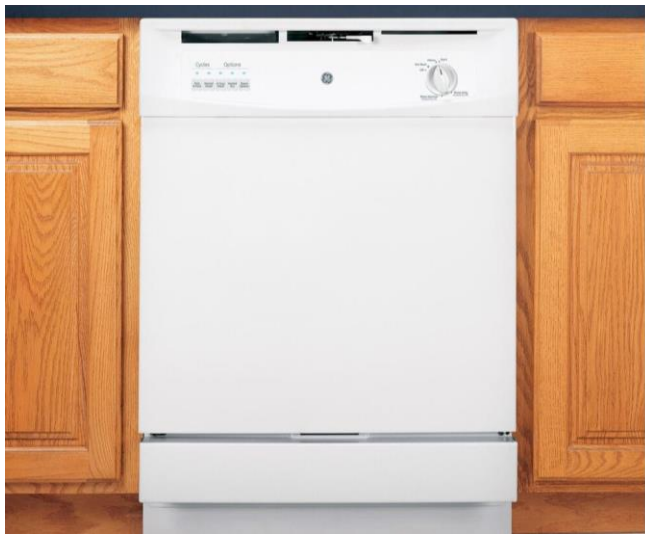
Figure 20: Typical Apartment Dishwasher

The apartments at the property are each equipped with a refrigerator, a dishwasher, a natural gas stove, and a natural gas oven. The refrigerators throughout the property vary in age and annual consumption. Based on our in-unit survey, all of the refrigerators warrant replacement. During our site survey, we conducted tests on a sampling of in-unit refrigerators. According to the sample set and discussion with the property staff, approximately 70% of the refrigerators are not ENERGY STAR-certified and some refrigerators are over 10 years old. The existing refrigerators use considerably more energy than ENERGY STAR-certified equivalents.

Improvement Summary:	Install 129 new ENERGY STAR-certified dishwashers in place of the existing inefficient dishwashers. A full assessment shall be conducted to determine the proper sizing and replacement schedule.
Benefits Attained:	ENERGY STAR-certified dishwashers use 12% less energy and 30% less water than similar non-ENERGY STAR models. Existing dishwashers that use 6 gallons per cycle (GPC) are significantly less efficient than the current ENERGY STAR minimum performance standard of 3.5 GPC.
Assumptions:	This improvement was based on data acquired from a sample of 15 apartments that we extrapolated to determine the estimated total consumption of the dishwashers. Actual quantities may vary from these estimates during replacement. Costs for this measure were based on common costs of equivalent sized ENERGY STAR-certified dishwashers. The savings calculations assume new dishwasher water consumption of 3.5 GPC and energy consumption of 270 kWh/yr.

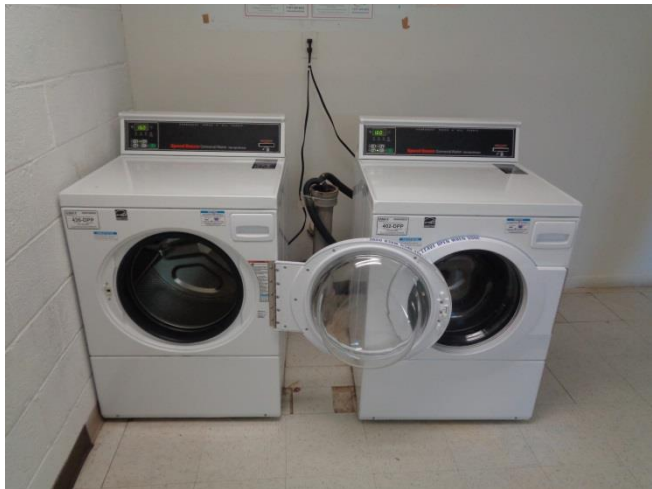
Figure 22: Typical Common Area Washers

Laundry service at the property is provided through dedicated leased laundry equipment in the property's laundry facility. Based on the age of the equipment, they do not warrant replacement. The dryers use natural gas.

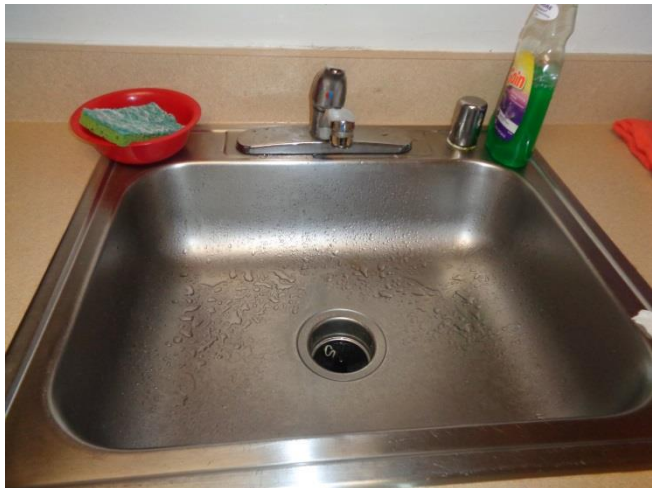
Figure 24: Typical Kitchen Sink

GEC found the plumbing fixtures in all sampled apartments to be identical. The kitchen and bathroom faucets are rated at 2 gallons per minute (GPM) but their average flowrates were measured by GEC to be 2.4 GPM and 2.04 GPM, respectively. The showerheads are rated at 2 GPM, but the average flowrate was measured to be 2.25 GPM. The toilets in the apartment are rated to flush 1.6 gallons per flush but were measured to flush about 2.54 gallons per flush, which contributes significantly to the high water usage at the property. A sample of volumetric flowrates at the faucets and showerheads as well as toilet flush rates can be found in the Exhibit D.

Improvement Summary:	Retrofit 129 kitchen faucets at the property with a 1.5 GPM low-flow aerator. Kitchen faucet aerators should be of a similar quality to WaterSense-certified fixtures. Both the aerator and aerator housing should be replaced.
-----------------------------	---

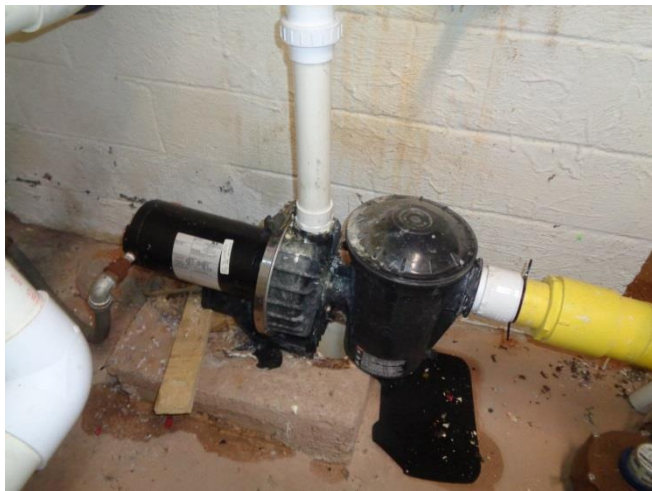
Figure 26: Pool Pump

7. The property has a pool that is open to residents during the summer. The pump serving the pool operates at constant volume, which results in excess consumption of electrical energy.

Swimming Pool: The property houses a non-heated, outdoor swimming pool located behind the rental office building. The pool is open from Memorial Day weekend through Labor Day weekend. A single 5-HP pump circulates water through the pool and operates on constant flow.

Improvement Summary:	GEC recommends replacing the existing 5-HP continuous-speed pool pump with a variable frequency drive (VFD)-controlled pool pump. VFDs will take advantage of the varying pool water circulation demand to reduce the speed of the pool pump. The drive allows the pump to unload, which saves energy by delivering only the amount of water required by the operating heat pumps.
Benefits Attained:	Installing VFD-controlled pool pumps will result in savings through reduced electrical consumption when the pumps operate at lower speeds. The VFD-controlled pool pumps also have additional ancillary benefits. By avoiding hard start/stop of the pumps every day with manual controls or timer controls, the pumps will last longer and require less maintenance and repair. Additionally, pumps are often oversized, which results in sediment forcing through the filter, which may cause damage to the pump and chemical systems. With VFDs, this damage can be reduced, therefore resulting in a longer useful life for the pump.

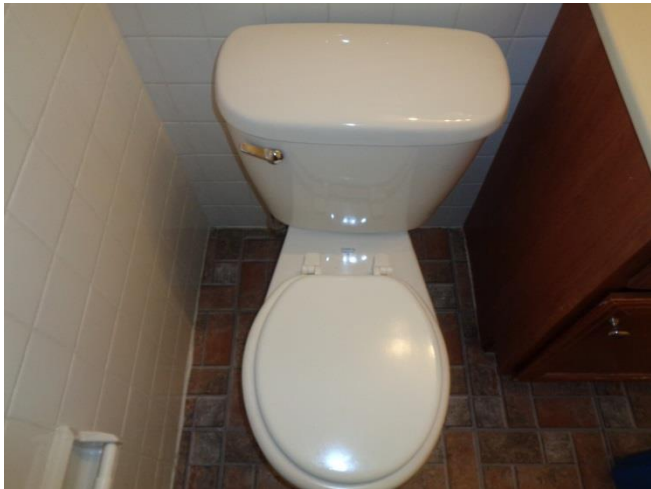
Figure 28: Typical Existing 1.6 GPF Toilet

Assumptions:	GEC modeled water savings as a reduction in toilet flow rates per flush from the average flow rates measured on site to the recommended flow rate, specified above. GEC assumed that toilets are flushed five (5) times per day per occupant and 100% of the toilets will be replaced.

Improvement Summary:	<p>Replace 235 existing toilet fixtures with 0.8 GPF pressure-assisted toilets. Pressure-assisted toilets are hybrids of gravity and flush-valve toilets. A pressurized tank, placed inside the porcelain tank, compresses a pocket of air and releases pressurized water into the bowl and out the trap way at high velocity, creating a vigorous flushing action that whisks away waste and cleans the bowl. The flushing action of these toilets is quieter than common pressure-assisted toilets.</p> <p>GEC observed that the piping configuration at the property should allow for 0.8 GPF toilets to be installed without extensive replacement of plumbing. An experienced plumbing contractor should be engaged to assess requirements prior to installation.</p>
Benefits Attained:	<p>Replacing old model toilets with new low-flow toilets will immediately reduce the water consumption at the property. Water-efficient pressure-assisted toilets also reduce the pressure demand on the water supply. These toilets require less maintenance because they have fewer moving parts.</p> <p>Moreover, with a pressure-assisted system, the flush water is contained in a plastic tank inside the ceramic tank, which eliminates the potential for condensation (sweating) on the outside of the tank. This design prevents water from dripping onto the floor, which may result in mold growth and damage to the flooring.</p>

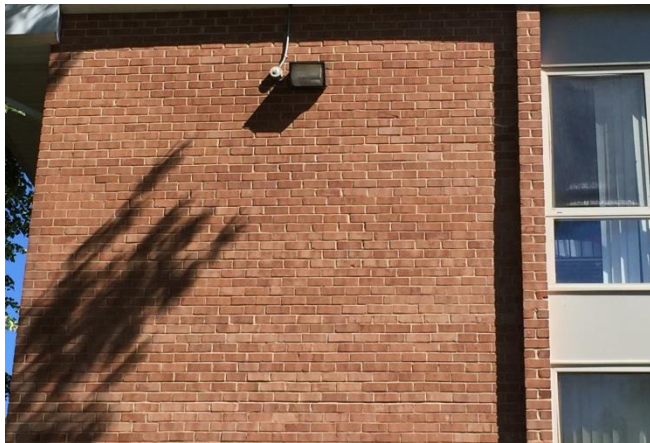
Figure 32: Typical Façade at the Property

Roof: Buildings on site are constructed with flat shed roofs. Building roofs are Trumbull built up roofs. Most roofs have fiberglass insulation, and several have been retrofitted with sprayed polyurethane foam. Roof framing consists of site-built wooden rafters, supporting plywood or OSB roof decking. Roof framing is made up of 2x8's on 16" centers, which adequately supports 2.5-3lbs per sq. ft for new solar panels. Median age of the roofs is 10 years. Foam roofs (Buildings C, D, J, and K) have reported age of 4-5 years. Other roofs have reported age of 20 years.

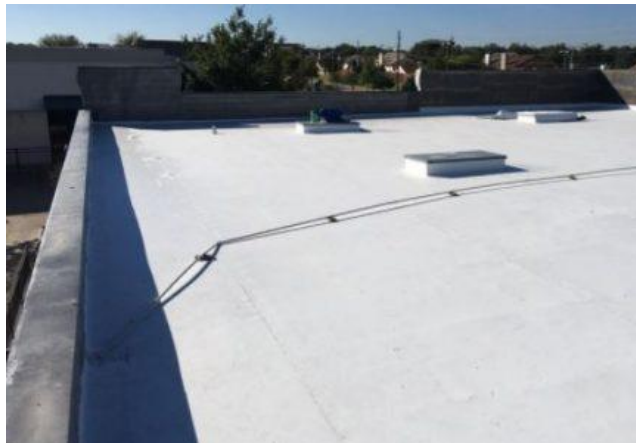
Figure 33: Typical Rooftop View

8. Ample roof space and high baseload electricity use present an opportunity to install solar PV to offset the need to purchase electricity for the property.
9. Installation of a solar PV system must be accompanied by roof replacement for a portion of buildings.

Improvement Summary:	Install foam roof overlap on top of existing roof for Buildings A, B, E, F, G, H, I, and leasing office. (This recommendation is required to be selected as part of the EWEM “Install 850.8kW Solar PV system.”)
Benefits Attained:	Improved roofing would be an overlap on top of the existing roofing. The foam overlap will seal around the solar attachments.
Assumptions:	<p>The following assumptions were made for the proposed roof installation:</p> <ul style="list-style-type: none">• Due to their age, roofs at Buildings A, B, E, F, G, H, I and the leasing office need to be replaced to support installation of a solar PV system• Proper installation of the solar PV system would not void the warranty of the new roofs for replacement.

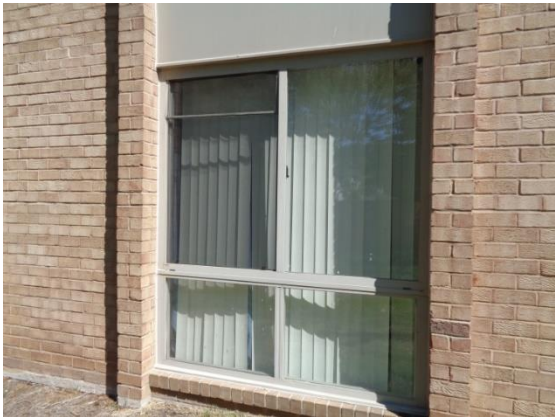
Figure 34: Typical Window in Apartments

Exterior Windows and Doors: The majority of the windows at the property are sliding type with double pane glass and ½" air gap. The windows appear to have functional weatherstripping and appeared to allow minimal draft through them when closed. All windows have aluminum framing with a thermal break.

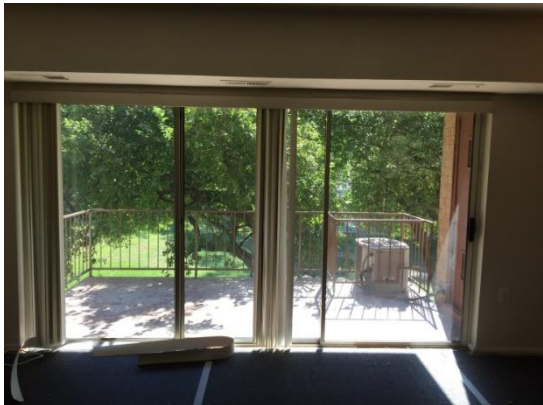
Figure 35: Typical Balcony Door

Each residential building at the property has one (1) main door for residents to access the building. These doors are made of wood and have a wooden frame. The doors appear to have functional weatherstripping. All the apartments at the property have sliding doors that provide access to a balcony or a patio. During the in-unit survey, we observed that the majority of the doors in the apartments have functional weatherstripping and appear to have minimal infiltration into the apartments.
