Sample Gardens

123 Sample Street
Mid City, OH 23445

PREPARED BY:
GENERIC ENERGY CONSULTING

I. EXECUTIVE SUMMARY

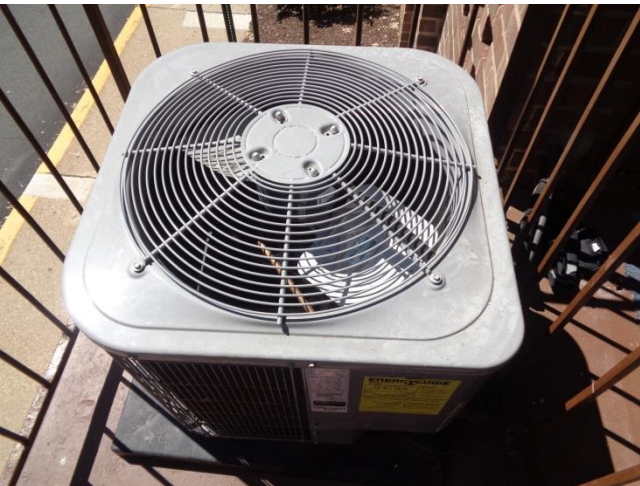
Figure 8: Typical Condensing Unit for Apartments

Cooling to units is provided by a dedicated condensing unit. The air conditioning system tempers the outdoor air to provide conditioned air to the space based on the thermostat settings. The condensing units serving the apartments have a 2-Ton cooling capacity and use R-22 refrigerant. Due to their lower efficiency, these units should be replaced.

Improvement Summary:	Install high efficiency heat pumps (minimum 10 HSPF, 16 SEER) in apartments to replace existing furnaces and AC units. Equipment must be ENERGY STAR-certified.
Benefits Attained:	While replacing heating and cooling units for apartments is an expensive measure, many of the units will need replacement in the coming years as they are reaching the end of their useful life. Replacing now with high efficiency alternatives provides significant cost savings and comfort benefits and reduces large future capital expense.
Assumptions:	To calculate heating and cooling savings, we assumed an improvement in efficiency from 75% AFUE to a HSPF of 10 for heating and from 12 to 16 SEER for cooling units. We used existing system specifications and historical fuel usage data for heating and cooling to calculate the estimated run-hours for existing equipment and true-up to existing utility consumption.

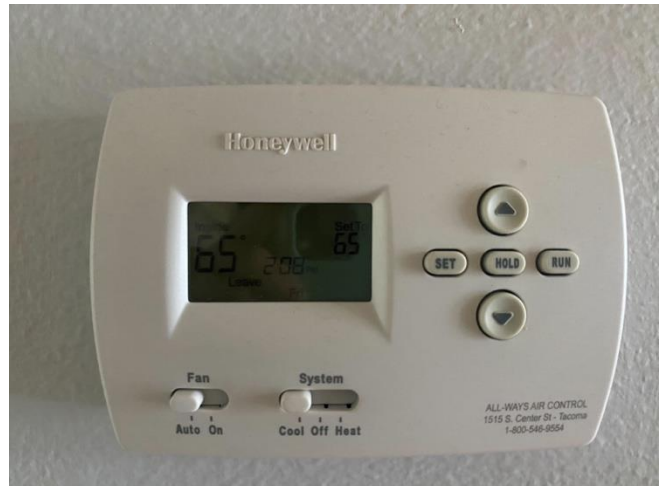
Figure 9: Typical Thermostat in Apartment

A dedicated thermostat is installed in the common spaces in the apartments to control heating and cooling. The thermostat allows the occupant to choose the mode of conditioning and choose a temperature setpoint. The existing thermostats have simple programming capabilities.

Improvement Summary:	<p>Install one (1) ENERGY STAR certified Smart thermostat to control the operation of the furnace within the living room of each tenant apartment. Thermostats shall be selected based upon the units’ electrical ratings.</p> <p>Thermostats shall be located:</p> <ul style="list-style-type: none">• 4 to 6 ft. above finished floor (AFF)• On an interior wall, away from direct sunlight, furniture, shelves, doors, windows, skylights, drafts, fixtures, and any heat-generating or radiating appliances• In a location where natural room air currents occur (i.e., away from supply diffusers and exhaust areas, such as kitchens and bathrooms).
Benefits Attained:	<p>Replacing the existing thermostats with ENERGY STAR smart thermostats will reduce overheating or overcooling of the apartments. They will allow the residents to control the heating and cooling in their apartments more closely, improving comfort. Many devices can also sense when a space is empty, reducing heating and cooling when occupants are away.</p>

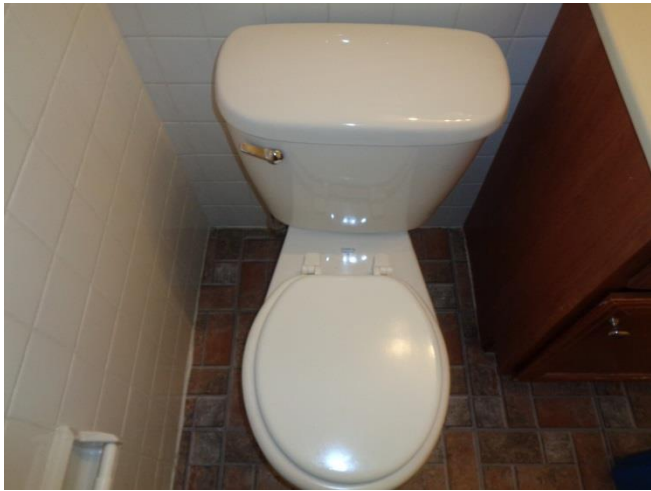
Figure 28: Typical Existing 1.6 GPF Toilet

Assumptions:	GEC modeled water savings as a reduction in toilet flow rates per flush from the average flow rates measured on site to the recommended flow rate, specified above. GEC assumed that toilets are flushed five (5) times per day per occupant and 100% of the toilets will be replaced.

Improvement Summary:	<p>Replace 235 existing toilet fixtures with 0.8 GPF pressure-assisted toilets. Pressure-assisted toilets are hybrids of gravity and flush-valve toilets. A pressurized tank, placed inside the porcelain tank, compresses a pocket of air and releases pressurized water into the bowl and out the trap way at high velocity, creating a vigorous flushing action that whisks away waste and cleans the bowl. The flushing action of these toilets is quieter than common pressure-assisted toilets.</p> <p>GEC observed that the piping configuration at the property should allow for 0.8 GPF toilets to be installed without extensive replacement of plumbing. An experienced plumbing contractor should be engaged to assess requirements prior to installation.</p>
Benefits Attained:	<p>Replacing old model toilets with new low-flow toilets will immediately reduce the water consumption at the property. Water-efficient pressure-assisted toilets also reduce the pressure demand on the water supply. These toilets require less maintenance because they have fewer moving parts.</p> <p>Moreover, with a pressure-assisted system, the flush water is contained in a plastic tank inside the ceramic tank, which eliminates the potential for condensation (sweating) on the outside of the tank. This design prevents water from dripping onto the floor, which may result in mold growth and damage to the flooring.</p>

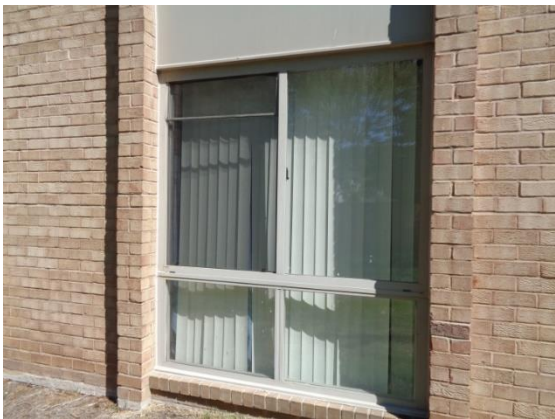
Figure 34: Typical Window in Apartments

Exterior Windows and Doors: The majority of the windows at the property are sliding type with double pane glass and ½" air gap. The windows appear to have functional weatherstripping and appeared to allow minimal draft through them when closed. All windows have aluminum framing with a thermal break.

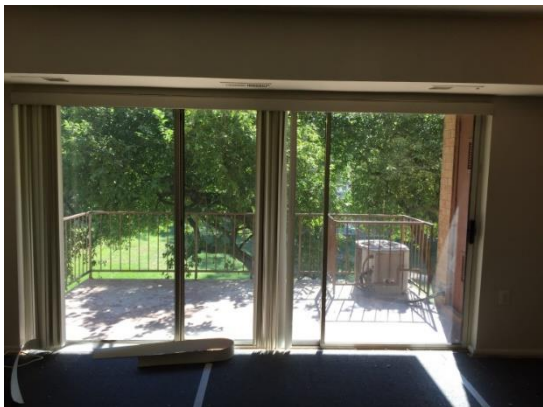
Figure 35: Typical Balcony Door

Each residential building at the property has one (1) main door for residents to access the building. These doors are made of wood and have a wooden frame. The doors appear to have functional weatherstripping. All the apartments at the property have sliding doors that provide access to a balcony or a patio. During the in-unit survey, we observed that the majority of the doors in the apartments have functional weatherstripping and appear to have minimal infiltration into the apartments.
