Effect of riparian vegetation on stream bank stability in small agricultural catchments

Dominika Krzeminska^{a,*}, Tjibbe Kerkhof^b, Kamilla Skaalsveen^a, Jannes Stolte^a

^a Department of Soil and Land Use, Division of Environment and Natural Resources, Norwegian Institute of Bioeconomy Research, NO-1431 Aas, Norway

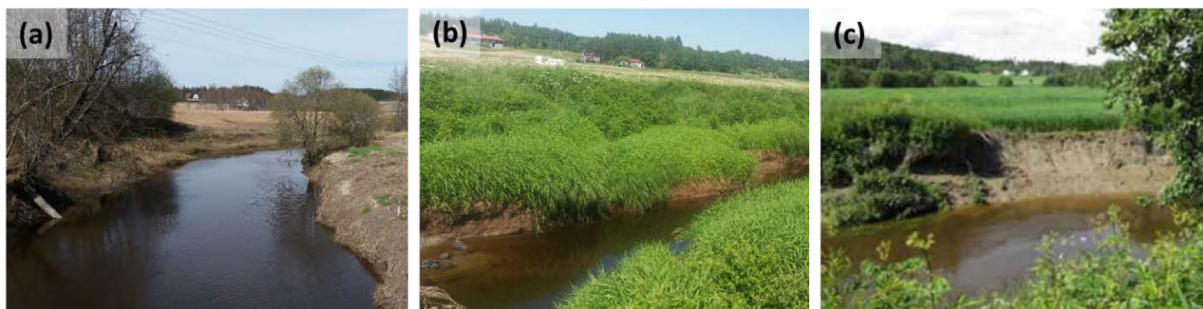
Fig. 1. Examples of observed undercutting processes and associated slope failures in small agricultural catchments in Eastern Norway: (a, b) Hobøl River and (c) Lier River.

The main cause of the streambank failures observed in small agricultural catchments in Eastern Norway is undercutting of bank toe and resulting steepening of the slope (Fig. 1; Skarbøvik et al., 2014; Skarbøvik, 2016) while the triggers are either hydrological factors (snow melt, intensive/prolonged rainfall) or human activity (using heavy machinery close to the edge of streambanks). Majority of the erosion events are observed in spring and autumn when the flooding risk is high (Skarbøvik and Bechmann, 2010): during the drawdown phase, the confining pressure of the water in the streams disappears and (partly-) saturated stream banks tend to fail (e.g. Jia et al., 2009). Relatively planar failure surface are commonly observed in the area (Fig. 1).

There are few limitations of the current version of BSTEM that influence the stability analysis. Presented modeling results do not account for potential seasonal changes in additional root cohesion, that we observe in the field (Fig. 6) and that is confirmed by other studies (e.g.: Pollen-Bankhead and Simon, 2009). During winter and early spring the vegetation is dormant and additional cohesion coming from the roots can be smaller or even negligible, especially in case of grass cover. Moreover, additional load coming from vegetation weight is not included in stability calculations. This, in turn, might be important in case of trees cover (e.g.: Ott, 2000; Pollen, 2007). It is also necessary to mentioned pre - assumed planar failure plan as a general limitation of BSTEM model. However, in our case, this assumption is valid as planar plane are commonly observed in the area (Fig. 1).

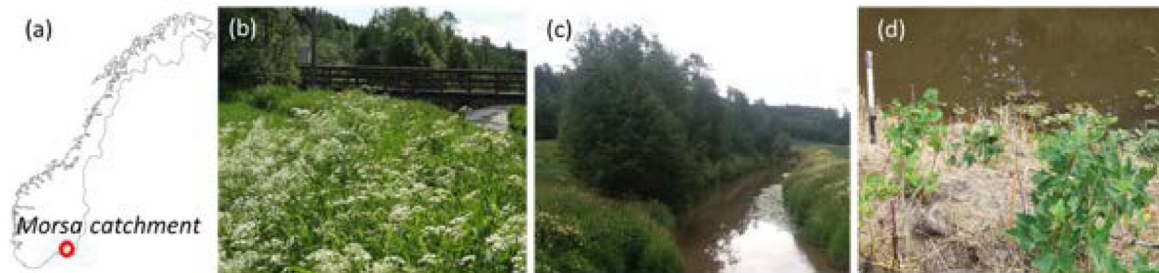
Fig. 2. Location of the monitoring plots (a) and pictures from the plots: (b) grass plot, (c) trees plot, (d) shrubs plot.

Hydrological monitoring of two plots representing vegetation typical for Norwegian agriculture areas (Fig. 2): mixed grass (root depth up to 20 cm) and trees (root depth more than 100 cm) were installed. Additionally, on the site with mixed grass, redcurrant berry bushes (*Ribes rubrum* 'Jonkheer van Tets') have been planted (in July 2016). All plots are located within distance of 50 m to ensure similar soil and environmental conditions. The height of the bank, at all three test plots, is 4 m above riverbed, while the slope varies greatly: 27.5°–32.6° for the grass plot, 39°–54° for the trees plot and 24.7°–39.7° for the shrubs plot. No visible soil stratification was observed within vertical profiles during installation of the equipment.

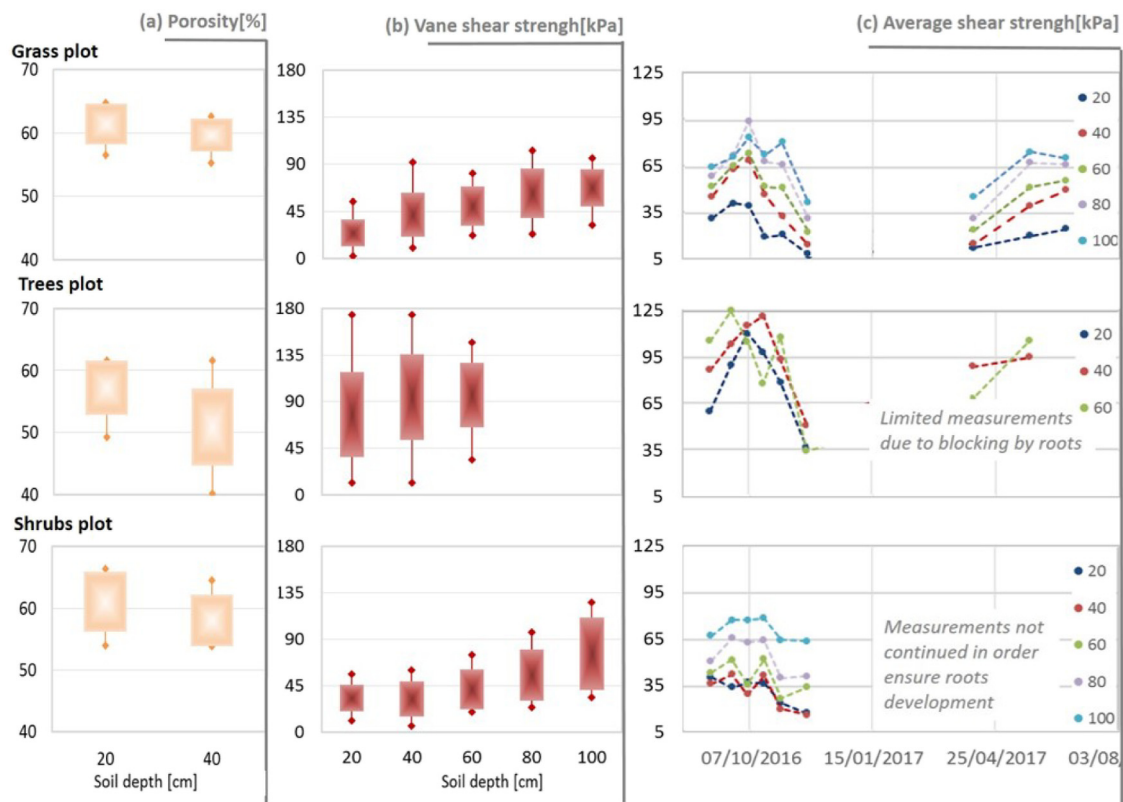
Fig. 6. Measured porosity (a) and vane shear strength (b) at different depths within three plots. Graphs show boxes of average values \pm standard deviation, together with max and min measured values; (c) changes in average shear strength with time and with depth, for the three plots.

Fig. 6a shows the soil porosity values measured at two depths within each plot. In general, soil porosity decreased with increasing soil depth.

Soil porosity at the trees plot was lower than at the other two plots. The results of vane shear strength measurements are shown at Fig. 5b. In all plots vane shear strength increased with soil depth. This behavior is a combined effect of soil compaction with depth (Table 2) and presence of the root-reinforced soil (different root depths for different vegetation cover type). The vane shear test measurements in the trees plot were the highest and showed the most variability, as they strongly depend on the position relative to main root systems. Fig. 6c shows the soil-roots strength changes with time. A clear trend is visible in all three plots: higher values of vane shear strength can be observed during late spring and summer. Again this trend is a combination of two factors: intensity of the vegetation grow (higher root density) and lower soil moisture content (Fig. 5).

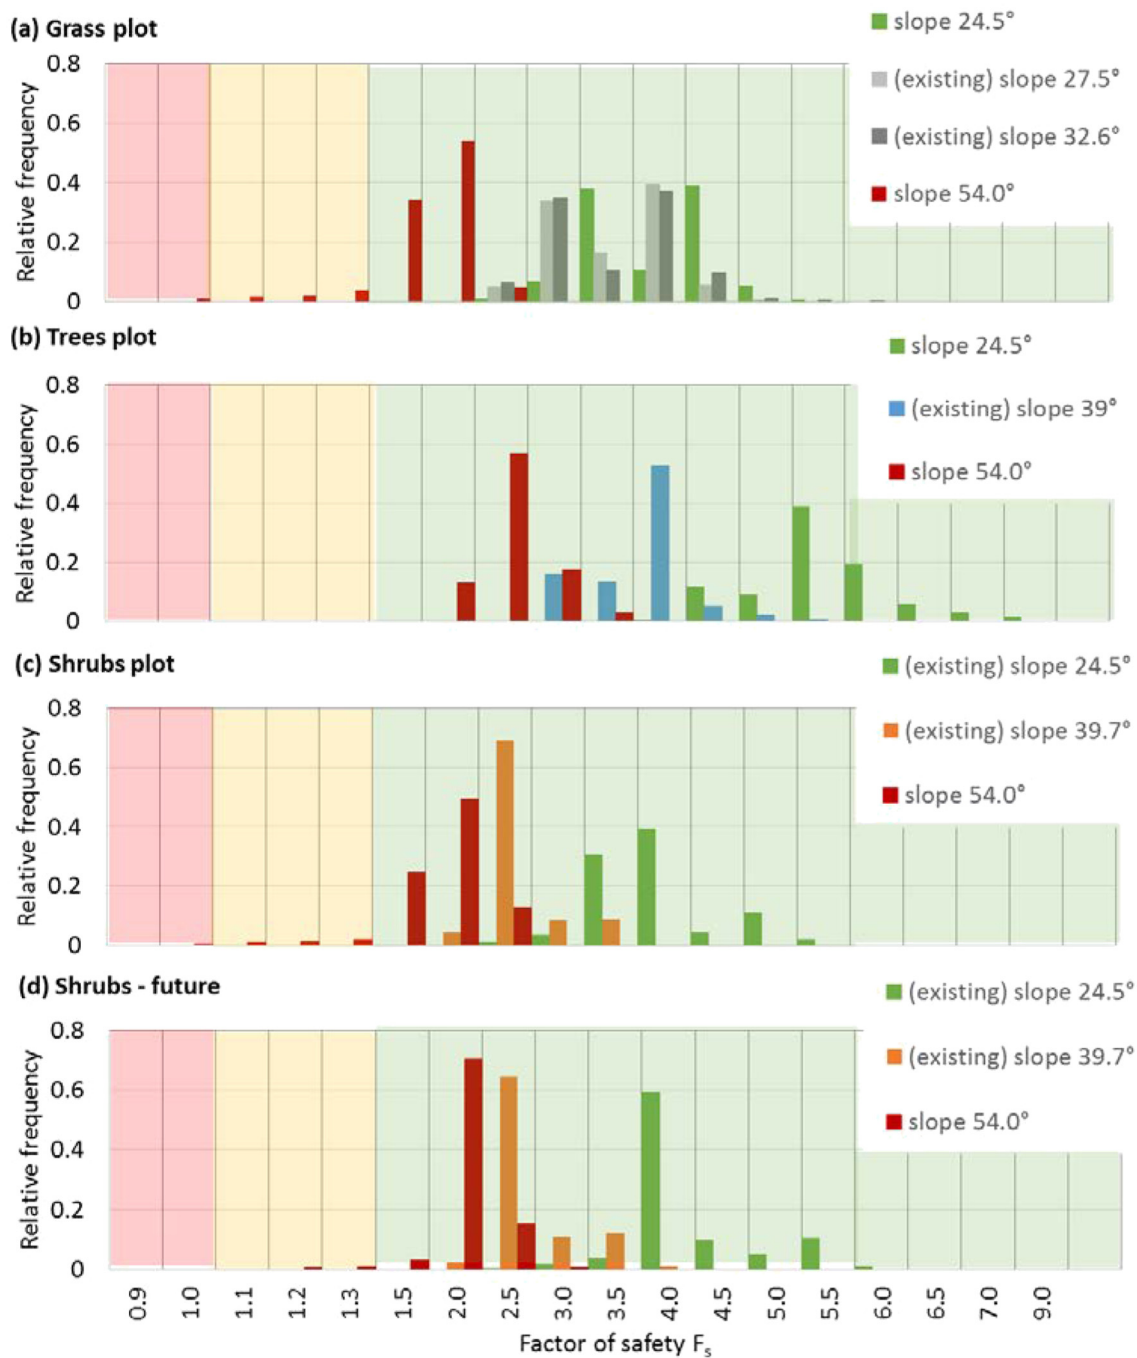
Fig. 9. Histograms of F_s for all simulated scenarios. Shaded areas indicate stability classes according to the BSTEM model: red – unstable slope; yellow – conditional stability; green – stable slope. (For interpretation of the references to colour in this figure legend, the reader is referred to the web version of this article.)
