## **Causes and Effects of Culvert Blockage During Large Storms**

E.H. Rigby\*, M.J. Boyd\*\*, S. Roso\*\*\*, P. Silveri\*\*\*\* and A. Davis\*\*\*\*\*

### **Abstract**

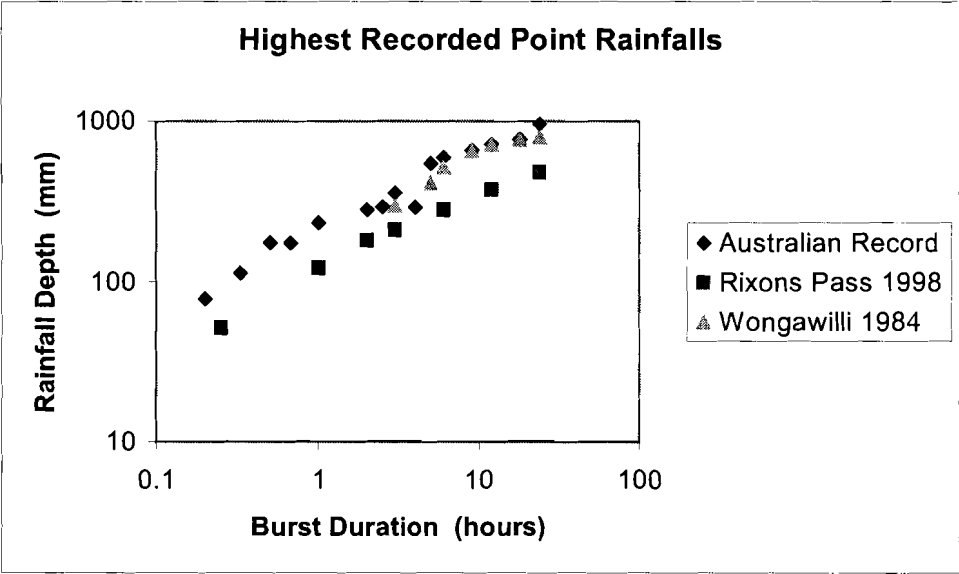
Figure 1 Extreme Rainfalls in Australia

A storm on 18<sup>th</sup> February 1984 centred on the town of Dapto, 5 km south west of the CBD, produced record rainfalls, which exceeded the historical extreme rainfalls by up to 29% (Shepherd and Colquhoun, 1985). Figure 1 shows rainfall recorded at the Wongawilli gauge. The highest 24-hour rainfall in this storm was 796 mm. This storm led to revision of the Australian Probable Maximum Precipitation procedure for short duration storms (Australian Bureau of Meteorology, 1994)

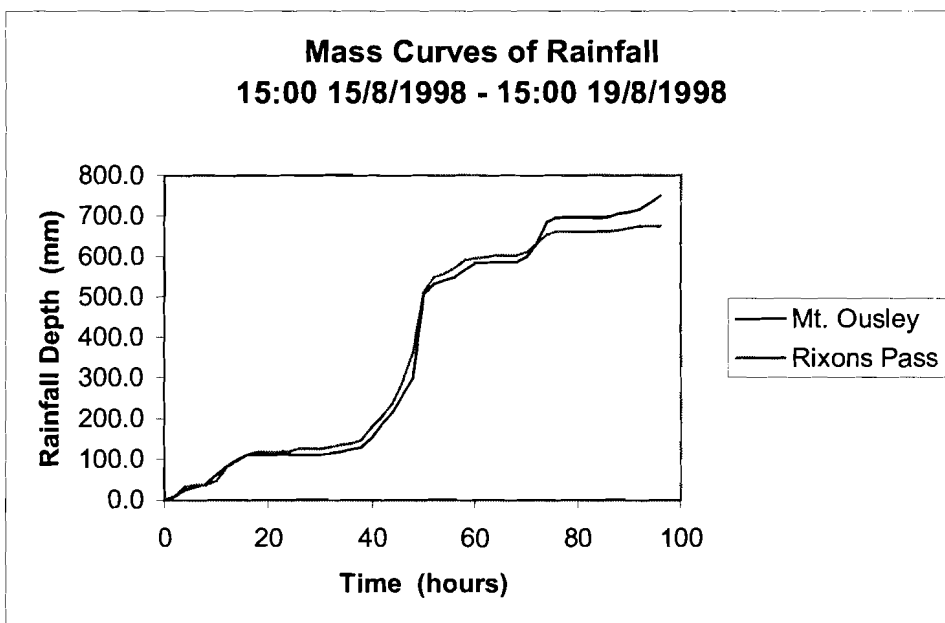
**Figure 2 Rainfall Mass Curves – August 1998**

From 13 to 17 August 1998, a low pressure system in the northern Tasman sea, and a high pressure system to its south, combined to direct moist unstable air onto the mid coast of NSW. This, combined with an upper air trough and the orographic effect of the escarpment, produced very heavy rainfall. The highest rainfall recorded over the 5 days was 745 mm. At Mount Ousley, high on the escarpment, 445 mm was recorded over a 24-hour period, with 180 mm falling in the most intense 2 hour burst within this time (Evans and Bewick, 1999). Figure 2 shows rainfall mass curves for 2 stations located near the top of the escarpment.

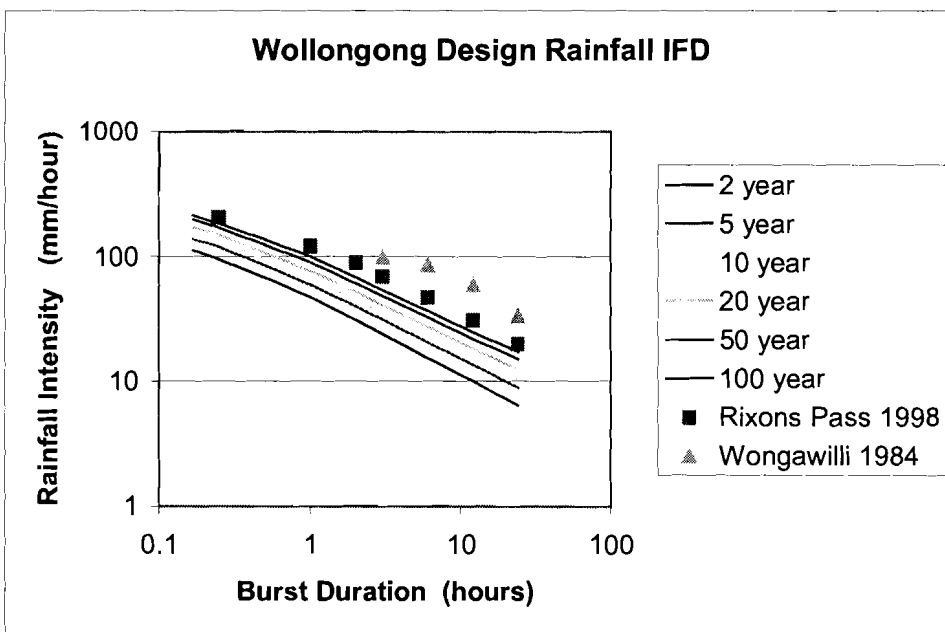
**Figure 3 Wollongong Rainfall Intensity – Frequency – Duration Data**

Comparison with design rainfall Intensity-Frequency-Duration data (Institution of Engineers Australia, 1998) gives Average Recurrence Intervals ARIs exceeding 100 years for durations between 30 minutes and 6 hours at some locations. These high ARIs occurred at locations high on the escarpment. It should be noted that ARIs were less than this in the lower parts of the catchments, lying between 20 and 50 year ARI near the coast. Figure 3 shows rainfall intensity-duration data for the August 1998 storm and the February 1984 storm superimposed on design rainfall Intensity-Frequency-Duration data for the City of Wollongong. This figure is indicative only, because design IFD curves would be higher for locations on the upper escarpment, and lower for points on the lower catchments.
