AW Six-Speed

Valve-Body Diagnosis

By Bob Warnke

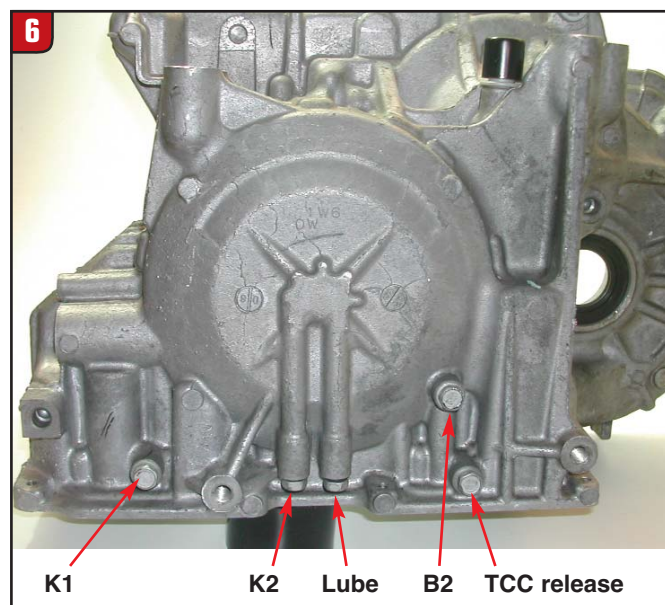
With the complaint of harsh shifts from 3 to 6 and 6 to 3, and C/K-1 pressure has not been elevated, you should tap TCC release (Figure 6). As mentioned, the TCM strategy brings the converter clutch on directly after the 2-3 shift. It will go to full application at light load. If you are graphing engine and turbine speed, lines should be overlaid at full application. TCC will be modulated off to disconnect the turbine shaft during subsequent upshifts and downshifts. If this control is not evident on your graph and release-pres-

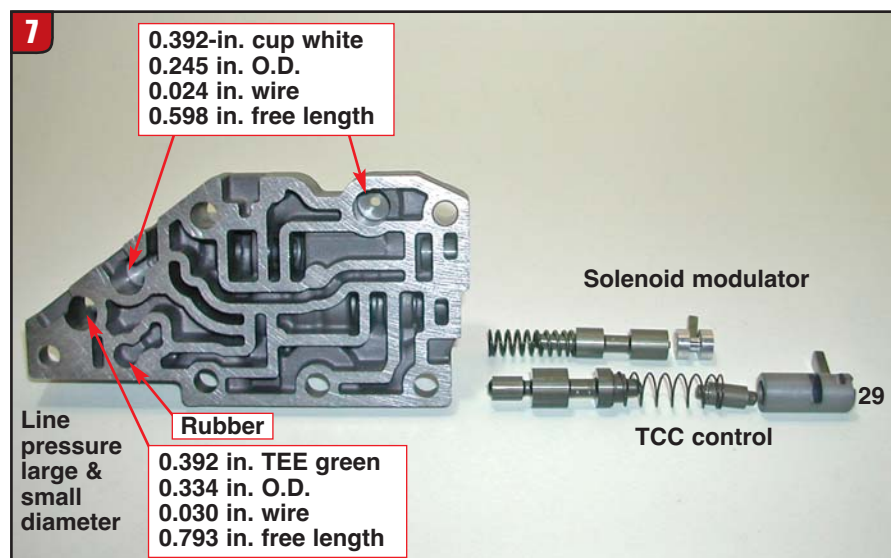
sure test, inspect the TCC control bore for wear. The scan tool will indicate an amperage change, but the TCC release pressure will not be affected (Figure 7).
