# A4LD /4R44E

## Ford 4.0L Crank Spacer Puzzle

By Gregg Nader

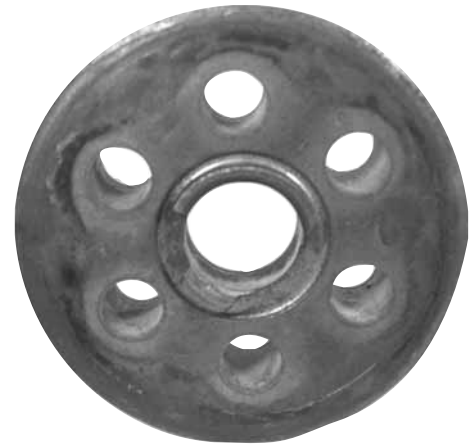
Figure 1 shows the crankshaft spacer. This part lives between the engine crankshaft and the flexplate. It is very common to find this part cracked, broken or worn where the torque converter pilot fits into the center of the spacer. When the spacer is worn or broken, the converter can move out of alignment. It doesn't help that the spacer is made of a brittle powdered-metal material that wears and cracks easily. It should be routine to inspect or replace this part on every vehicle.

- ☐ Use later thicker flywheel
- ☐ Use converter with longer pilot
- ☐ Always replace spacer
- ☐ Torque crank bolts in two stages:  
10 ft. lbs. then to 52 ft. lbs.

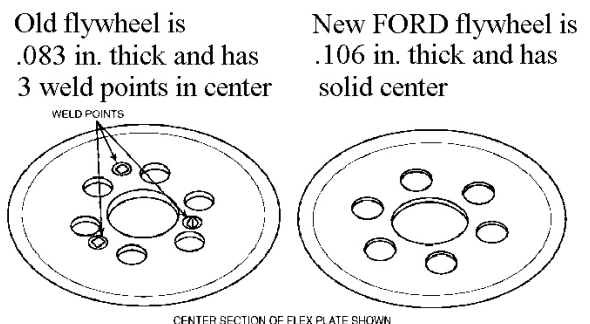
Figure 2

The flywheel/flexplate on early A4LD/4R44E 4.0L flexplates was .083-inch thick steel and can easily be identified by a second layer around the crank bolt area and three spot welds. In 1997 Ford revised the flywheel to .106 inches thick (Part No. F1TZ-6375-BA). The later flexplate can be identified by NOT having a second layer around the crank bolt area and three spot welds (See Figure 2). The thicker flexplate is more resistant to fatigue, keeps the converter running true, and helps prevent the converter pilot from bottoming in the crank spacer. Be careful, because not all replacement flywheels are of the thicker design.

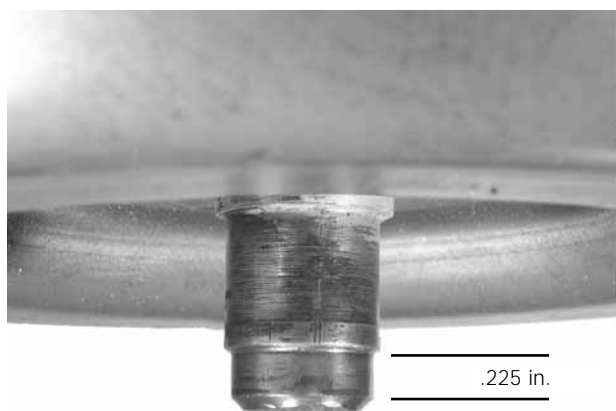
Figure 3

Ford also changed the pilot on the torque converter. Figures 3 & 4 show the early and late converter pilots. The newer pilot is longer and has a smaller chamfer on the end.

Short Pilot

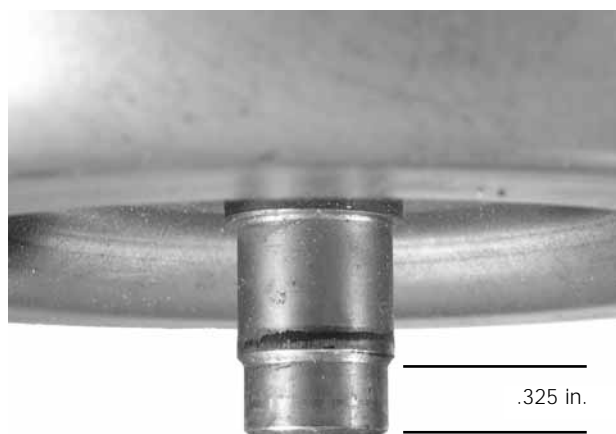
Figure 4

Long Pilot

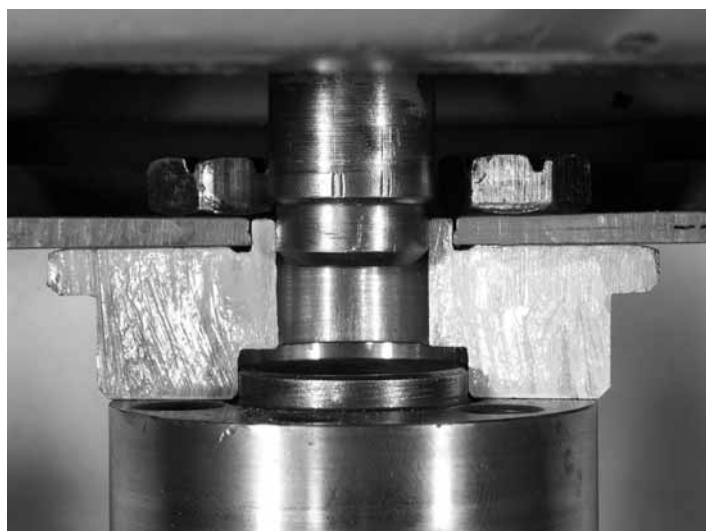
Figure 5

Figures 5 & 6 show the short and long pilots assembled with crankshaft, spacer and flexplate. The longer pilot has .100 inches more contact area in the spacer than the earlier short version. Unfortunately, not all converter rebuilders update to the longer pilot, so it is common for transmission shops to replace long pilot converters with the earlier short pilot version, unknowingly taking a step backward. Whenever possible, your replacement torque converter should have the longer pilot.
