Throttle Valve Kit

22771-HDK

Sonnax Part Summary

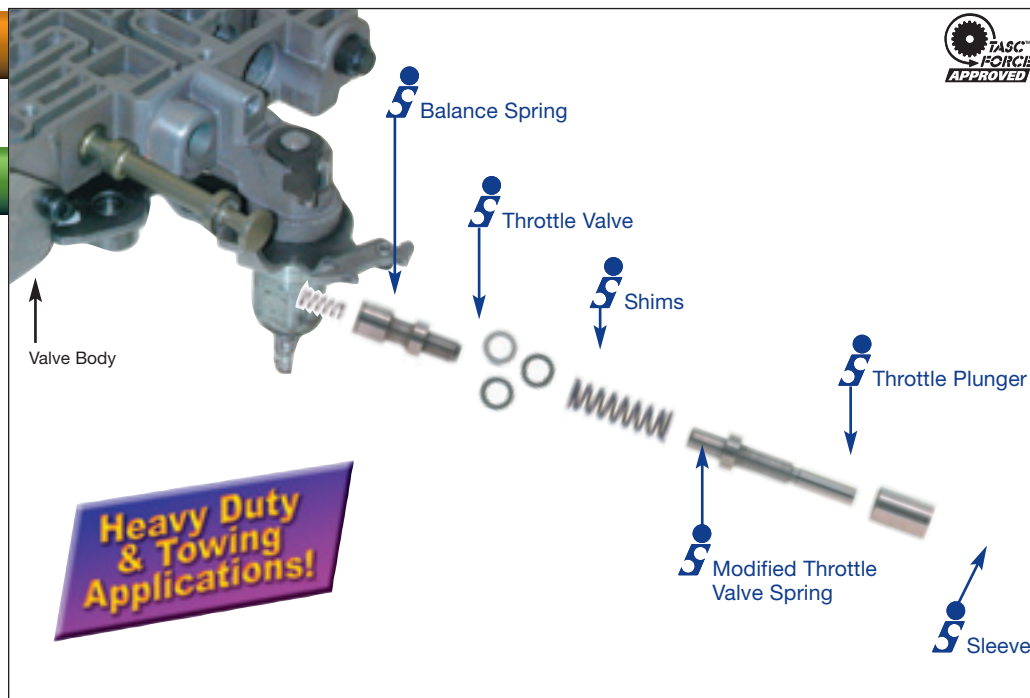
- 1 Throttle Valve
- 1 Throttle Plunger
- 1 Balance Spring
- 3 Spring Shims
- 1 Alternative TV Spring
- 1 Sleeve

Note: The modified TV spring should never be installed alone. Always use at least one shim with spring.

Vehicles with 42-47RH/RE and A904-A727 transmissions may have problems with late 2-3 upshifts and oversensitive 3-2 downshifts. These complaints are often due to excessive wear between the throttle valve and throttle valve sleeve. Sonnax now offers the 22771-HDK throttle valve kit to address these problems.
