**Article No.:** TASC-TIP-03-2009

## Transmission versus Cooler Line

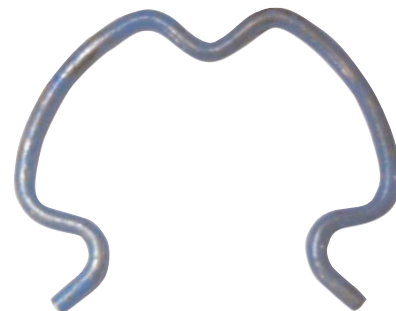
**Figure 1**

*OEM cooler line retaining clip*

Here is a real life experience from our shop that started about 3 years ago. A 2000 Chevrolet pickup came in with no reverse, no 2nd, and no 4th. While I feel for the customer, I have to say this is a 'sweet' complaint and we are eager to fix this 'gravy job'. The vehicle has better than 130,000 miles on it so the customer chooses an overhaul. We take out the transmission, do the standard overhaul, flush the cooler, and back in the vehicle it goes. Before we let the truck down it gets a double check to make sure everything looks as if we had never worked on it. We fill it up with fluid, test drive it a couple of times and it is ready to deliver to the customer. The customer picks up the vehicle and it works great.....for about a year. Then we get that dreaded phone call that goes something like this: "You know the truck you just overhauled for me? Well, it just started slipping and quit all at once". We send a wrecker after it. Once it gets to the shop we raise the hood and find out that the cooler line at the radiator has been on the move. That's right; the top cooler line has decided to move rearward approximately 6 inches. The cause: the tiny metal cooler line clip (*see Figure 1*) gets worn or breaks (*see Figure 2*) and allows the cooler line to pop out of the radiator.

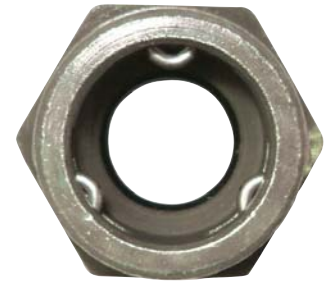
**Figure 3**

*Inside view of the GM cooler line fitting. You can see the 3 small contact areas.*

I know some of you out there have not run into this problem yet, so you may be reluctant to start replacing the clips on these vehicles. I challenge you to start taking the clips off at the radiator and inspecting them, especially on higher mileage vehicles. These tiny clips only contact the cooler line in three small areas (see Figure 3). Once the clip is worn through in one of the three contact areas, it breaks and out goes the line. We have seen them badly worn at 65,000 miles (see Figure 4).

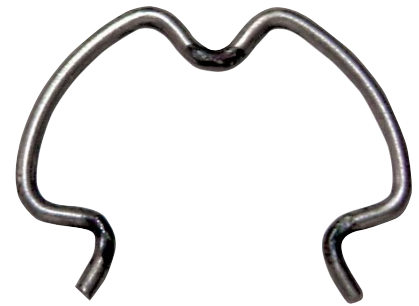
**Figure 4**

*This clip has 65,000 miles on it. Note the wear on the 3 contact areas.*

Why take a chance? Replace them and charge the customer for it. What is that old saying? "While the customer has his wallet out, make sure you get the money you deserve to fix their vehicle, because once the wallet goes into their pocket, it is nearly impossible to get them to pull it back out later."
