Stator Support Sleeve

71812-01

Sonnax Part Summary

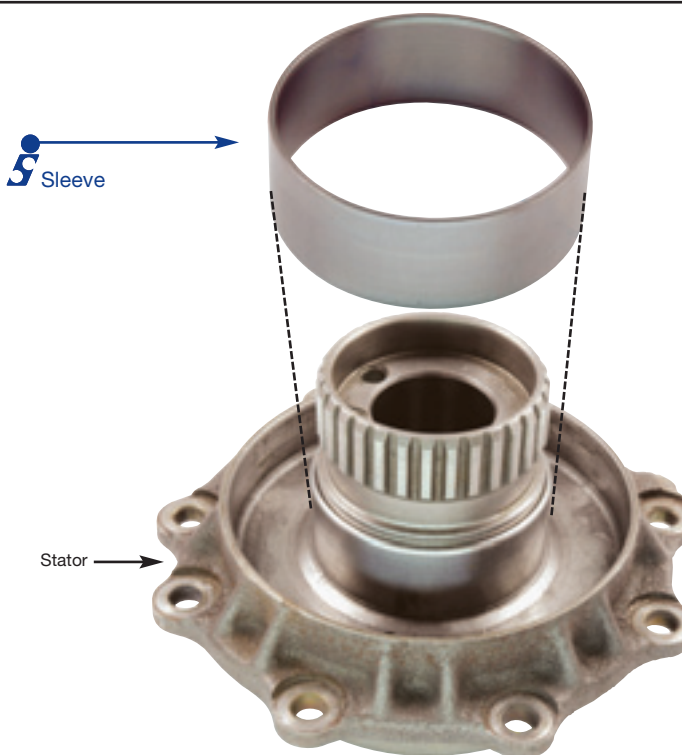
Stator support sleeve wears at the interface of the converter bushing journal

The cast-iron surface is not durable.

This steel sleeve can be pressed onto a machined-down stator support bushing journal and will fit all variations.

The converter bushing journal in Mazda/Ford F4EAT, G4A-HL, -EL and -FEL units is often excessively worn. A worn bushing journal contributes to converter seal leaks, vibration, converter drain-back and loss of converter oil. There are many variations in bolt pattern and other stator features in these units that make it difficult to locate the correct replacement stator support, but the converter bushing journals are the same diameter. The Sonnax stator support sleeve **71812-01** allows any stator with a 2.084" diameter converter bushing journal to be repaired by machining the original journal down to accept the press-on steel sleeve.

- Allows salvage of stators with worn converter bushing journals.
- Steel sleeve is harder and more durable than original cast-iron surface.
- Allows original support to be repaired and prevents having to find a replacement with correct bolt pattern.
