**Article No.:** TCTIP-01-10

## Checking for Cracks

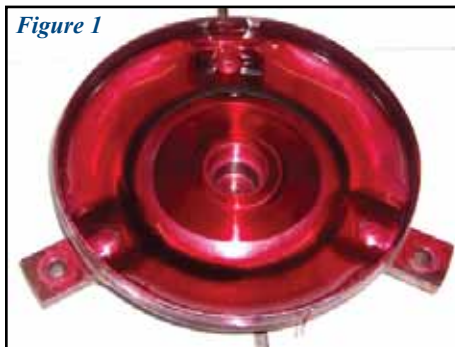
*Figure 1*

Ken Kelly, from Trans Specialties in Aston, PA, talked about one conventional method during the round table discussion at the seminar. His method also appeared as a Tech Tip in the July 2009 edition of the TCRA Newsletter. Ken's method is called Dye Penetrant Inspection or Liquid Penetrant Inspection. Materials needed to conduct this test can be purchased as a 3 part kit from your local welding supplier for under \$20.00. The kit consists of a cleaner, a penetrant, and a developer. The cleaner is used to insure a clean, dry, contaminate free surface that is necessary for good results. After cleaning, the penetrant is applied to the surface of the part being tested (*Figure 1*). After allowing the penetrant

15 to 30 minutes to soak into all the crevices of the part, the excess penetrant can be removed by wiping with a lint free cloth which has been lightly soaked with a cleaning solvent. The last step in the process is to apply the developer to the surface of the part. The developer will highlight any areas that the penetrant was able to get into (*Figure 2*). Allow the developer about 10 minutes for its blotting action to work fully. A visual inspection will now reveal any cracks or defects in the part.

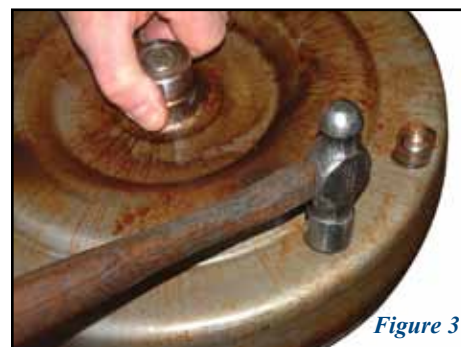
*Figure 3*

tour of the DACCO Torque Converter Rebuilding facility. Robert Cravens, a long time rebuilder, showed attendees his tap method for checking for cracks in torque converter covers. To illustrate his method, Robert held an E4OD cover by the pilot, and lightly tapped the front of the cover in several places. He explained that a crack free cover will emit a crisp, bell-like sound, while the area of a cover with a crack will have a dull thud sound. The method appeared to be very simple and straight forward, but Robert cautioned that there were several important elements of the test which must be done correctly, beginning with how the cover is held. Holding the pilot lightly by your finger tips will yield the best results. Holding the cover firmly at its outer edge will muffle the sound and make it more difficult to identify a crack. The second element is where the cover is tapped. Robert taps the outside of the front of the cover directly over the torque converter clutch (TCC) reaction surface (*Figure 3*).

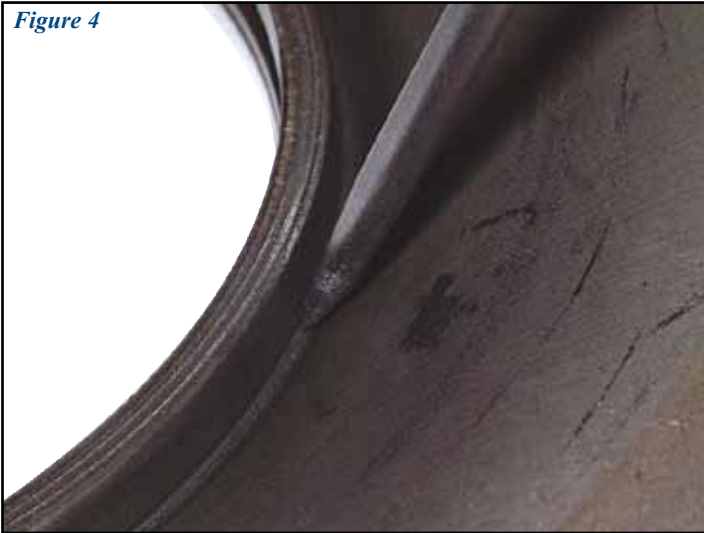
**Figure 4**

pistons for cracks. The 518 pistons are notorious for cracking, and the cracks are equally well known for being difficult to find. The cracks are difficult to find because they are usually located in the crease at the bottom of the pocket that houses the I.D. sealing ring (**Figure 4**). While it is common for converter shops to discard 518 TCC pistons that are noticeably burned, they often mistakenly re-use pistons that appear sound but are actually cracked.

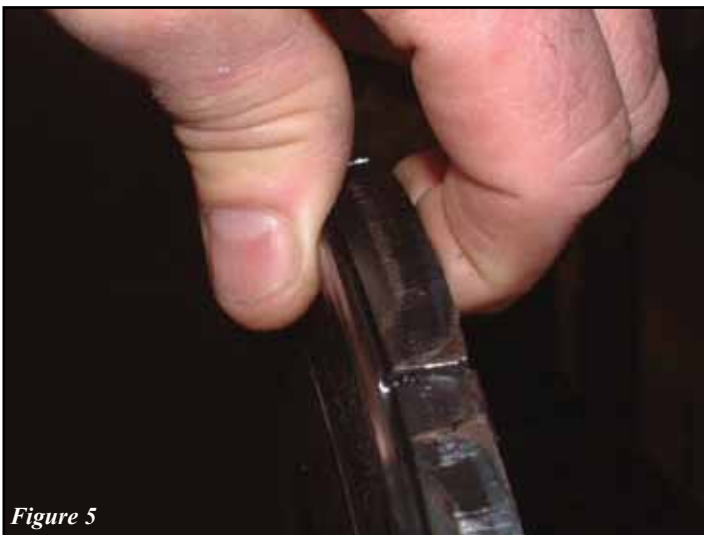
**Figure 5**

Josh's technique for checking the pistons is very similar to Robert's method. Josh places the tips of his index and middle fingers into one of the spring pockets and lightly holds the piston by clamping his thumb on to the friction material surface of the piston (**Figure 5**). He then taps on the front of the piston in four places (12:00, 3:00, 6:00, and 9:00). Josh's tapping tool of choice is a lathe chuck key, but a small ball peen hammer will also work.

When one or more of the taps produces a dull tinny sound, Josh verifies the leak by either holding the piston up to a high intensity light or by using solvent and an air nozzle.

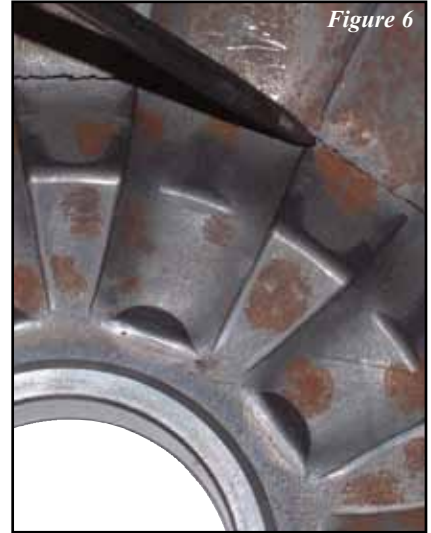
**Figure 6**

There are many other pistons and covers that have cracking issues. The late model Honda piston, as shown in **Figure 6**, is a good example.

This piston was cleaned and was being prepped for rebonding before the crack was found. The location of the crack indicates that the crack was caused by the flexing action of the piston. Remembering what the industry experienced with cracks caused by flexing of E4OD or 4L80-E pistons, it is likely we will see many more Honda pistons cracking.
