# THE TORQUE CONVERTER JOURNAL

Volume 5 Number 1

## *Another Great Sonnax Solution:* Salvage those worn out Ford RWD stator castings

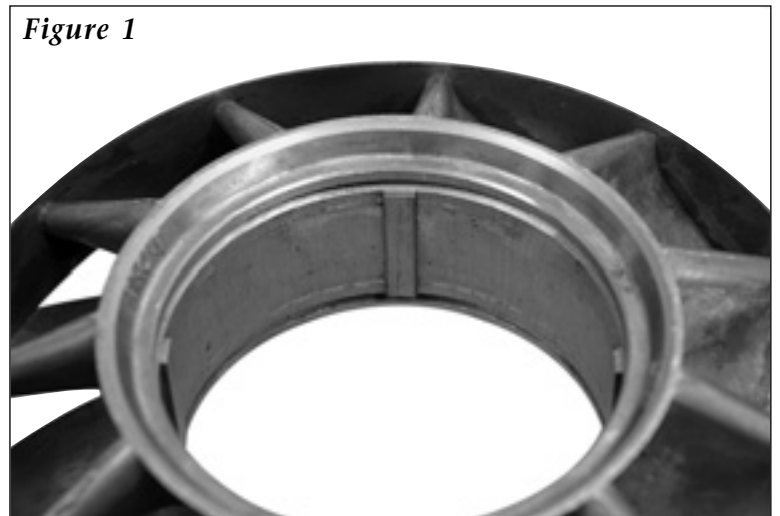
*Figure 1*

lugs that keep the caps from spinning – have worn. **Figure 1** shows a stator with good lugs. These lugs are fully formed and show no signs of wear at the location where they engage the notches in the stator caps. **Figure 2** shows stators with significant lug wear. These worn out lugs do not have enough material to fully engage the notches in the phenolic stator caps. Without fully formed and intact lugs in the stator body, the plastic caps

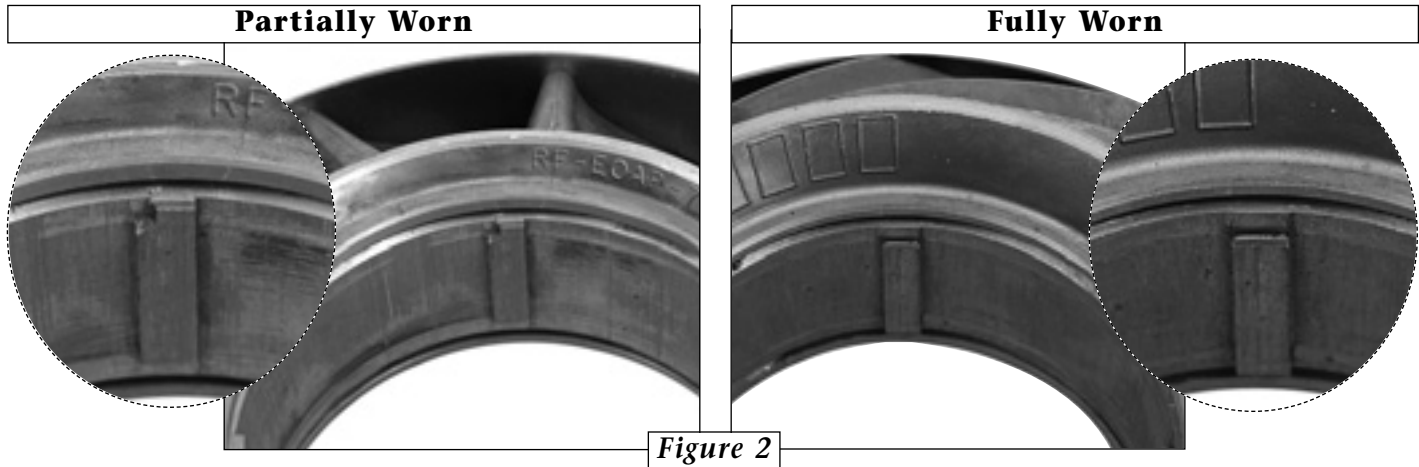
Figure 2

themselves can wear, fracture and rotate. When the phenolic caps start to spin in the stator, complete cap failure is not far behind. Even worse, full converter failure and substantial transmission contamination can occur quickly thereafter.

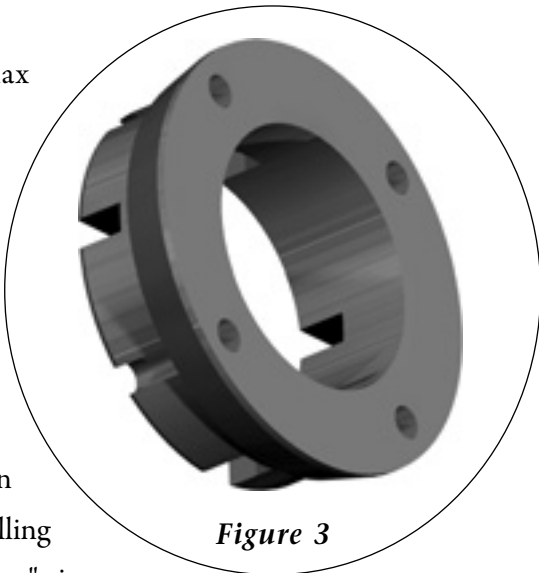
Figure 3

The Sonnax Drill Jig **FD-DJ-1** (*Figure 3*) allows you to salvage an OE stator with worn lugs by drilling new "pockets" into

the stator casting. The jig insures the precise location of these 'pockets,' so that you consistently get the same results. With new pockets in the stator casting (*Figure 4*), you can then use the specially designed stator caps, **FD-WA-21** (impeller side) and **FD-DA-22** (turbine side) (*Figure 5*). These aluminum stator caps, which replace the

minimum, that you have a drill press and drill vise (**Figure 6**). Although some rebuilders may be tempted to use a hand drill, that is not advised. As a cutting tool, the **FD-DJ-1** uses a standard 5/16" diameter drill bit; however, the drill bit is not included with the tool. Repairing worn stators does not require the use of an end mill bit or any other more exotic cutting tools. Additionally, **FD-DJ-1** comes with detailed instructions, and Sonnax is available with tech support as always.

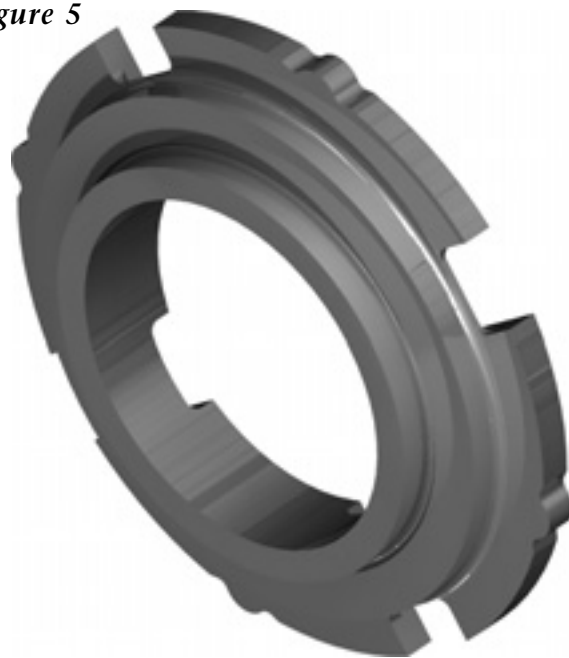
**Figure 5**

OE phenolic caps, each have 4 tabs on the O.D. of the cap that fit into the new pockets you drilled into the stator casting. As an additional benefit, the **FD-WA-21** and **FD-WA-22** also function as bearing adapters. The impeller side stator cap, **FD-WA-21**, uses the **GM-N-8HLT** bearing; the turbine side cap, **FD-WA-22**, uses the **CH-N-1** bearing. Use of these bearings is a great upgrade over the OE phenolic material. The bearings/cap combinations allow the stators to be used in applications ranging from vintage C4 and C6 transmissions up through late model, multi-disc 4R100 and 5R110 units.
