Article No.: TASC-Tip-12-06

ZF tips with a European flavor

ZFHP24 repair tips

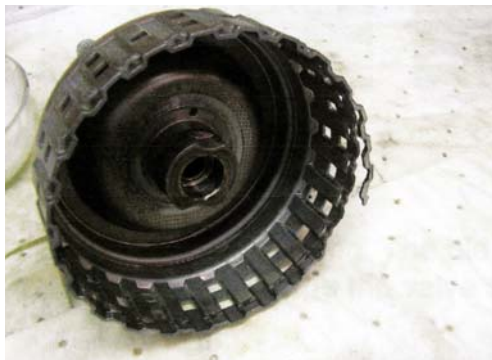
Figure 2

If the transmission is slipping in forward with the ratio out of limit, your problem is probably a cracked input drum A (*see Figure 2*). The snap ring breaks out of this groove and results in no forward or difficult forward.

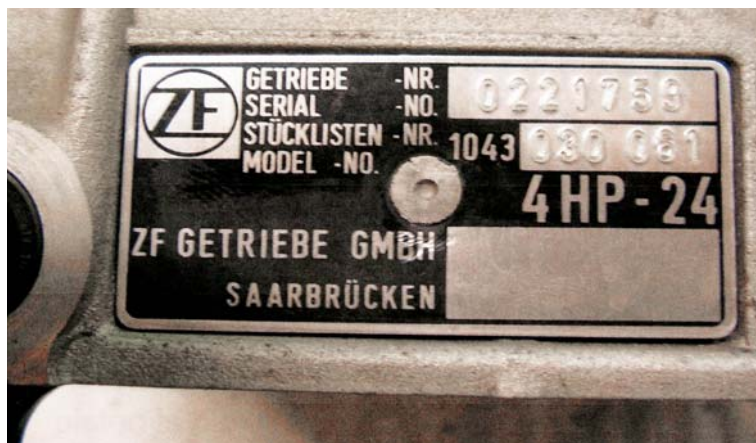
Figure 1

When you consider working on a ZF automatic, your starting point should be the tag, which leads you to the information and application required for the unit (*see Figure 1*).

The first line of the tag is the serial number, which is required to identify which running changes or modifications might apply.

The second line, the part number (stucklisten), is often the most important number. The first four digits of this number identify the type of transmission. For example, the 1019 is 4HP20, 1043 is 4HP24, and 1056 is 5HP18.

The next three digits of the stucklisten identify a design type, such as 000, 010, 020 or 030, telling you if there is a transfer case, electronic control or special application. For example, if the tag says 1043.030, it is a ZF4HP24. If it reads 1060.50, you know it is a ZF5HP19 specific for Porsche.

The last three numbers identify the application. If the tag reads 1058.000.026, it means you have a ZF5HP24 RWD Jag41 (AJ26).

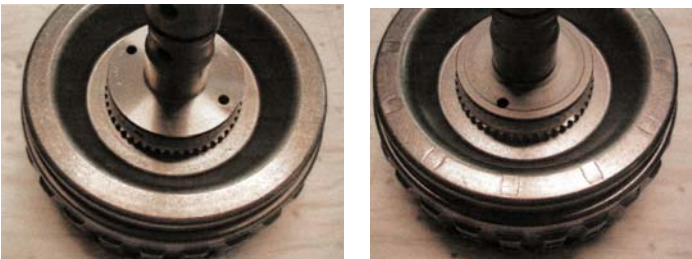
Figure 3: Old model of input shaft at left, new model with dimples, 1058.270.040 at right.

When working on the ZF5HP24 you must be sure to use the newest version of the input shaft A (see *Figure 3*).

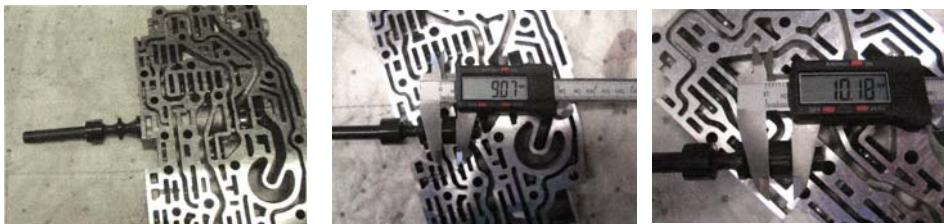
Figure 4: The location of the main pressure valve (left), the old valve (center) and the new valve (right).

Secondly, you must check the main pressure regulator valve. The last spool of the valve should be 10mm long. On the older valves, the spool is 9mm. If you have an old valve in your transmission, you must change both the valve and the valve body housing. The new valve number is 1058.327.030 and the valve body number is 1058.327.020 or 022, depending on the part number of the transmission (see *Figure 4*).
