Governor Bore Sleeve

54251-02

Sonnax Part Summary

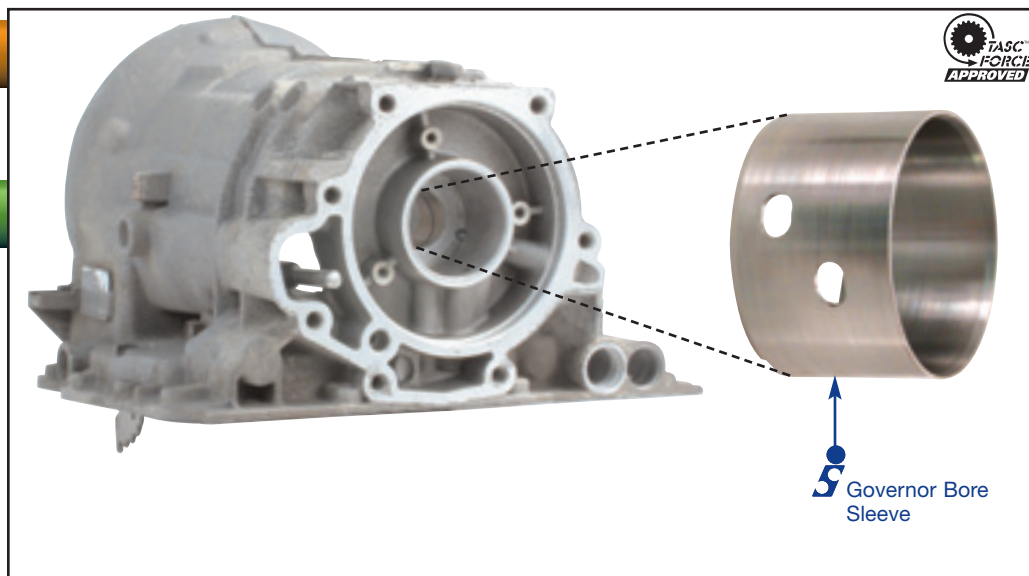
- Case wear at the governor hub seal area

OEM steel governor sealing rings wear the aluminum bore.

1 Governor Bore Sleeve

Vehicles with GM 180 (3L30) transmissions frequently have excessive wear at the governor hub seal area. These units use steel seal rings against an aluminum bore. Because these components are often found in high-mileage vehicles, excessive wear in the sealing ring area leads to fluid leakage and can destroy the case. Sonnax now offers this wear-resistant governor bore sleeve **54251-02**.

This governor bore sleeve restores hydraulic integrity to the case.

Note: Requires advanced machining.

- Sleeve is made from hardened and ground steel and prevents excessive wear.
- Sleeve salvages worn cases and restores hydraulic integrity.
