## **Rear Clutch Inner Lip Seal**

### **3647-01**

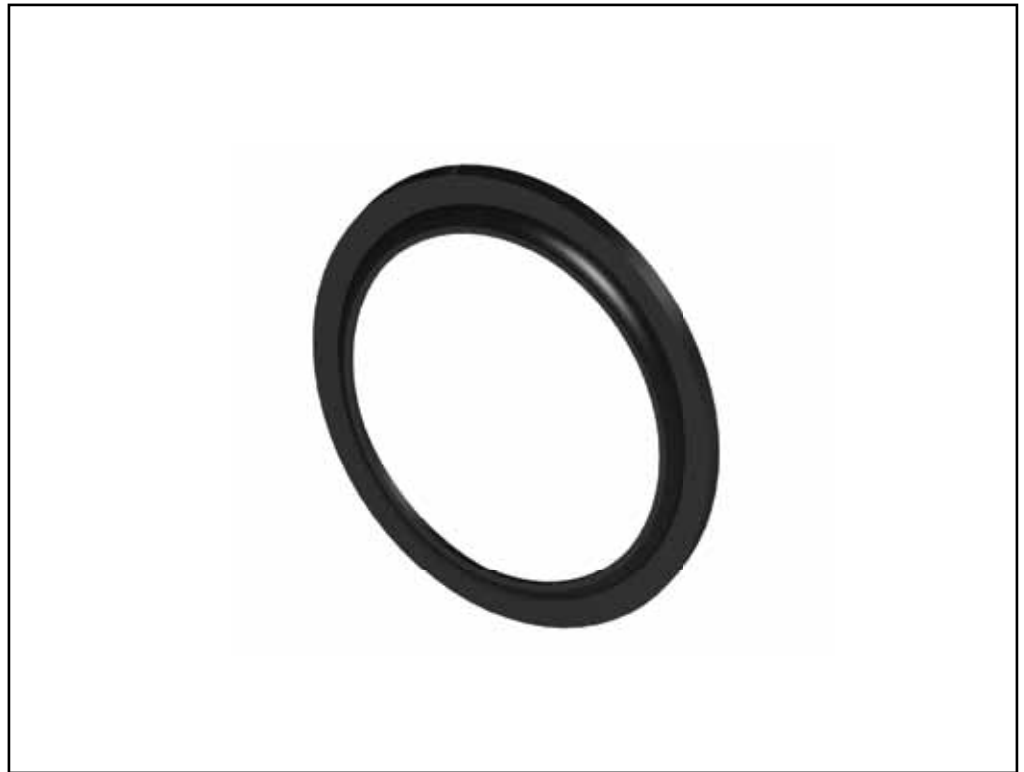
Delayed or no forward engagement cold is often caused by a shrunken or deteriorated inner lip seal in the rear (forward) clutch piston.

Improved seal material and design provides better sealing and enhanced seal life.

- Improved design features a longer/beefier lip
- Seal material upgraded to Viton® compound

**NOTE:** Clutch drum surface should be prepared with 600 grit Wet/Dry paper. Seal should be well lubricated prior to installation.
