Article No.: GN-TASC\_09-06

## 4R44E, 5R55E case-wall movement and comebacks

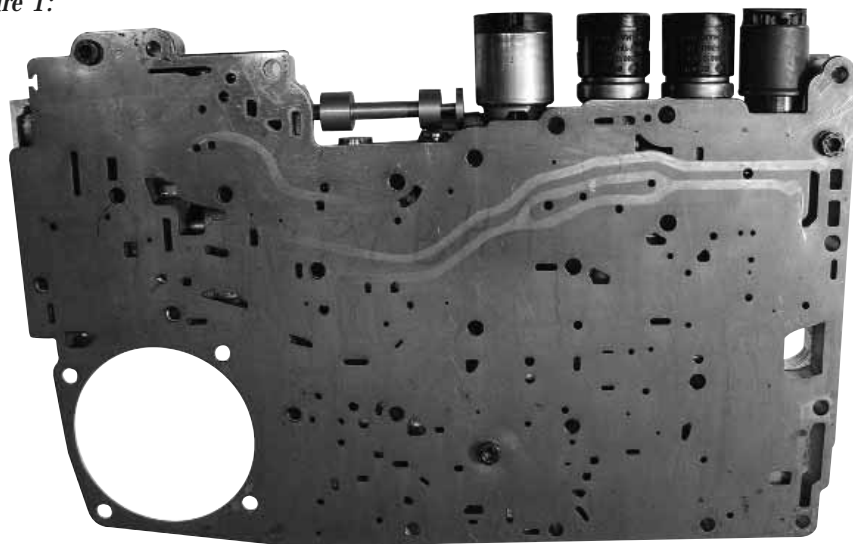
Figure 1:

I've heard complaints of blown-out valve body gaskets, loose valve body bolts and various otherwise unexplained symptoms due to cross leaks in Ford 4R44E through 5R55E units. These problems are usually accompanied by an odd wear pattern or "fuzzing" visible on valve body gaskets and witness marks on the separator plate (see Figure 1).

Visible marks on the separator plate are created from case-wall movement.

The cause is the case oil passage worm track walls, which are susceptible to side-to-side movement due to large surface area and few reinforcements. The longest passage is line pressure, which varies from 70 – 350 psi. The adjacent long passage that runs parallel is "CC" converter oil, where pressure is limited to about 80 psi by the vertical blow-off valve/spring in the CC passage near the front of the valve body. The large surface area and pressure difference between these long passages is the major cause of case wall movement. For example, just part of one section of the worm-track wall is roughly 1 1/4 x 5", which works out to a surface area larger than most servos. Calculating the pressure differences between these two oil circuits shows the forces pushing on the case wall can be over 1,000 pounds in drive and more than 1,500 pounds in reverse.

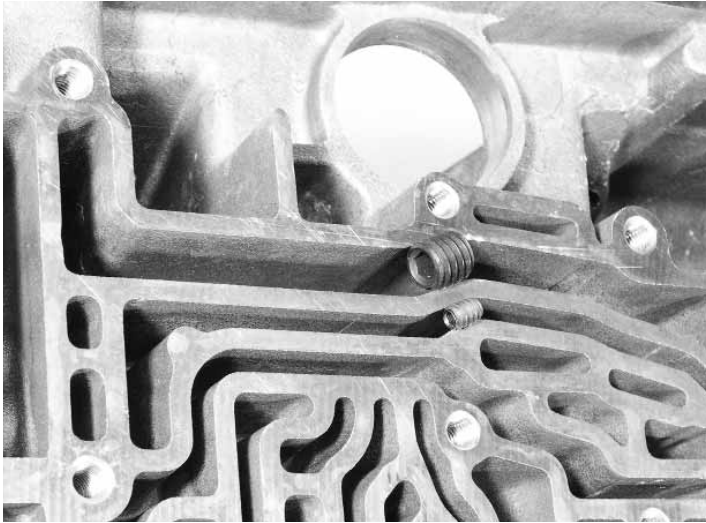
*Figure 3: Place set screws horizontally over passages.*

The fix for the problem is surprisingly simple and inexpensive. Inserting common set screws (see Figure 2) sideways into the case gives additional stability to the case walls and is not a significant restriction to oil flow. Refer to Figures 3 through 5 for step-by-step procedures to install the set screws. Just a couple will act as a bridge and make a big improvement. You can add additional screws as necessary, but be cau-

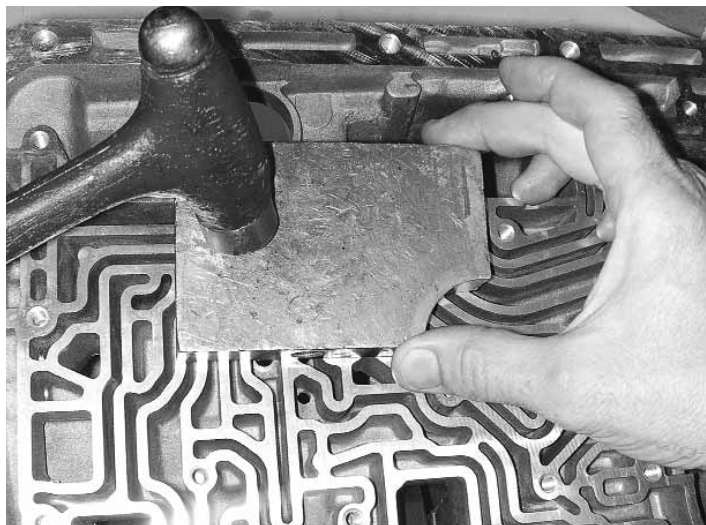
*Figure 4: Use a flat steel plate to drive the set screws flush with the case.*

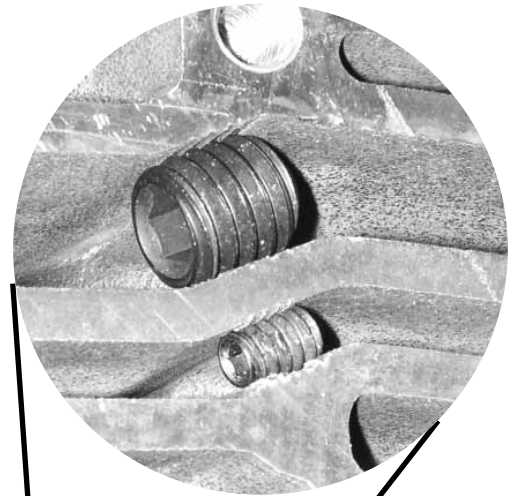
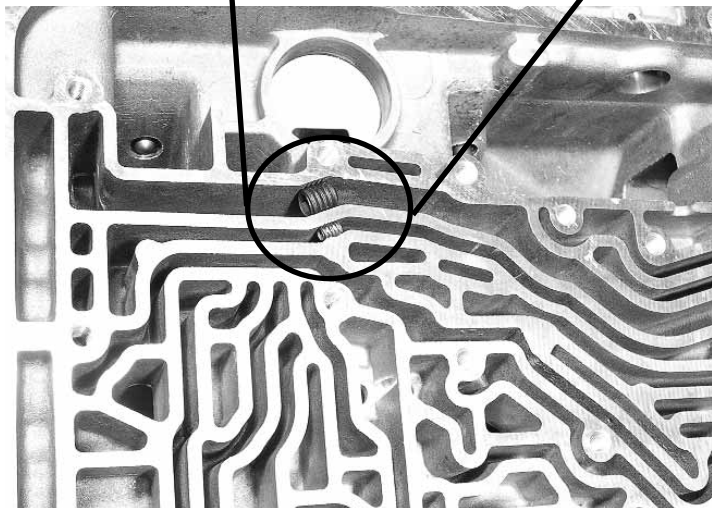
*Figure 5: Set screws installed. Additional locations can be added as desired.*

tious about selecting the right size for the gap so that there is no chance of cracking a wall. I admit, this approach is a bit odd, but once you try it, I am sure you will see how simple and effective it really is.
