Chrysler 41TE & 42LE Range Sensors

By Mike Steen

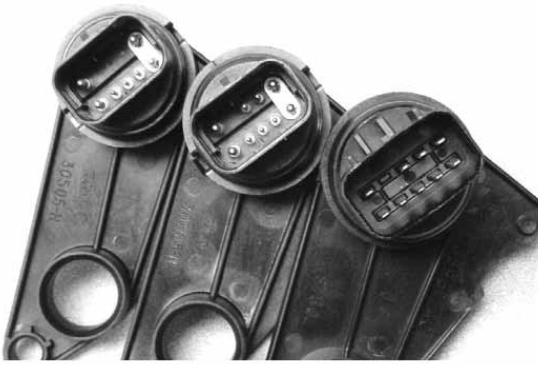
Figure 1

Three Generations

In October 1998 Chrysler changed its connector from the familiar round pins to a new blade type connector (see Figure 1). This change took place to address concerns of DTCs caused by the sockets for the round pin connector spreading out, which would set codes from continuity problems. The switches are not interchangeable. The neck of the switch and the corresponding case hole are different diameters between the two parts (see Figure 2), and of course, the vehicle harness is different. This should be one of the things you check before you install the unit into the vehicle.

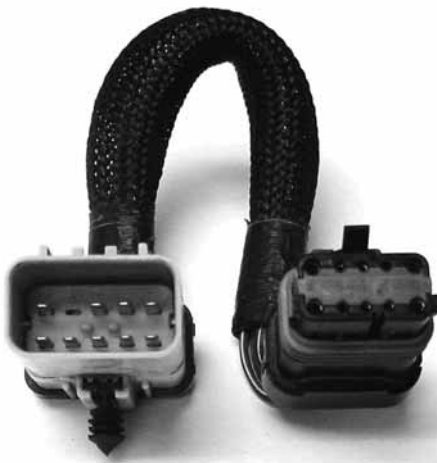
Figure 3

1999 Jumper Harness

Here's where it gets tricky. At the start of production, the early model 1999 vehicles were built with 1998 style transaxles with the round pins. A jumper conversion harness (see Figure 3) was used to mate the 1999 vehicle harness to the 1998 transaxle in all models except the JA model. On the JA model, the main vehicle harness connector was changed to directly fit the 1998 range sensor. If you are installing an exchange unit, and it's a 1999 transaxle with the late range sensor, all you need to do is remove the jumper. If it's a JA model vehicle, a splice kit is required to convert the early harness to the late harness (see Figures 4 and 5).

OK, back to the predicament and the promised job. Say we've installed a 1998 transaxle in a vehicle with the late harness. All we'd need to do in this case is install a jumper (Chrysler Part No. 4868295AA). Another scenario could be a 1999 transaxle in a vehicle with an early round pin harness. There are actually two ways to get out of this jam. One is to convert the early harness using the splice kit. Or, you could install an early range sensor and use a larger seal (see Figure 6, Chrysler Part No. 5013863AA) to fit the late case with the larger diameter hole.

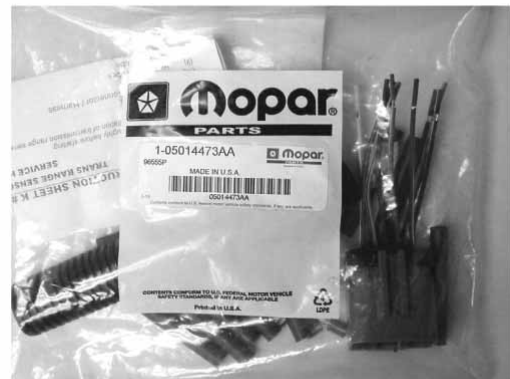
Figure 4

41TE Splice Kit

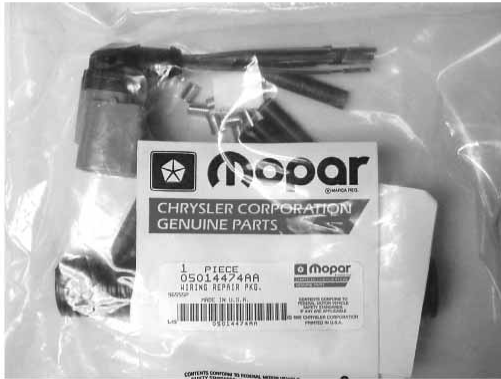
Figure 5

42LE Splice Kit

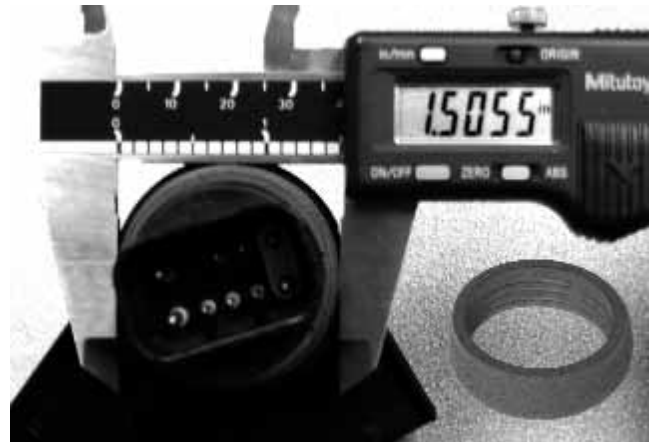
Figure 6

Round pin style connector with large seal
