Cooler Line Adapter Kit

22000-01K

Sonnax Part Summary

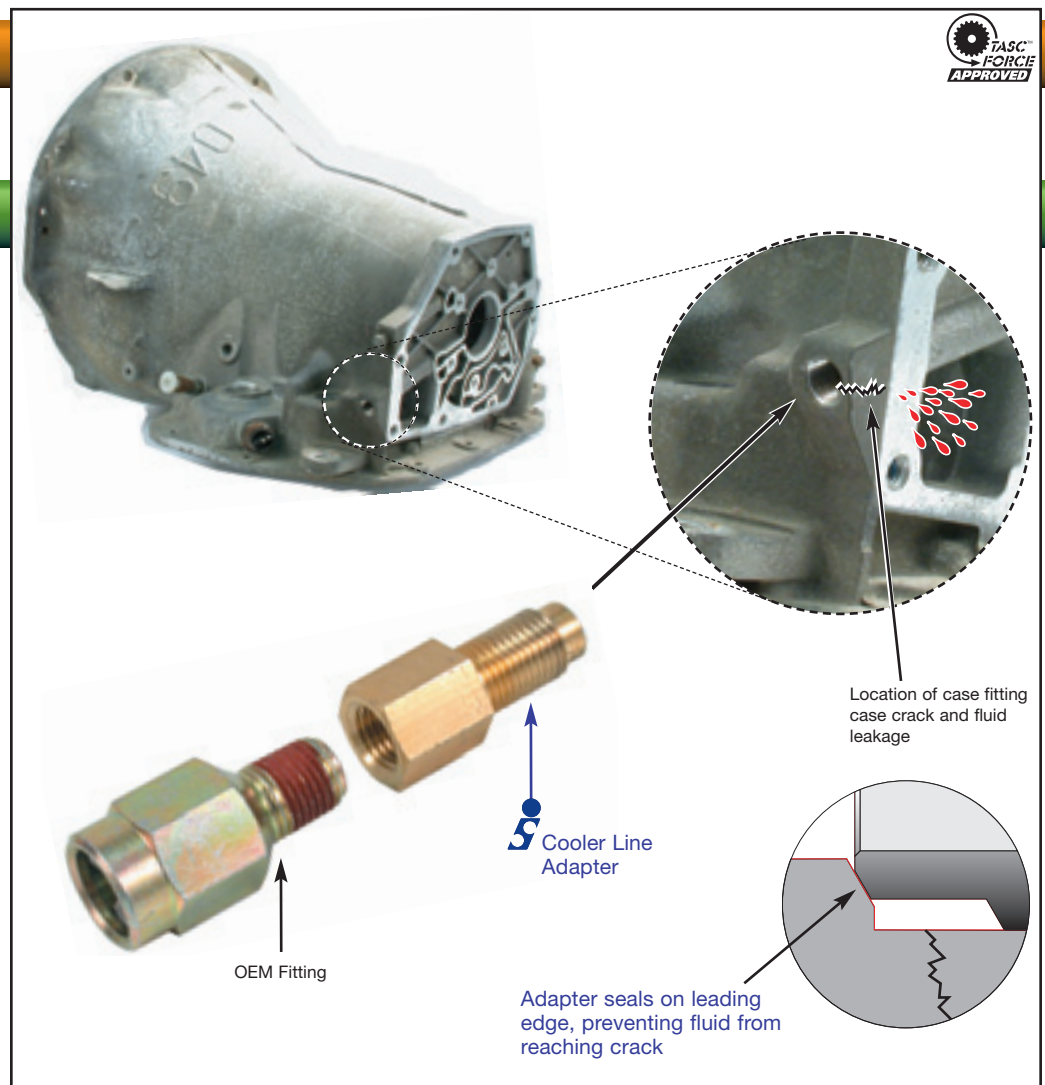
Oil leaks due to cracked case

Tapered threads of OE fittings crack case when overtightened.

A common complaint in late-model Chrysler rear-wheel-drive units is a cracked and/or leaking case caused by installing the cooler lines. The tapered threads and the lack of a stop on the OEM cooler line fitting can load the case and create a fracture, resulting in leakage that may require replacing the case. The Sonnax adapter seals on the leading edge, preventing fluid from reaching the fitting threads and crack. The fitting has straight, not tapered threads to prevent the crack from spreading.

The Sonnax adapter allows the case to be salvaged without removal.

- Allows case salvage without transmission removal.
- Includes special tap for case threads.
