Oversized Primary Pressure Regulator Valve Kit

113741-09K

NOTE: Fits JF010E & JF011E

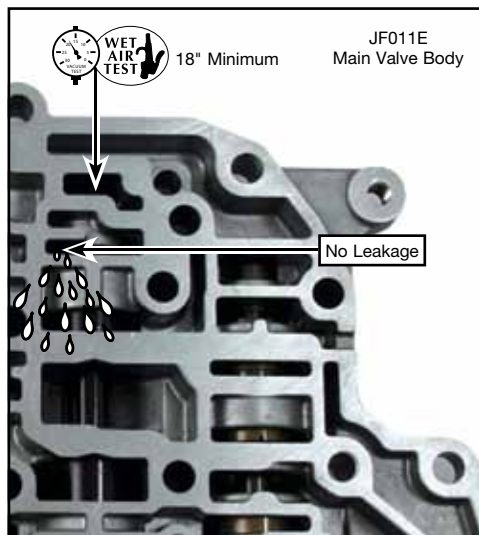
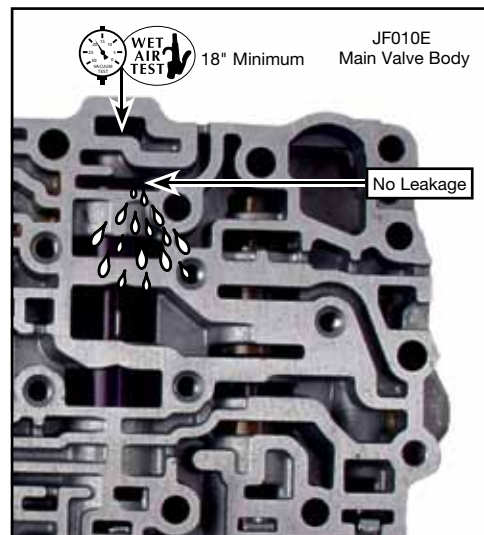
Either a vacuum or wet air test in the location shown results in leakage. Vacuum test must hold a minimum of 18".

Refurbish the valve bore and install the Sonnax valve, spring and end plug to restore accurate pressure control.
