96706-01

(4) 1-2 Accumulator Pins

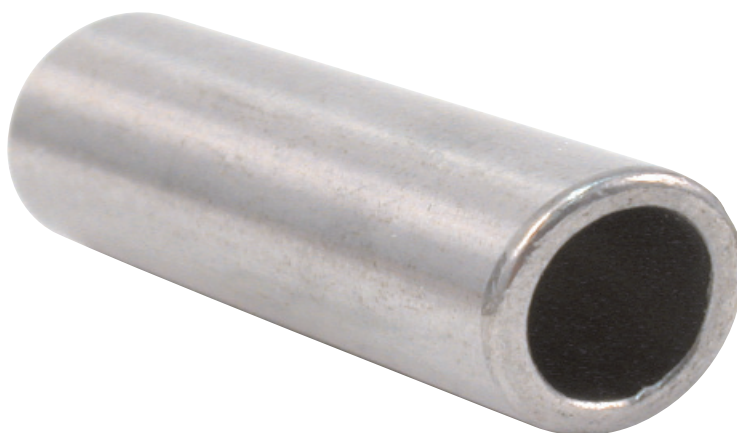
The accumulator piston and pin become scored due to uneven spring loading on the piston surface. This loading wears the pin and eventually the piston surfaces. As the surfaces wear, excess clearance causes an oil cross leak or loss of accumulator pressure control. The loss of accumulator oil affects shift quality and line pressure. Loss of line pressure can create delayed engagements or clutch failure. The Sonnax 1-2 accumulator pins **96706-01** restore line pressure and improve shift quality and engagements.

Each accumulator bore can be Wet Air Tested. Put some ATF into the piston pin and follow it up with regulated air pressure. During the test, the air should try to push the pin out of the piston and through the chain cover. There should be no oil loss around the diameter of the piston or from the piston feed circuit.
