## 1-2 Accumulator Spring Set

### 36946-05K

### Installation Instructions

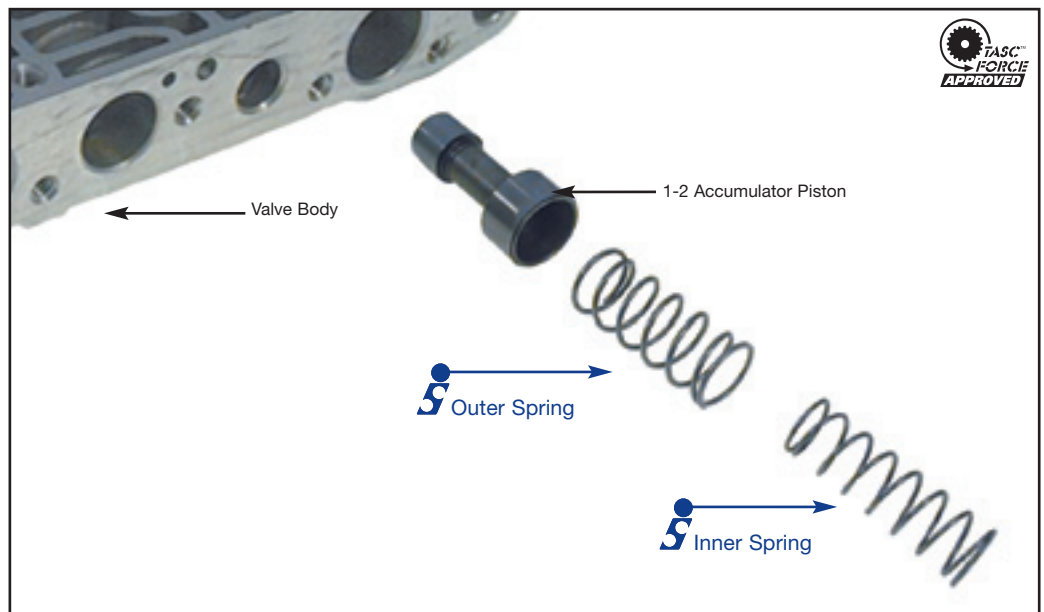
5 Outer Springs  
5 Inner Springs

If either of the 1-2 accumulator springs are broken or measure less than 1 <sup>5</sup>/<sub>16</sub>" long, then the spring set needs to be replaced (do not stretch out existing springs since they will quickly collapse again in service). Discard the damaged springs and replace with the Sonnax springs 36946-05K.

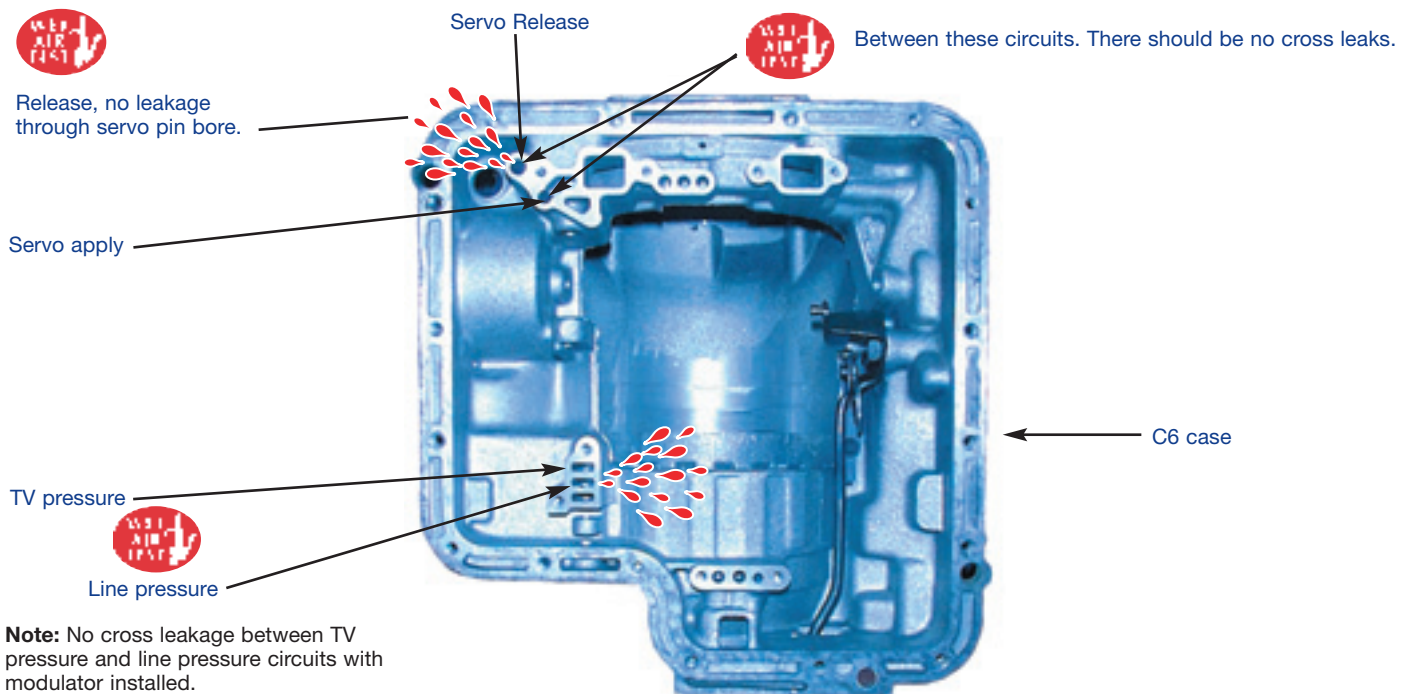
**Note:** A burned clutch band may also be caused by problems other than the 1-2 accumulator spring. To check for other problem sources, perform the Wet Air Tests indicated in the diagram below.

**Note:** No cross leakage between TV pressure and line pressure circuits with modulator installed.
