Rear Clutch Inner Lip Seal

3647-01

Chrysler 46-47RH/RE, 48RE

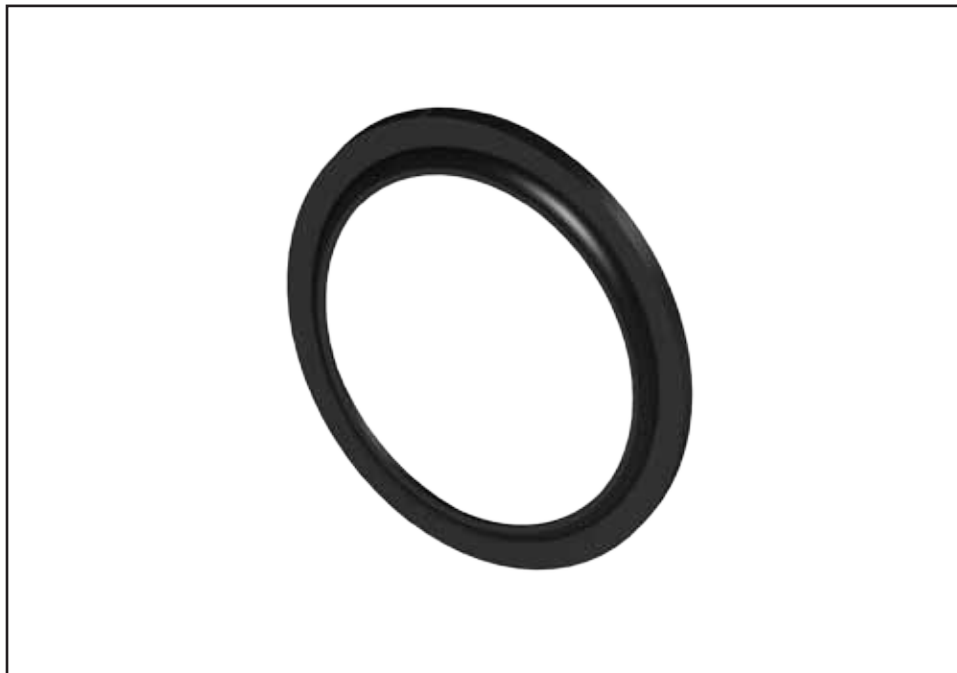
Delayed or no forward engagement in Chrysler 46-47RH/RE and 48RE units is often caused by a shrunken or deteriorated inner lip seal in the rear (forward) clutch piston. The Viton[®] material and improved design of the Sonnax rear clutch inner lip seal **3647-01** provides better sealing and enhanced seal life.

- Improved design features a longer/beefier lip
- Seal material upgraded to Viton[®] compound

NOTE: Clutch drum surface should be prepared with 600 grit Wet/Dry paper and seal. Seal should be well lubricated prior to installation.
