## Throttle Boost Valve & Sleeve

## Sonnax Part Summary

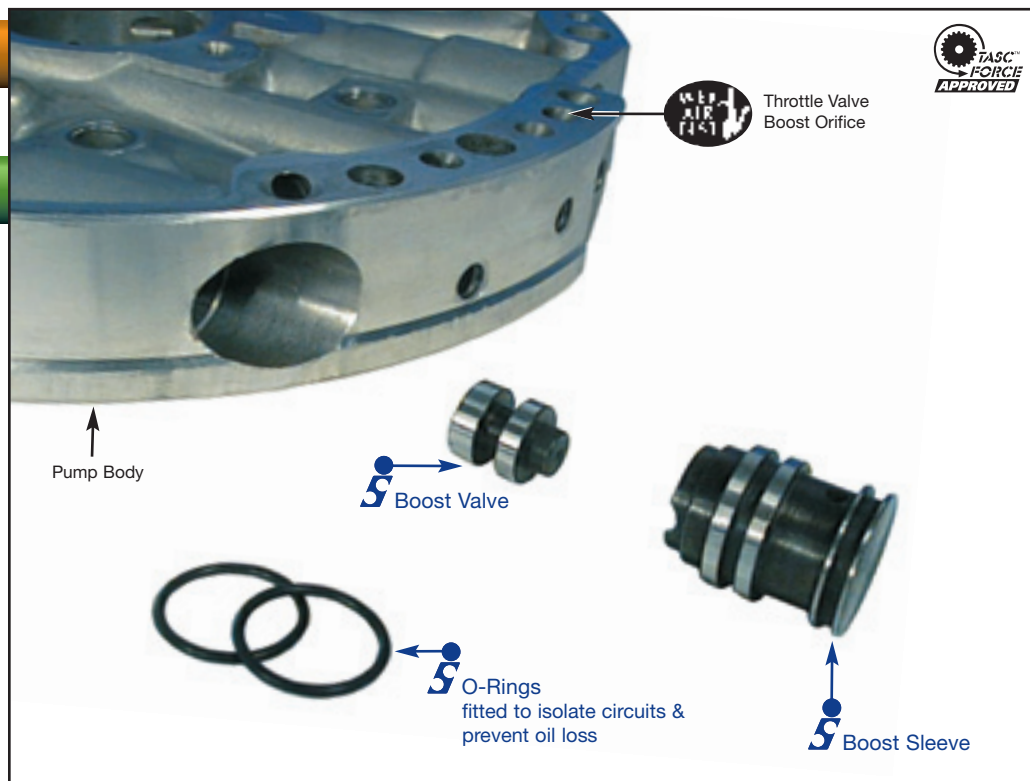
**77917-01K** .423" diameter

**77917-471** .471" diameter

**77917-500** .500" diameter

Each includes the following

- 1 Boost Valve
- 1 Boost Sleeve
- 2 O-Rings

These replacement assemblies prevent oil loss between the outside diameter of the TV sleeve and the pump body.

A common problem in 4L60 transmissions is burned bands and/or 3-4 clutches. This failure can be reduced by eliminating throttle boost oil leakage. The Sonnax replacement assemblies **77917-01K** (.423" diameter), **77917-471** (.471" diameter) and **77917-500** (.500" diameter) eliminate these problems for a variety of applications.

- Throttle valve boost valve and sleeve are made from hardened steel for better wear resistance.
- O-rings on sleeve separate throttle pressure and reverse boost circuits, providing additional protection against cross leaks.
- O-rings prevent loss of oil between the outside diameter of the throttle valve sleeve and pump body.
