NATIONAL RESEARCH COUNCIL CANADA

***EVALUATION OF AIRCREW NOISE
EXPOSURE DUE TO THE USE OF
INTERCOM DEVICES IN RCAF CH-149
HELICOPTER FLIGHT OPERATIONS***

Report Number: LTR-FRL-2018-0025

Date: March 2018

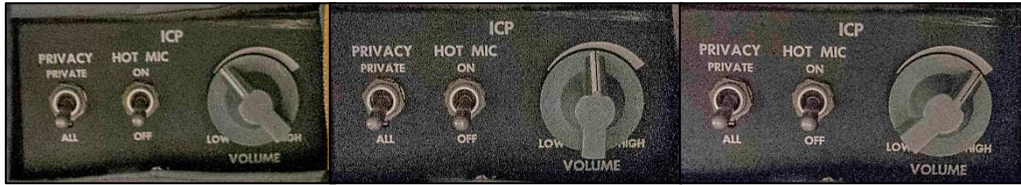
Figure 4: CH-149 Cormorant Cabin Intercom Audio Settings

Two separate and pre-recorded calibration files, one male and one female voice, were played back through the audio device. Three different ICS volume settings were used to characterize the dynamics of the ICS; the volume settings are shown in Figure 4. A total of 6 calibration measurements and one repeat condition were recorded in the characterization process. The helmet speaker volume setting was set to the maximum in all test conditions.

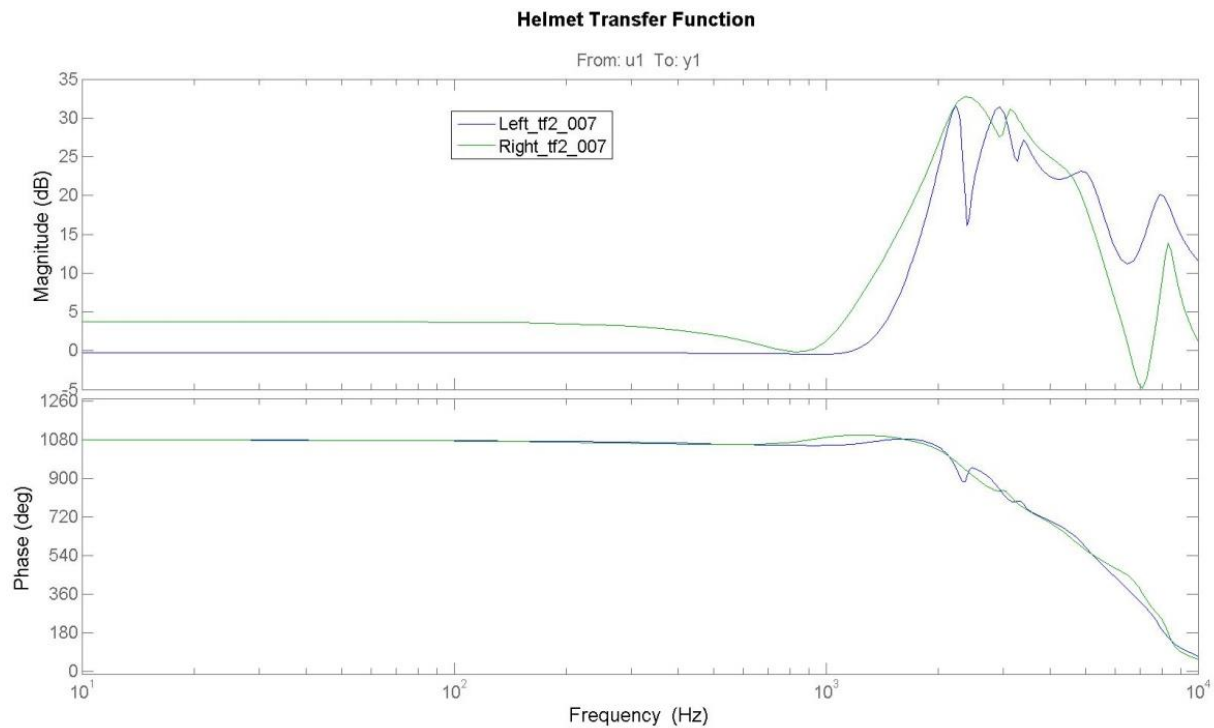
Figure 7: Transfer Function of the SPH5-CF Flight Helmet

A calibration test dataset was used to derive the transfer functions of the voice signal transfer paths; the gain of the intercom box was set at the maximum. The gain setting of the intercom box was not expected to affect the results of the helmet transfer function characterization. The identified transfer function of the SPH5-CF helmet is shown in Figure 7.

The characterization results showed that the dynamic performances of the left and right ear voice paths were generally consistent in terms of both magnitude and phase features. It was important to note that the SPH5-CF flight helmet demonstrated effective amplification to the speech signals only above the frequency range of 1k Hz, while the frequency range below 1kHz was not enhanced at the same magnitude.

Despite the fact that these dynamics might be helpful to attenuate helicopter cabin noise related to the rotor aerodynamics, the fundamental frequency components of human speech (typically a few hundred Hertz) are also attenuated, which may have resulted in degraded quality of voice communication over the SPH5-CF flight helmet. However, since the higher harmonic frequency components of the aircrew voice signals above 1 kHz were effectively transmitted, the intelligibility of the aircrew voice speech was not expected to be reduced significantly.

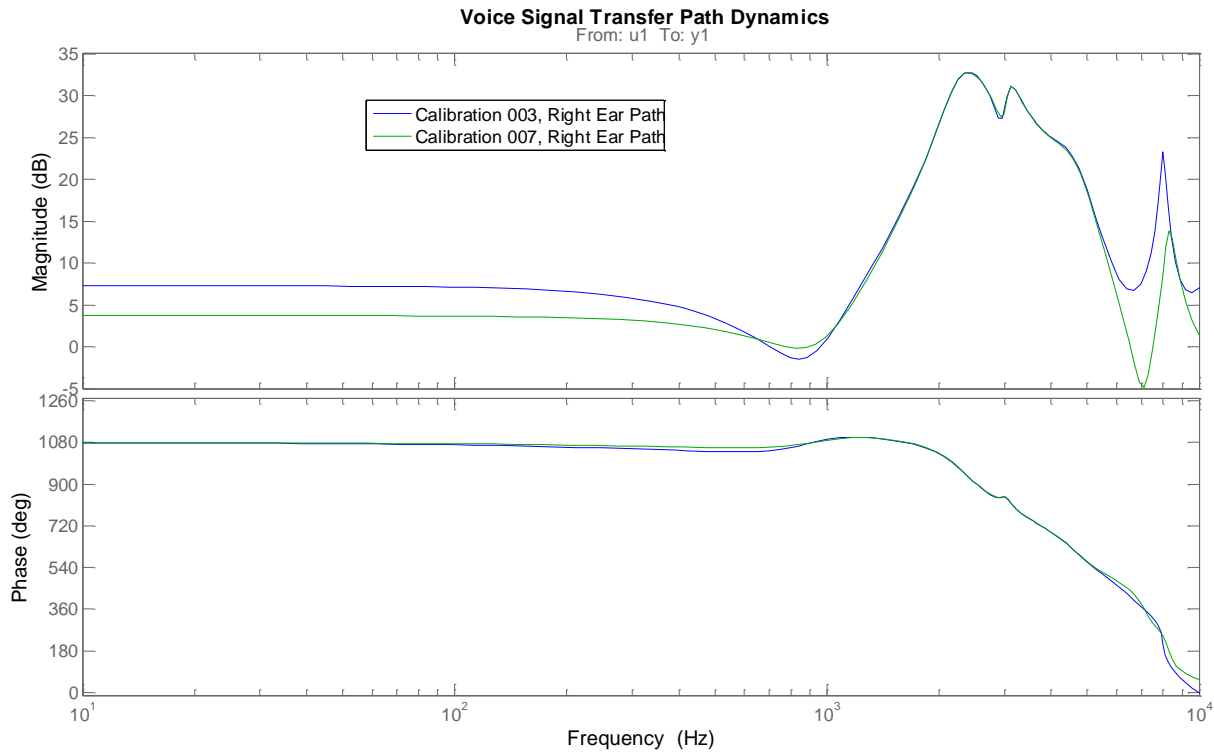
Figure 8: Derived Transfer Functions for the Voice Signal Path, Right Ear

To verify the accuracy of the identified dynamics of the voice signal transfer paths, other calibration datasets were used for validation. As an example, the derived transfer functions of the right ear transfer path in two separate calibration datasets are shown in Figure 8.

As expected, it is shown that the gain setting of the intercom communication box and the male and female voice used as the simulated voice speech did not affect the results of the characterization. The identified transfer functions in two separate calibration conditions showed consistent characterization.

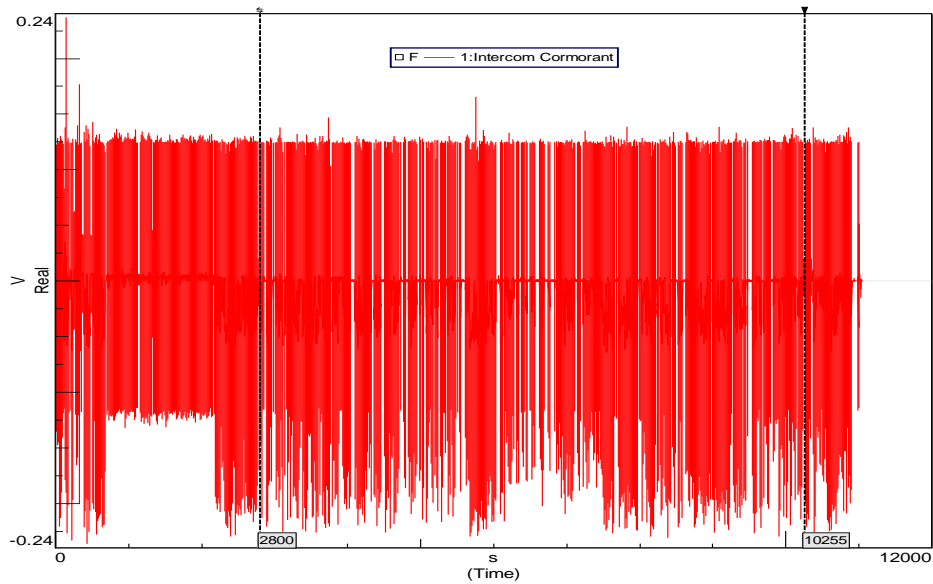
Figure 9: Voltage Signal of Voice Communications, During Flight

Compared with the typical records of ground calibration signals, as shown in Figure 10, the intercom voice signal recorded on the CH-149 helicopter ICS during the mission showed severe saturation at a relatively low voltage range of ± 0.2 V. In comparison, the recorded voltage of the voice communication signal exceeded ± 1 V in the ground calibration procedure, and there was no saturation observed. It is important to note that the severely saturated voice signal may have introduced strong background noise to negatively affect the quality of aircrew voice communication.

The recorded CH-149 ICS voice signal exhibited a severe signal saturation issue, with the maximum voltage less than 0.24 V. The saturated ICS signals may have contributed to the strong background noise in the aircrew intercom voice communication. The squelch issue was confirmed in the ICS signal, and was at times observed to be severe; audio playback of the recorded voice signal also confirmed this issue. Spectral analysis of the CH-149 ICS signals indicated that the squelch issue was related to strong tonal noises at multiple discrete frequencies. Further spectral analysis indicated that higher squelch levels and multiple tonal frequency peaks mainly existed in the ground start-up and taxi sections of the mission, which may have adversely affected the quality of aircrew ICS communications. In comparison, the tonal noise peak issue was less severe in the flight section. However, strong background noise still existed in the ICS signals, which may be related to the ICS saturation issue.

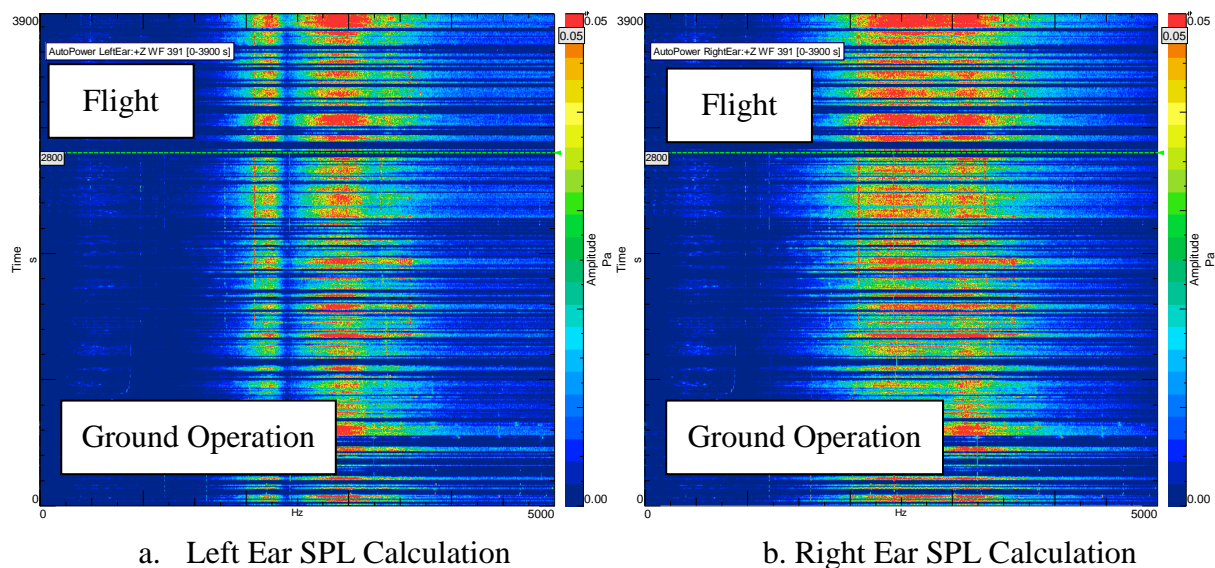
Figure 15: Waterfall Plots of ICS SPLs in the Stat-up Section

Waterfall analysis were generated to identify the flight segments associated with the tonal peaks during the flight mission; the results for start-up, flight and taxi sections are shown in Figure 15, Figure 16 and Figure 17, respectively. It was shown that multiple tonal noise peaks existed in the ICS signals in both ground calibration and flight operations. However, compared to the signals in ground calibration procedure, significantly higher peak amplitudes and more tonal frequencies were identified for the CH-149 helicopter during the start-up and taxi

- Dominant energy of the ICS existed between 1.5 and 4 kHz. Fundamental frequencies of voice speech below 1 kHz seemed to be suppressed. This was consistent with the observations in the ground calibration procedure. Despite the degraded quality of the voice signal due to this frequency dependent signal suppression, the speech intelligibility may not be significantly affected.

- In comparison, the tonal noise issue was not significant during the flight section, suggesting that the tonal noises could be related to landing operation equipment, ground operation or other electric interferences.

- The strong tonal noises may be related to the squelch issue.
- Considering the negative impact, the root causes for the severe saturation of the voice signal should be investigated to verify if this is unique to one station, one vehicle, the measurement method or rather a common issue within the RCAF CH-149 Cormorant helicopter fleet.

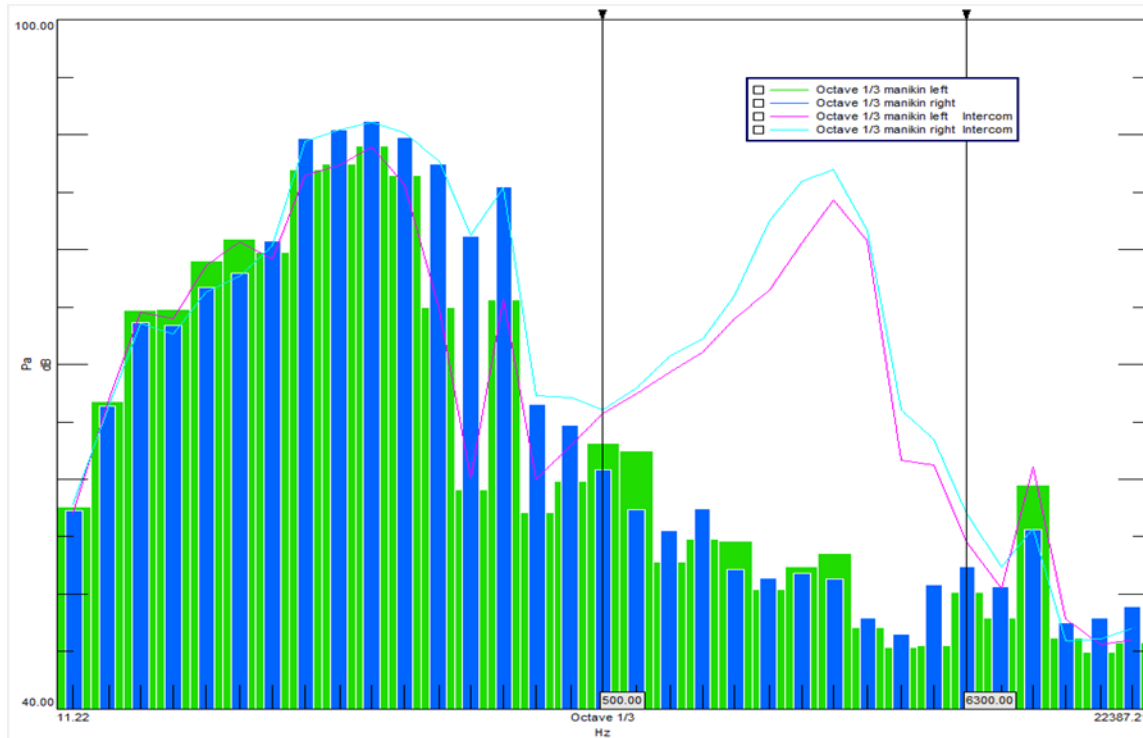
Figure 21: Preliminary Intercom Investigation: Cabin Noise with Speech, Linear Weighted 3rd Octave Band Logarithmic Sound Pressure Levels [dB]

Example results are shown in Figure 21. The green and blue 3rd octave band bars correspond to the left and right ear measurements of the GRAS 45 CB acoustic test fixture with a fitted headset and cabin noise replicated with speakers. The pink and light blue curves correspond to the left and right ear measurements of the GRAS 45 CB acoustic test fixture with a fitted headset, replicated cabin noise and intercom communications.

The A-weighted Overall Sound Pressure Level (OSPL) measured at the GRAS 45 CB acoustic test fixture eardrum was calculated and averaged for the various experimental conditions. It was observed that the intercom noise contribution to the OSPLs was sensitive to the different audio files used to replicate the aircraft cabin noise, as listed in Table 6. In the preliminary assessment using two voice files, the use of the aircraft ICS effectively increased the aircrew overall noise exposure level by 5.1 and 10.2 dB(A), respectively. Therefore, it was
