TF HOME INSPECTION

TFHI RESIDENTIAL REPORT

1234 Main St. Union NJ 07083

05/04/2020 9:00AM

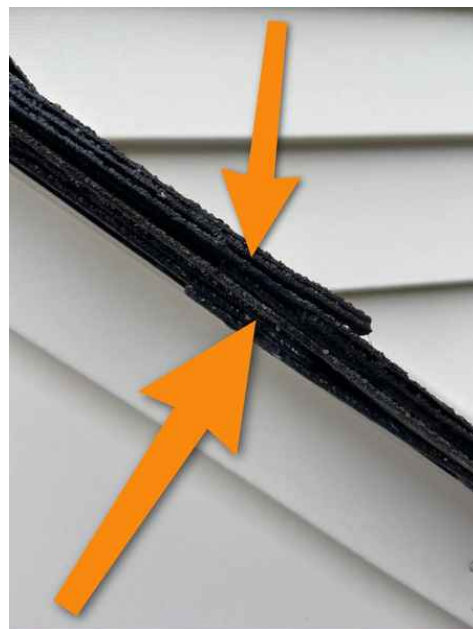
While it is common and permitted to have two layers of roofing, multiple layers of roofing can accelerate deterioration of the roofing materials, as well as add excess weight to the structure. The expected life expectancy for a roof is commonly 25 years, and a second layer can expect a 12-16 year additional life expectancy. The roof should be monitored

Contact a qualified roofing professional.

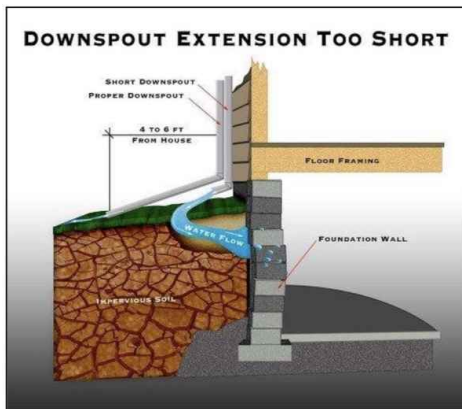
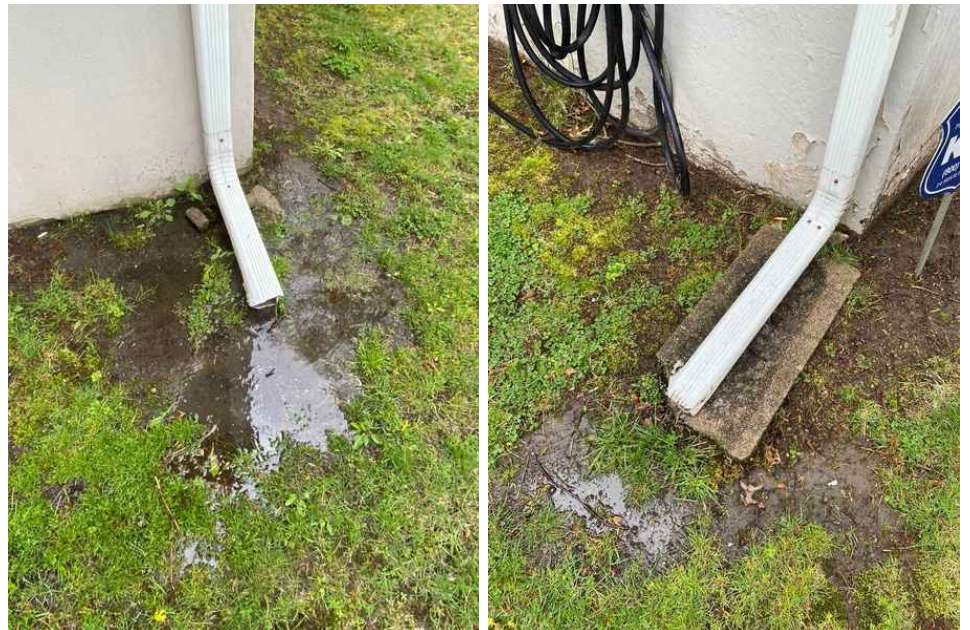
The downspout needs an extension and or a buried drain line to carry water away from the home at the front, rear and sides of home. Having the downspouts terminate at such a short distance can allow for water to penetrate the basement during heavy rain. This can cause damage to the interior finishes of the basement and the foundation. I recommend a qualified licensed contractor repair or replace as needed.

Contact a qualified gutter contractor

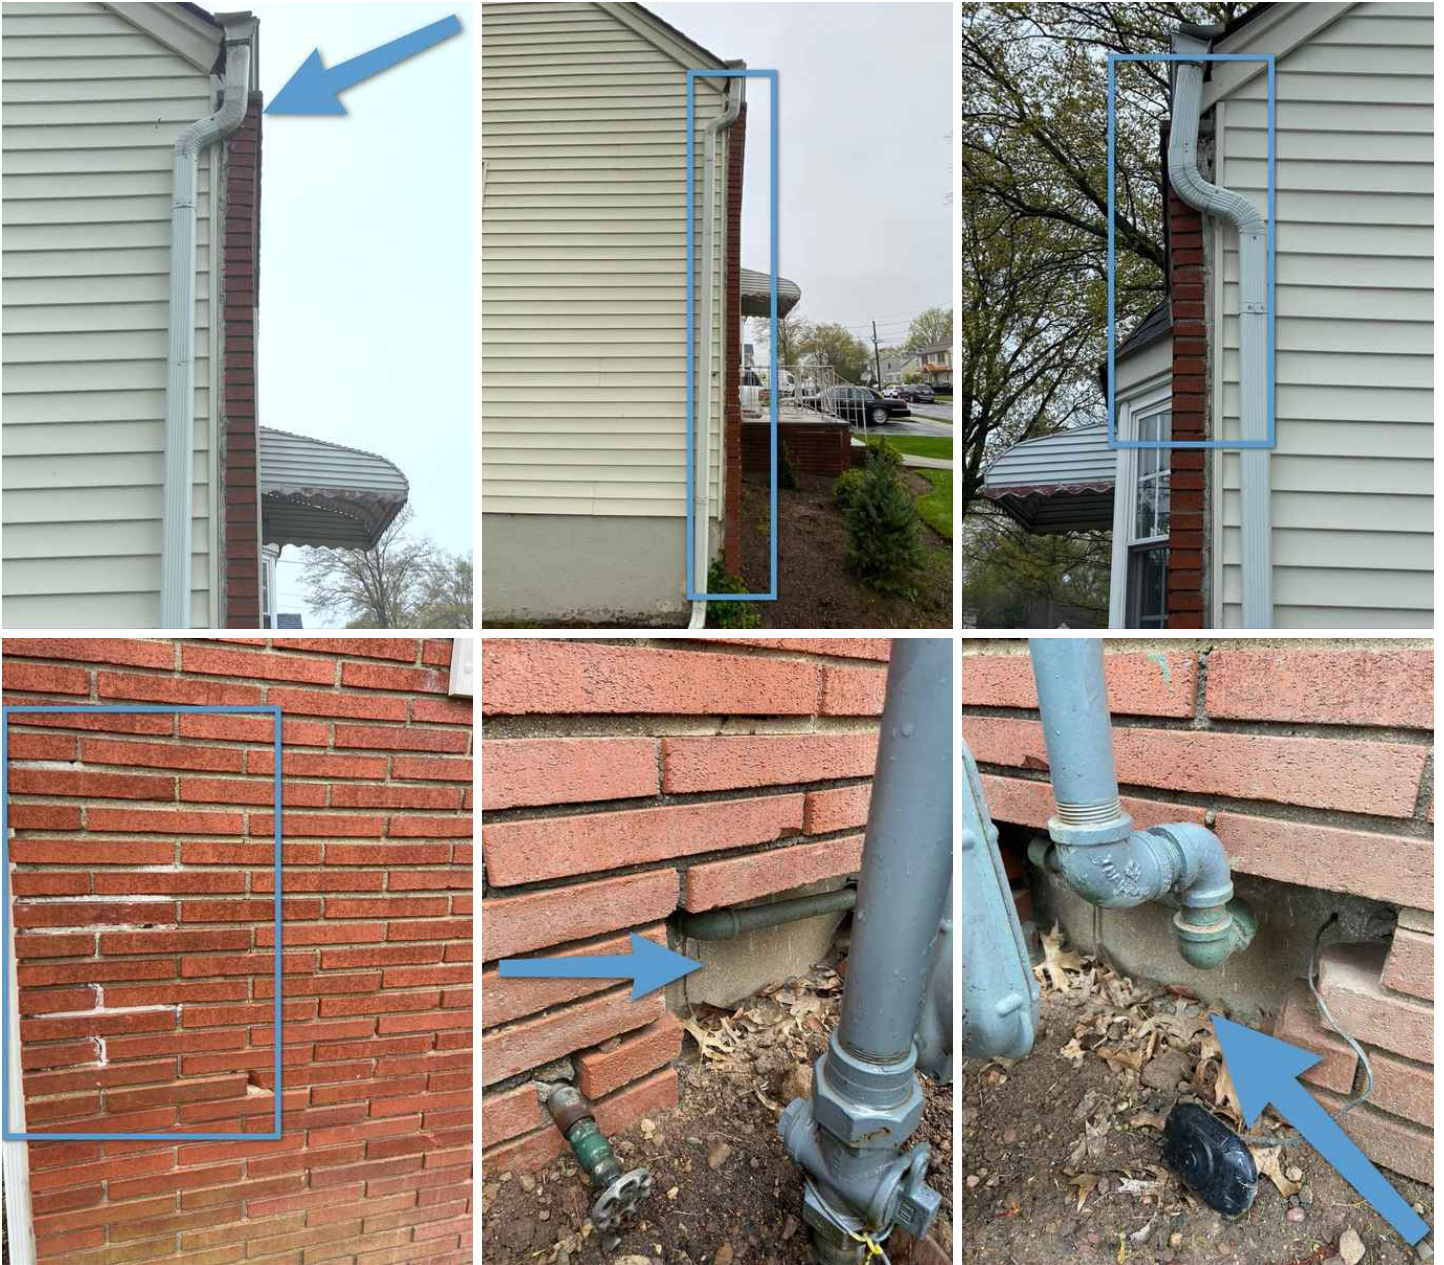
The brick veneer wall in the front of the home was observed to be leaning away from the home at the top level above the windows. Also due to the installation of the gas meter, brick veneer bricks are missing. A qualified licensed professional should evaluate, and advise as necessary, then repair and replace.

Contact a qualified professional.

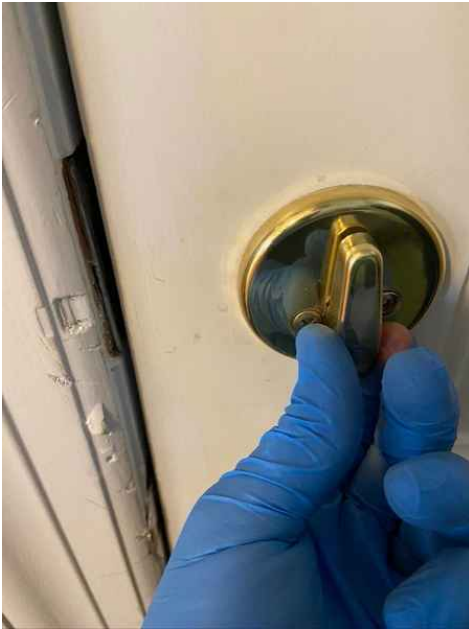
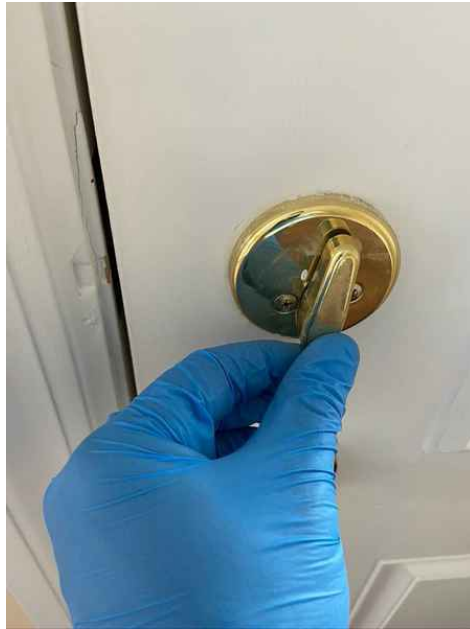
3.2.1 Exterior Doors

DOOR DOES NOT CLOSE OR LATCH

Both exterior doors have a dead bolt that does not close or latch properly. This is a safety hazard causing a security issue for the home. A qualified licensed contractor should repair and replace as necessary.

Contact a qualified carpenter.

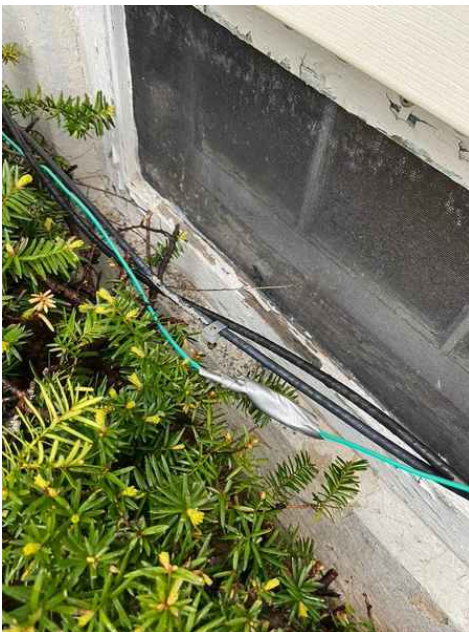
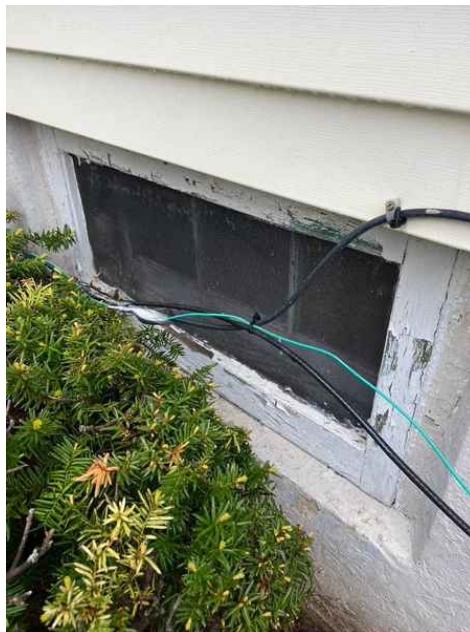
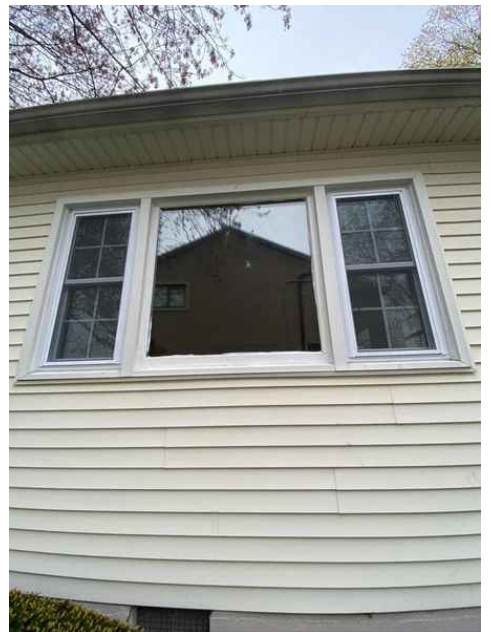
3.3.1 Exterior Windows

CAULKING/PAINTING

Exterior windows of the home would benefit from maintenance caulking and painting around the trim and window. This will prevent moisture from entering the materials of the home and causing damage. A qualified licensed professional should repair as necessary.

Contact a qualified professional.

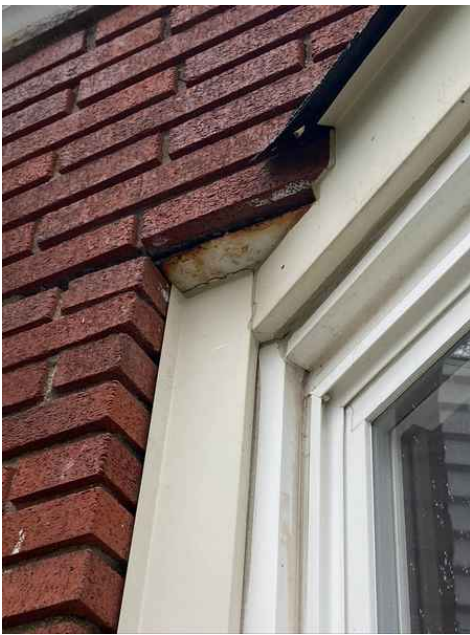
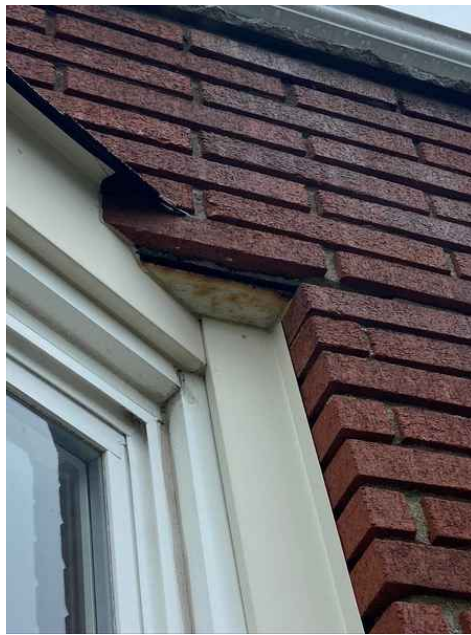
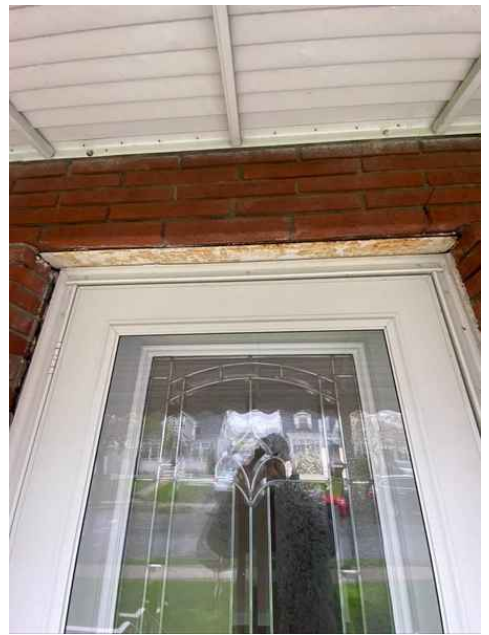
3.3.2 Exterior Windows

LINTELS RUSTED

The windows have rusted lintels above them. Lintels support the brick above the window. Rusting lintels can expand, causing movement to the brick veneer wall. I recommend a qualified licensed professional clean and remove the rust, and paint the lintel to protect its surface from rusting in the future.

Contact a qualified professional.

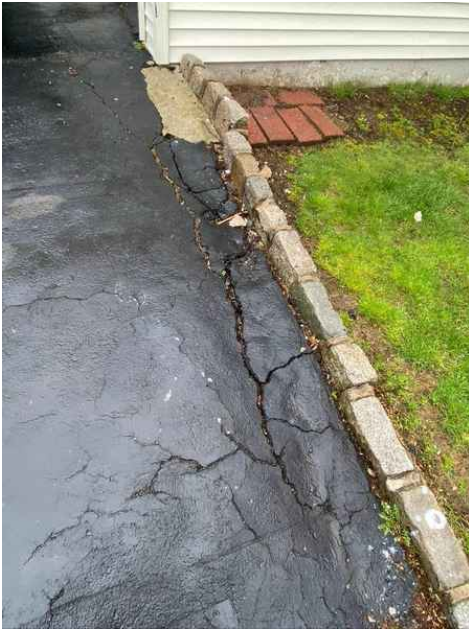
3.4.1 Walkways, Patios & Driveways

DRIVEWAY CRACKING

Cracking was observed in the surface of the driveway. This is a trip hazard. A qualified licensed contractor should repair and replace as necessary.

Contact a qualified driveway contractor.

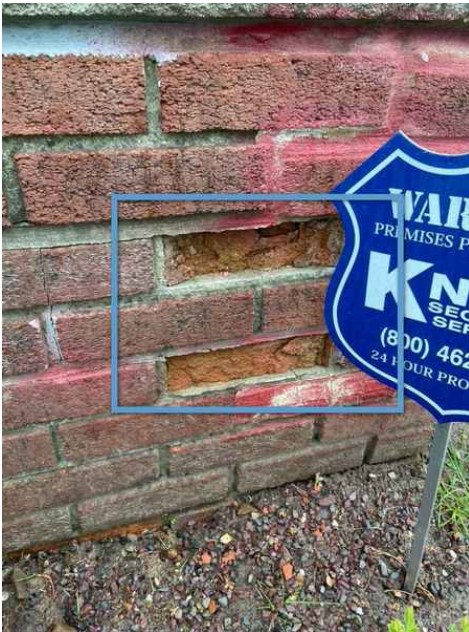
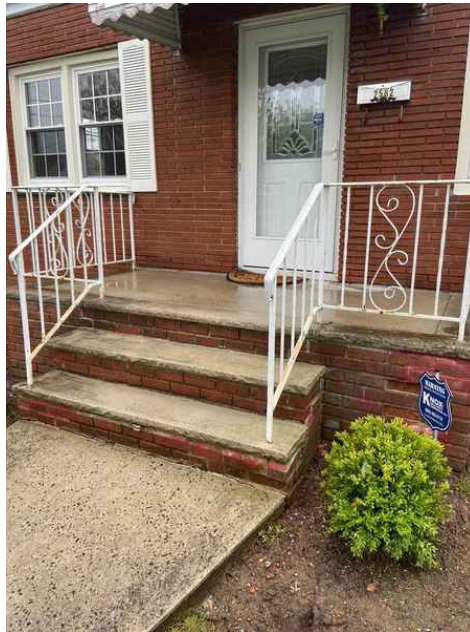
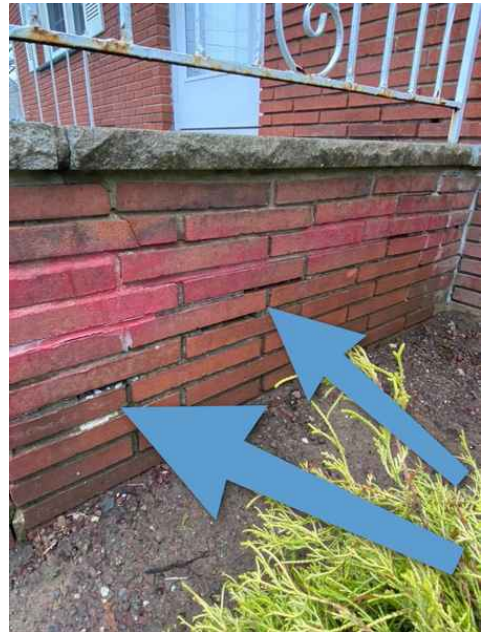
3.6.1 Decks, Balconies, Stoops, Porches, Railings & Steps

STEPS DAMAGED

The steps were observed to have bricks that are damaged, areas that are not sealed, and several bricks that have actually slid and moved outward away from the steps. Water can penetrate the masonry causing further damage. A qualified licensed mason should repair and replace as necessary.

Contact a qualified professional.

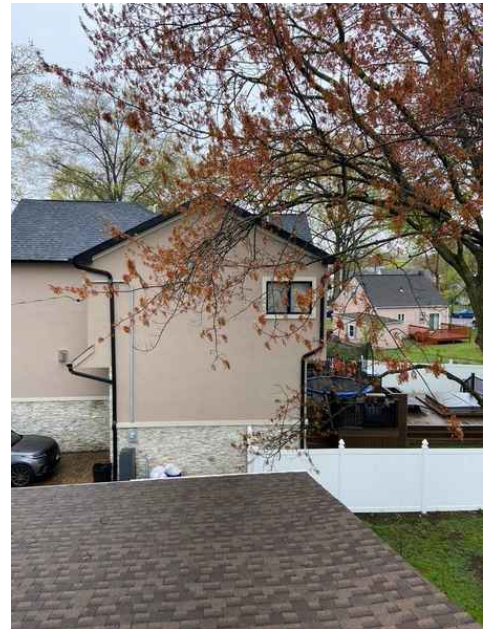
3.7.1 Vegetation, Grading, Drainage & Retaining Walls

Trees observed overhanging the roof. This can cause damage to the roof and prevent proper drainage. A qualified tree service should trim back vegetation to allow for proper drainage, as well as protect the home from falling vegetation.

Contact a qualified tree service company.

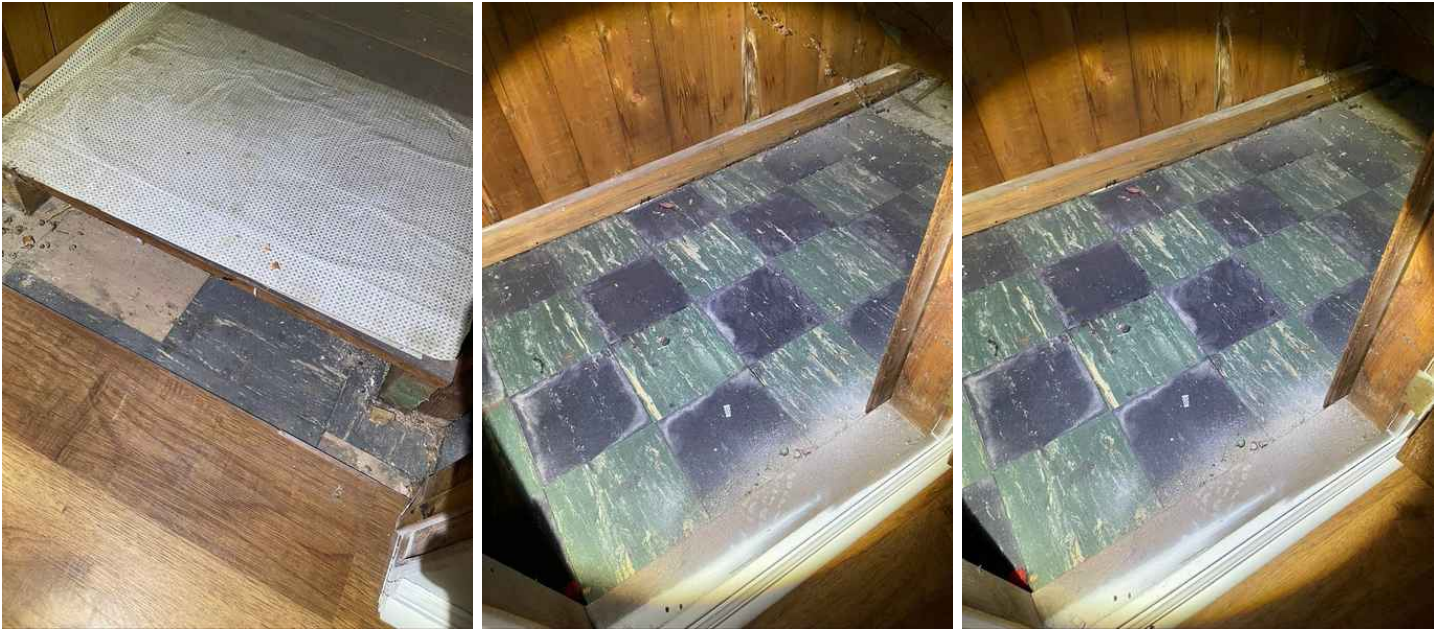
4.3.1 Floors

POSSIBLE ASBESTOS FLOOR TILES

The presence of possible asbestos floor tiles was noted in the basement. This is not posing a hazard as long as it is undisturbed. Please contact a professional if work is to be ever done or removal is needed of this flooring material, as disturbance to the tiles could be a health hazard.

Contact a qualified professional.

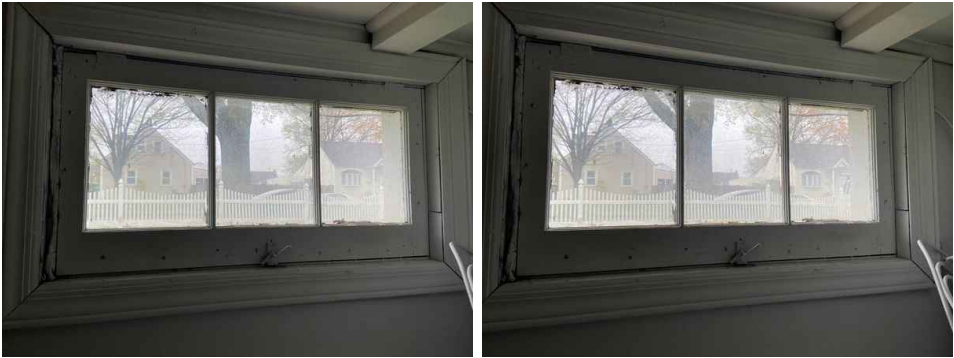
4.5.1 Windows (representative number)

WINDOWS NAILED SHUT

Basement windows of the home were observed to be nailed shut. This is a maintenance issue. This will need to be repaired and replaced by a qualified licensed professional.

Contact a qualified professional.

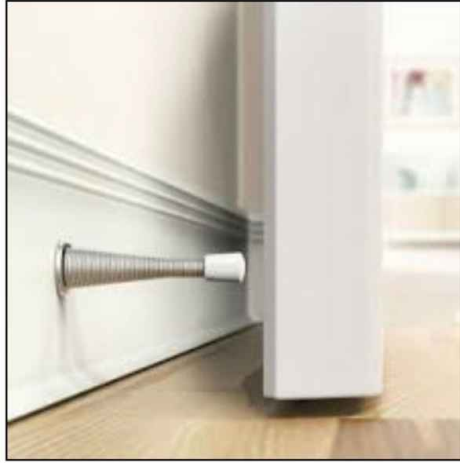
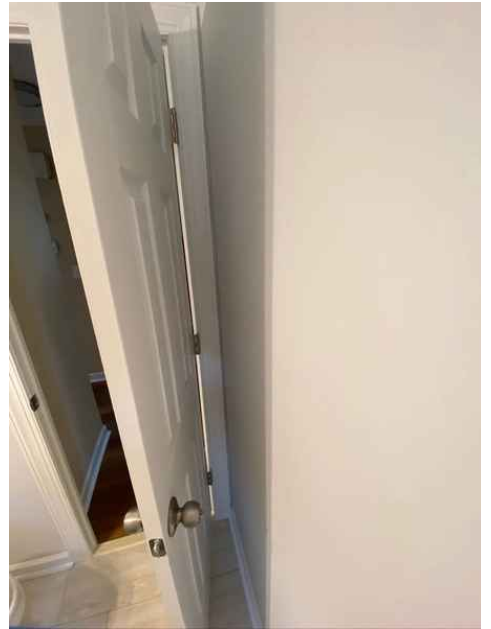
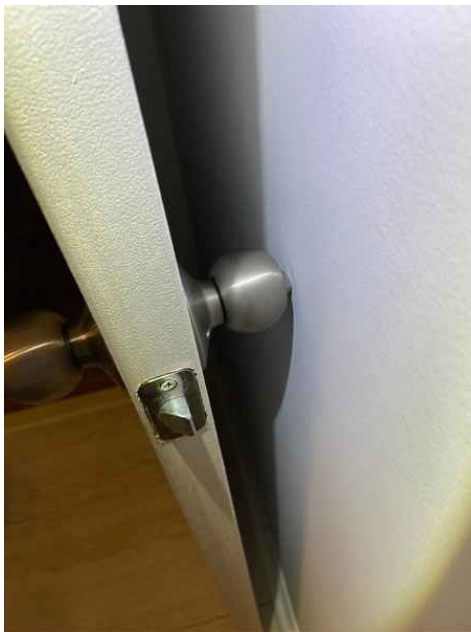
4.6.1 Doors (representative number)

DOOR STOPPERS MISSING/DAMAGED

Door stoppers are missing throughout the home behind doors. This is a maintenance issue that can prevent damage to walls. A qualified licensed contractor should install as necessary.

Contact a qualified carpenter.

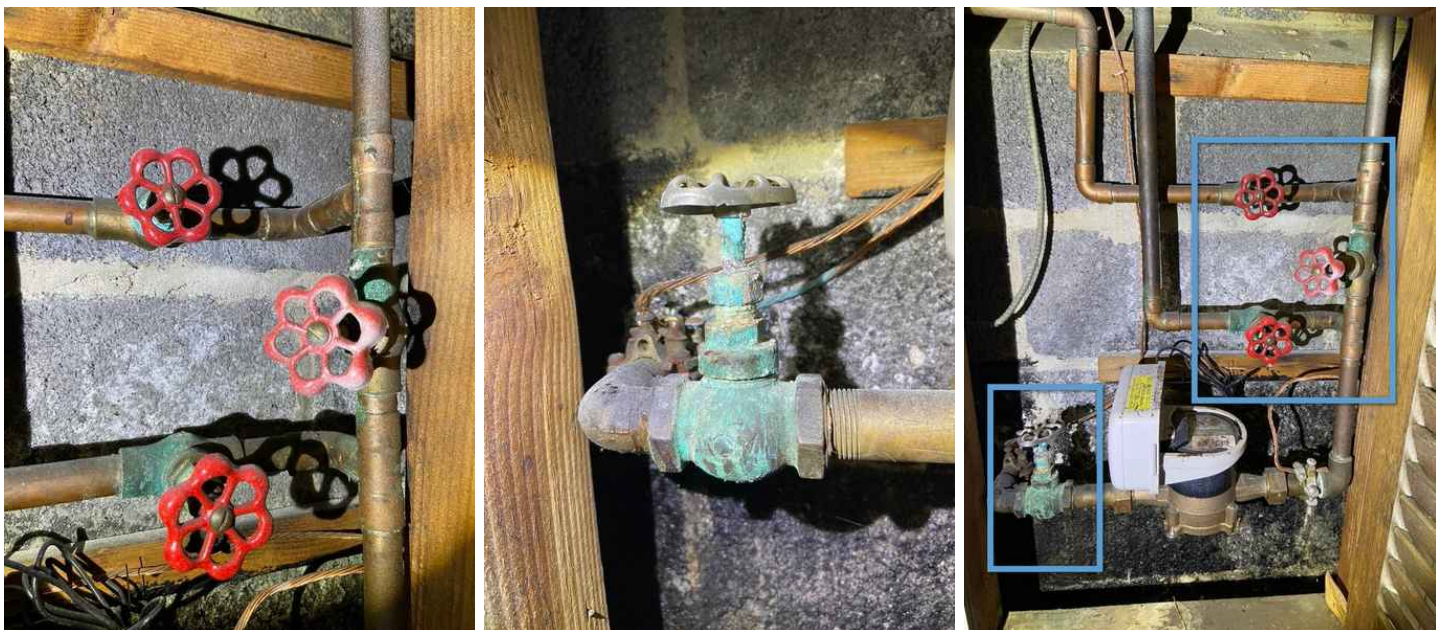
VALVES CORRODED

Several plumbing supply valves were corroded. This is a maintenance issue. A qualified licensed plumber should repair and replace as necessary.

Contact a qualified professional.

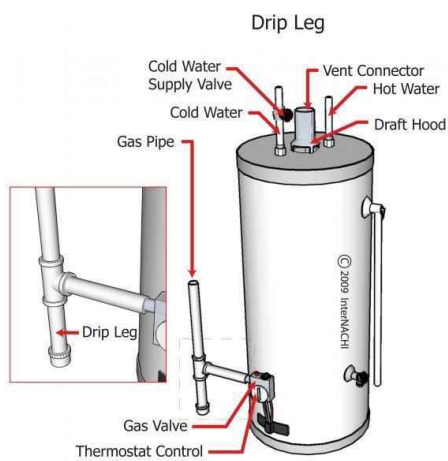
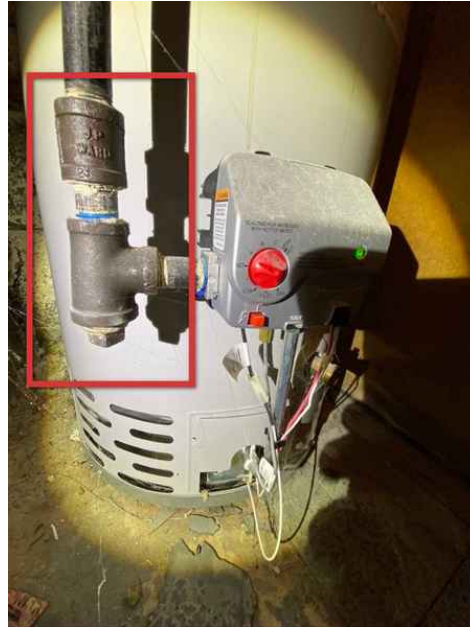
5.3.1 Hot Water Systems, Controls, Flues & Vents

DRIP LEG MISSING

There is no drip leg installed at the gas piping as it enters the water heater. This is installed to allow sediment and other materials in the supply gas to fall down before entering the water heater system, causing damage. A qualified licensed professional should repair and replace as necessary.

Contact a qualified professional.

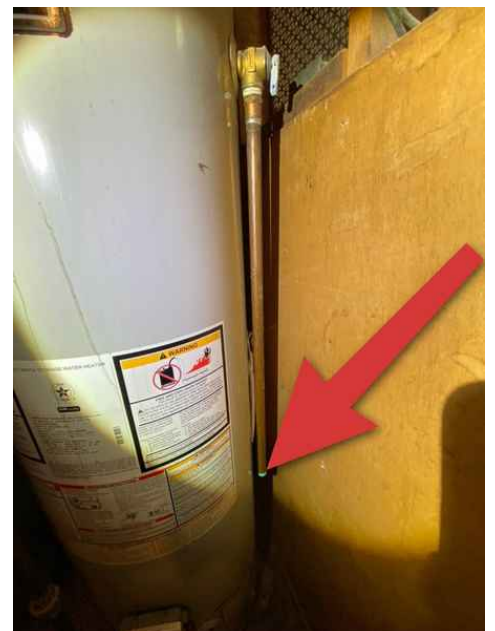
5.3.2 Hot Water Systems, Controls, Flues & Vents

TEMPERATURE/PRESSURE RELIEF VALVE CORROSION

The temperature/pressure relief valve (TP or TPR) lets water escape if the temperature or pressure is too high. This valve should be connected to a tube that discharges no more than six inches above floor level so hot water is not sprayed on to anyone nearby. The tube should be as large as the tank fitting and the tube end should never be threaded, capped, or plugged. The bottom was observed to be corroded indicating prior leaks. A qualified licensed plumber should evaluate, repair, and replace as necessary.

Contact a qualified plumbing contractor.

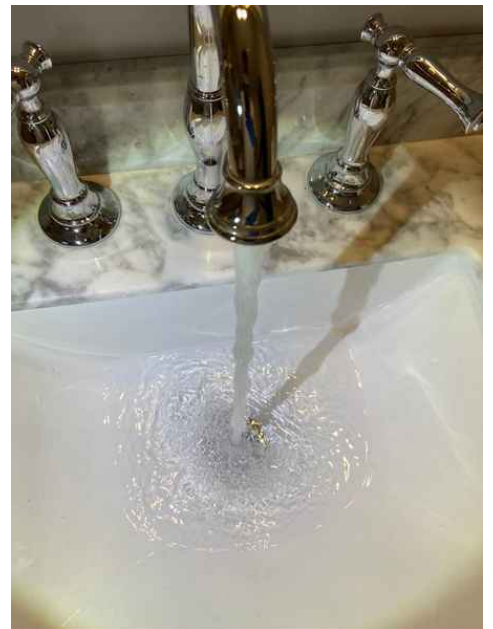
5.6.1 Sinks, Tubs & Showers

SINK - POOR DRAINAGE

Bathroom sink had slow/poor drainage. This is a maintenance item. A qualified licensed plumber should evaluate and repair as necessary.

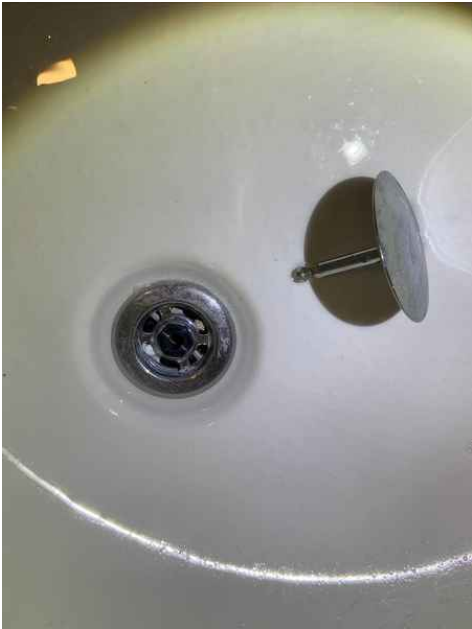
5.6.2 Sinks, Tubs & Showers

TUB STOPPER DISCONNECTED

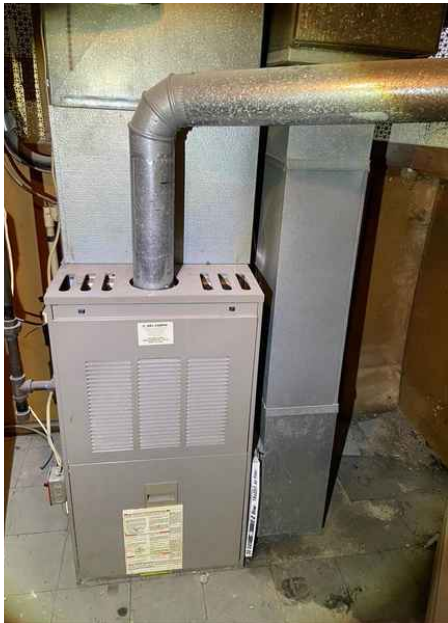
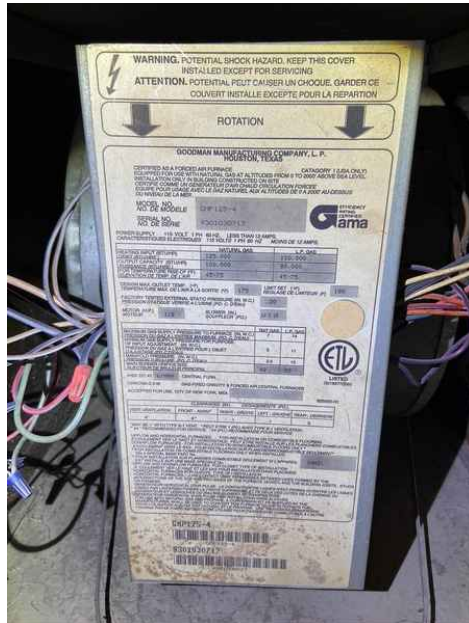
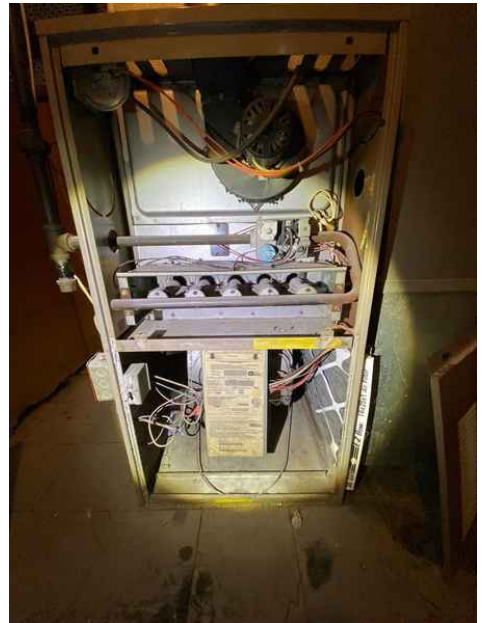
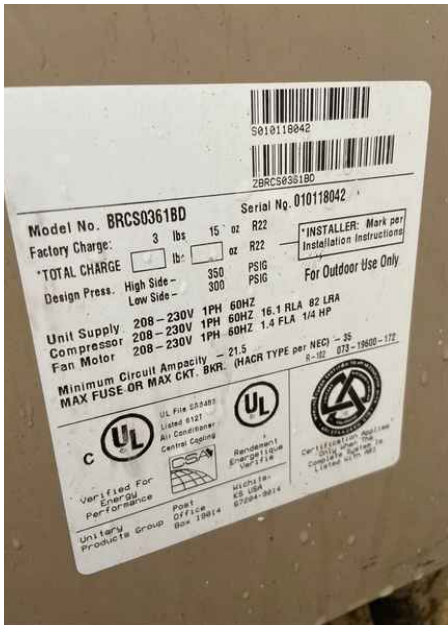
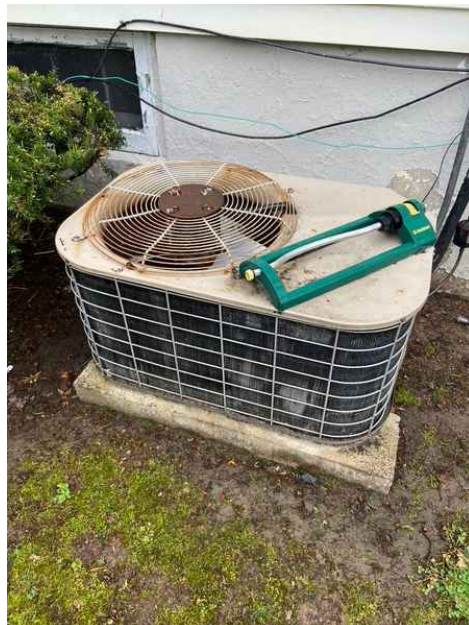
The a/c and heating system (Goodman) was manufactured in 1993. The serial number is (Please see image) and model number is (Please see image) and has a 15-25 year life expectancy. The condenser unit (Goodman) was manufactured in 2001. The serial number is (Please see image) and model number is (Please see image) and has a life expectancy of 8-15 years.
