PROPERTY INSPECTION REPORT

Concerning: 1234 Main St. Mckinney Texas 75071

By: Rod Little - TREC Professional Inspector license #23929

05/08/2020 9:00AM

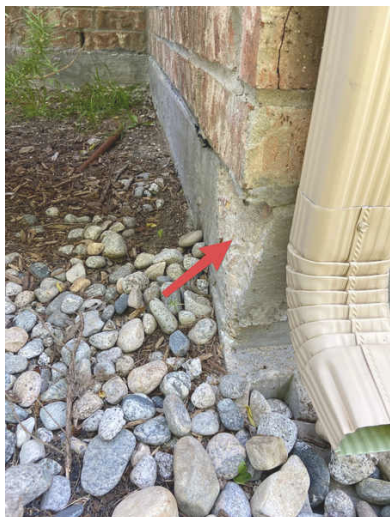
Northwest corner

1: Corner pop

Foundation corner cracks and/or pops observed in one or more locations around the exterior of the home. Note: This does not affect the structural integrity of the foundation; sometimes some cosmetic repairs are needed.

Recommendation: Contact a qualified masonry professional.

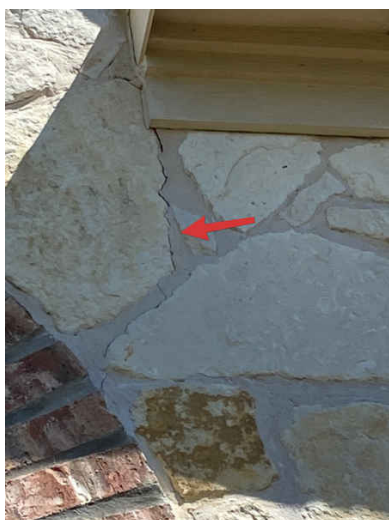
Front entrance

1: Cracks - Minor

Minor cracking was observed in wall structure in one or more areas. This is common in homes and in this location.

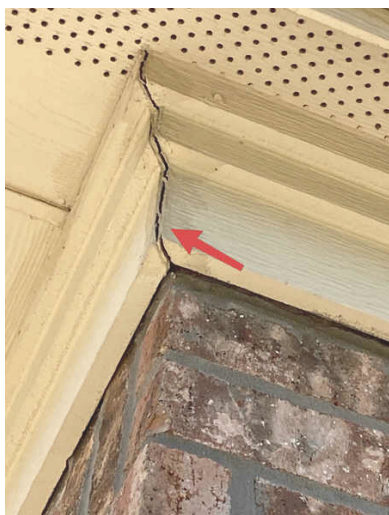
Southeast corner

2: Caulking missing or insufficient

Caulking missing or insufficient in one or more areas. Recommend caulking to prevent water damage

Recommendation: Contact a handyman or DIY project

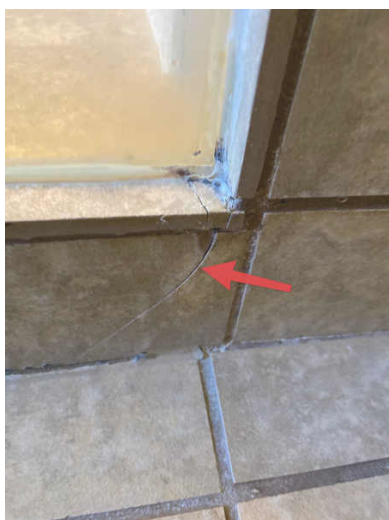
Hairline crack in tile in one or more areas. Doesn't appear to be any structural problem.

Master bathroom shower minor tile crack

Recommendation: Contact a qualified flooring contractor

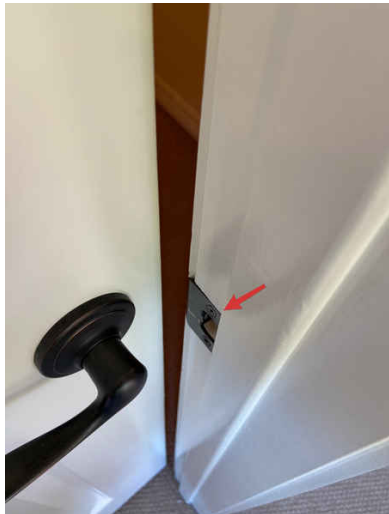
North east bedroom closet

1: Door Doesn't Latch Properly

Door doesn't latch properly. Recommend handyman repair latch and/or strike plate.

Recommendation: Contact a qualified handyman.

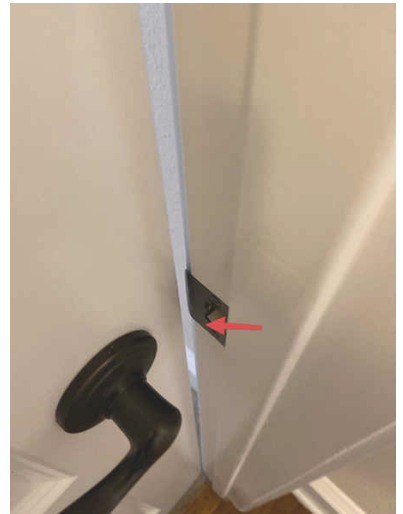
Southeast bedroom doesn't completely latch

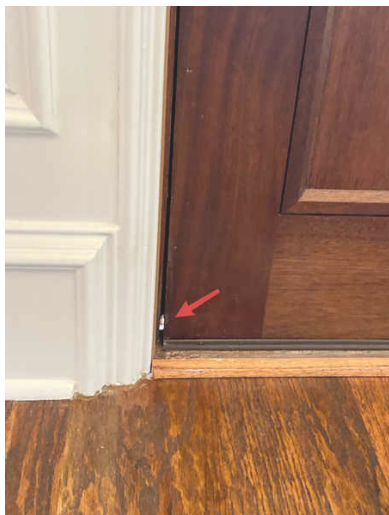
Front door

2: Gap in door/light showing through

One or more gaps in door could result in energy loss. Recommend handyman or door contractor evaluate and remedy.

Recommendation: Contact a qualified handyman.

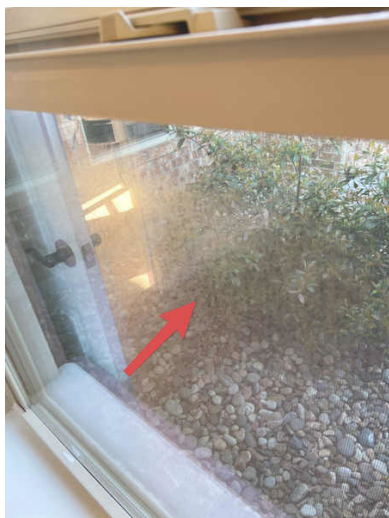
North east bedroom

1: Voided seal

One or more windows throughout home appears to have a voided seal. These can worsen over time when condensation builds up. Individual glass panes can usually be replaced if needed.

Recommendation: Contact a qualified professional.

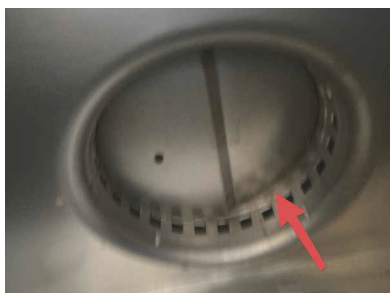
South fireplace

1: Missing damper clamp

No fireplace flue damper clamp installed. Recommend installing to reduce accidental spillage of carbon monoxide into the living space. Note: TREC standards of practice require a damper block be installed on the fireplace flue damper when gas is present to fireplace.

Recommendation: Contact a qualified chimney contractor.

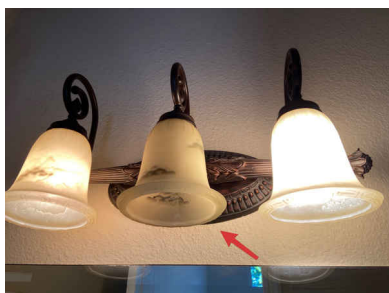
Northeast bathroom

1: Light Inoperable

One or more lights are not operating throughout home. Recommend replacement of lightbulb. If this doesn't correct issue recommend repair by electrician

Recommendation: Contact a handyman or DIY project

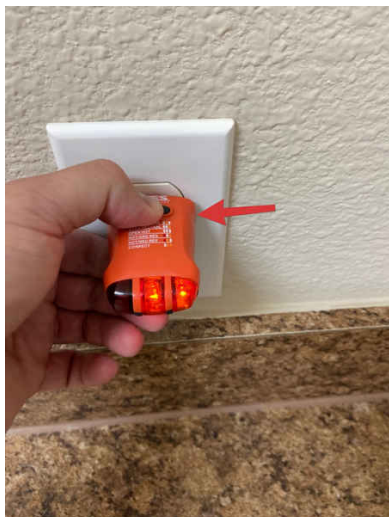
Laundry room to right of sink

2: No GFCI Protection

No GFCI protection present in one or more areas. Recommend licensed electrician upgrade by installing ground fault receptacles in all locations.

Recommendation: Contact a qualified electrical contractor.

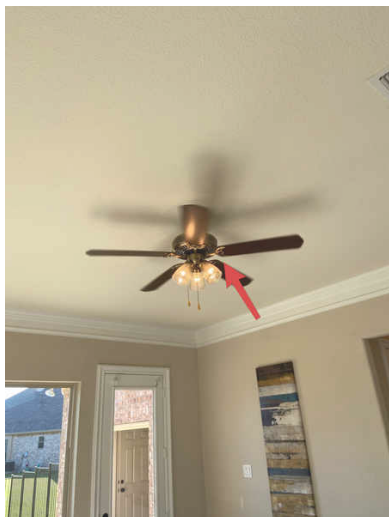
Game room fan

3: Fan out of balance

Fan out of balance in one or more areas. Recommend using fan balancing weights and checking installation

Recommendation: Contact a qualified professional.

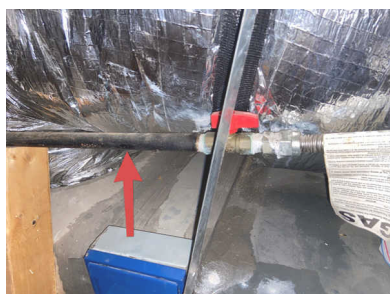
1: No sediment trap

No sediment trap installed on the furnace gas line at the time of the inspection. Note: This does not meet current building standards or practice. Recommend repair as needed.

Both units missing

Recommendation: Contact a qualified heating and cooling contractor

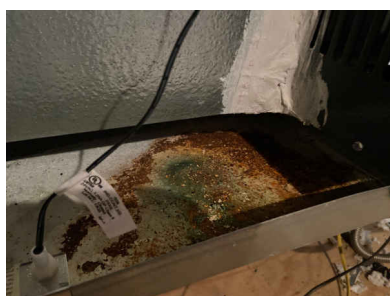
East unit

1: Corrosion in drain pan

Corrosion observed in the bottom of the AC condensate drain pan(s). Recommend painting with a rust inhibitor or replacement

Recommendation: Contact a handyman or DIY project

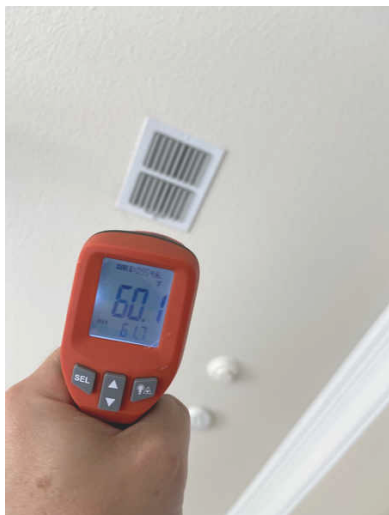
Game room

2: Temperature difference did not meet minimum standard

Temperature differential should be between 16-22 degrees greater than supply air. System did not met this requirement at time of inspection.

Getting an average of 14 recommend HVAC service and repair

Recommendation: Contact a qualified professional.

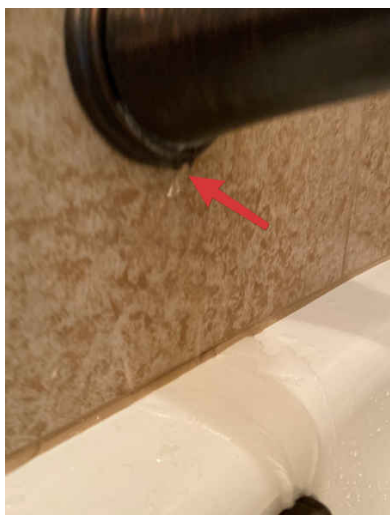
1: Faucet Leaking

A faucet is leaking. Recommend qualified handyman or plumber evaluate and repair.

Northeast bathroom when shower on

Recommendation: Contact a qualified plumbing contractor.

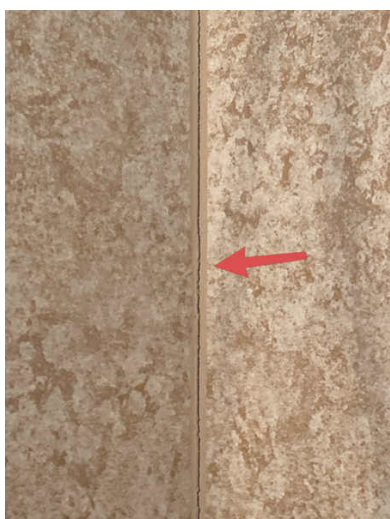
Northeast bathroom

2: Seal/caulking around tub missing or loose

Seal/caulking around tub or shower missing, loose or inadequate in one or more areas. Recommend caulking to prevent water intrusion

Recommendation: Contact a qualified professional.

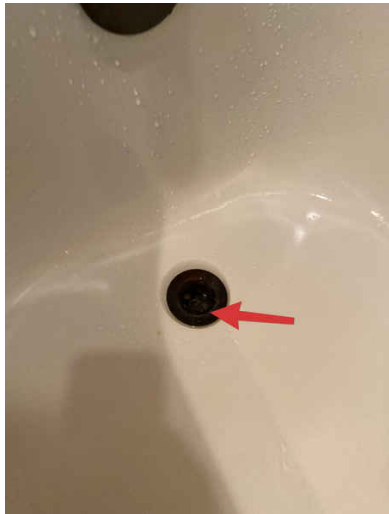
1: Missing or inoperative drain plug

Missing or inoperative drain plug in one or more areas. Recommend replacement or repair

Northeast bathroom needs drain plug

Recommendation: Contact a qualified professional.

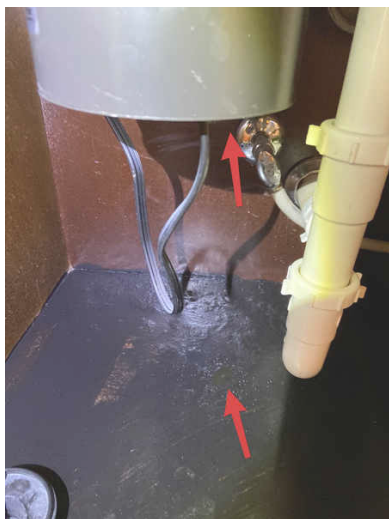
2: Leak in drain

Drain pipe leaking in one or more areas recommend repair to prevent water damage

Leak in disposal when running

Recommendation: Contact a qualified professional.

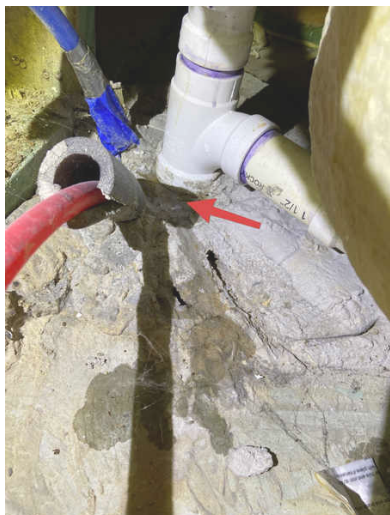
1: Leak in drain

Leak in drain observed in one or more areas. Recommend repair by licensed plumber

Drain leak

Recommendation: Contact a qualified professional.

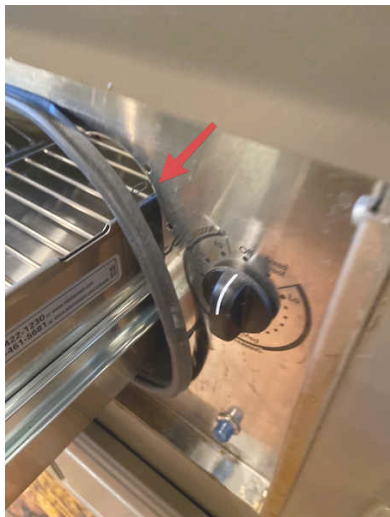
Warming oven

1: Loose seal

Loose seal around oven or warming oven. Recommend to re secure seal.

Recommendation: Contact a qualified professional.

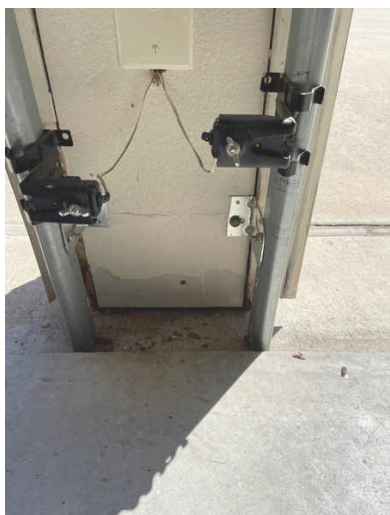
1: Sensor position

The garage door sensors should be installed within 6" of the finished floor

Recommendation: Contact a qualified professional.

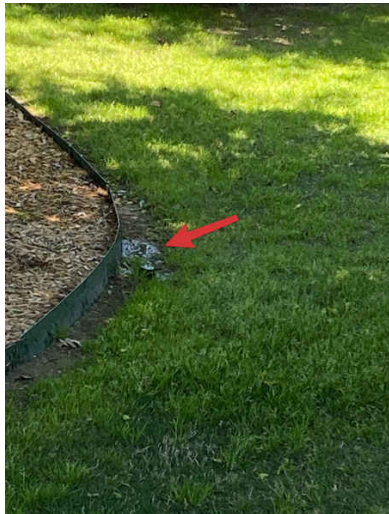
Back yard zone nine

1: Broken Sprinkler

One or more of the sprinkler heads were either damaged and/or missing. Recommend replacement.

Recommendation: Contact a qualified professional.

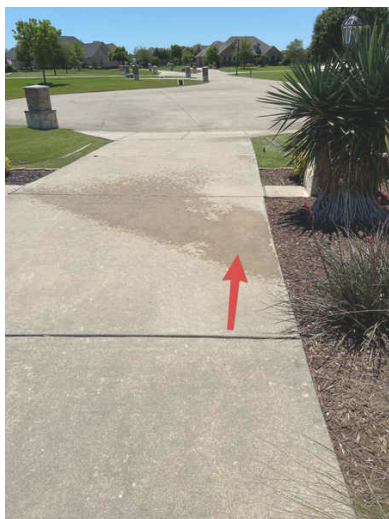
2: Sprinkler head adjustment

One or more heads on the sprinkler system need to be adjusted or replaced with a different head.

Spraying on front drive

Recommendation: Contact a qualified professional.

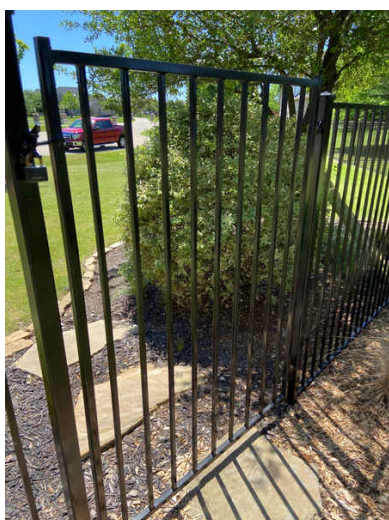
West gate

1: Gates not self-latching or self-closing

The perimeter gates that provide access to the pool/spa area should be self-closing and self-latching and open away from the pool area.

Recommendation: Contact a qualified professional.

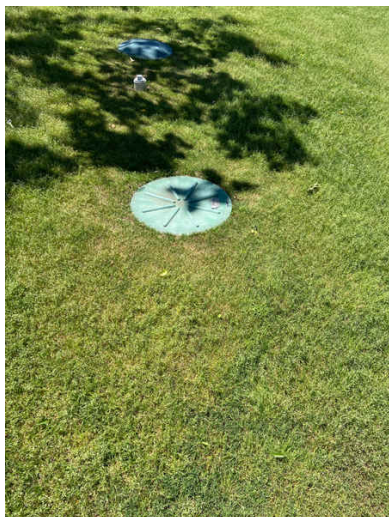
2: Recommend pumping tank

From a visual observation of the septic system it is recommended to pump out the septic tanks. This is also a good time to have the service company perform additional evaluations of the tank integrity that cannot be otherwise performed when there is effluent in the tank.

Sellers disclosure said tank had not been pumped. Cannot observe trash tank but recommend pumping

Recommendation: Contact a qualified septic system contractor.

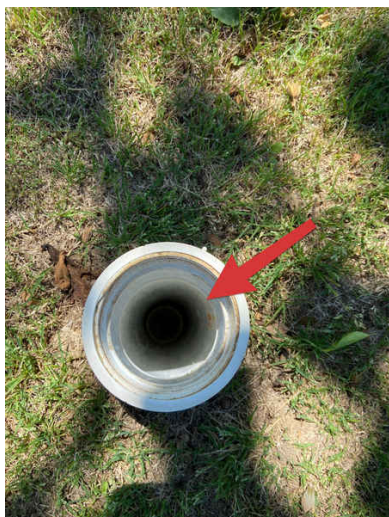
3: Need disinfectant added

Chlorine tablets for septic system or disinfectant need to be added to the septic system. This is maintenance that is normally done monthly

Recommendation: Contact a qualified professional.
