DETAILED INSPECTIONS OF NORTH TEXAS TREC#
20720

YOUR HOME INSPECTION

1234 Main St.
Garland, Texas 75043

PROPERTY INSPECTION REPORT

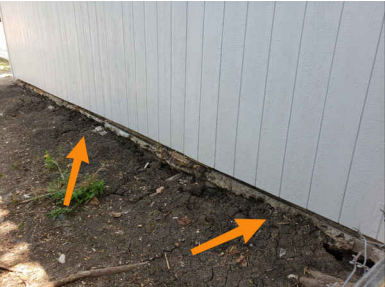
The soil line is low. Under current building standards there should be 4-inches of foundation visible

below masonry veneer and 6-inches of foundation visible below wood type veneer. It is recommended that fill dirt be added around the structure in the noted areas.

Recommendation: Contact a qualified grading contractor.

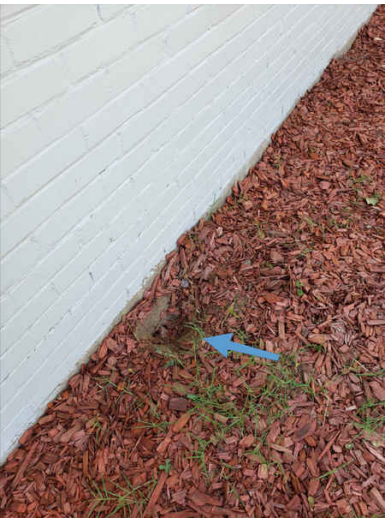
2: Low Spot Fill Dirt Needed

Fill dirt is needed. The low spots in the finished grade (ground) adjacent to the foundation perimeter wall need to be filled in to help prevent water from standing and/or ponding next to the foundation area.

Recommendation: Contact a qualified landscaping contractor

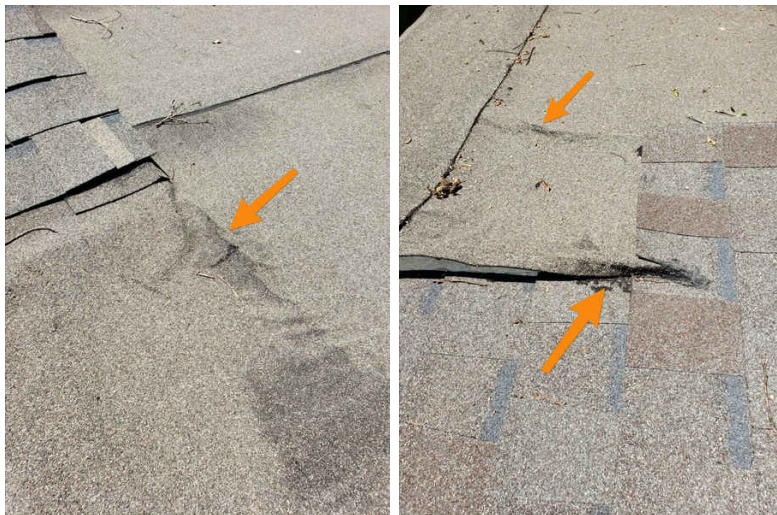
1: Damaged Coverings

Roof coverings exhibited general damage that could affect performance. Recommend a qualified roofer evaluate and repair.

Recommendation: Contact a qualified roofing professional.

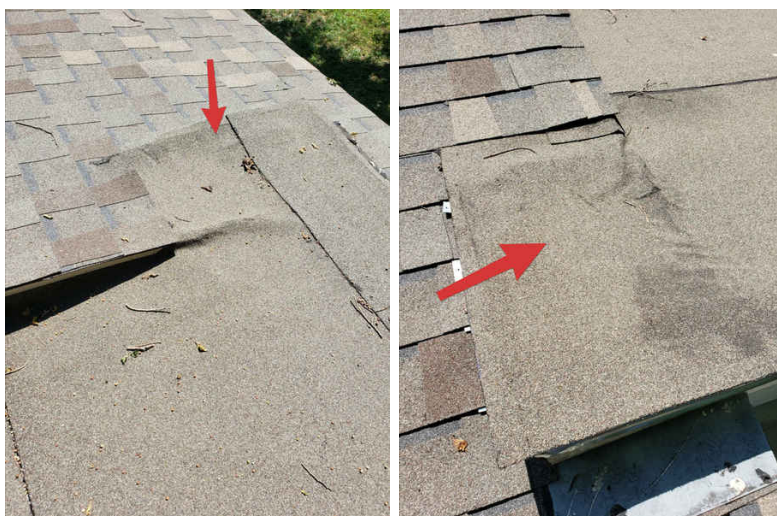
2: Possible Ponding area

Observed possible ponding in one or more areas of roof. Ponding can lead to accelerated erosion and deterioration. Recommend a qualified roofing contractor evaluate and repair.

Recommendation: Contact a qualified roofing professional.

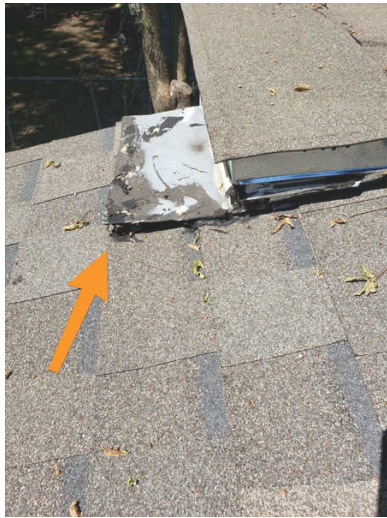
3: Flashing Lifted

The flashing is lifting and/or pulling loose and should be re-secured.

Recommendation: Contact a qualified roofing professional.

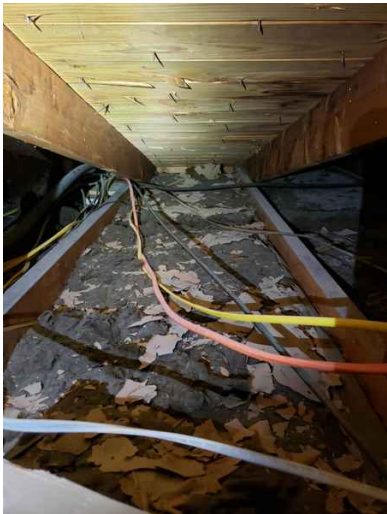
Attic insulation was noted to be inferior. This condition should be reviewed and remedied as necessary for comfort and energy efficiency.

Recommendation: Contact a qualified insulation contractor.

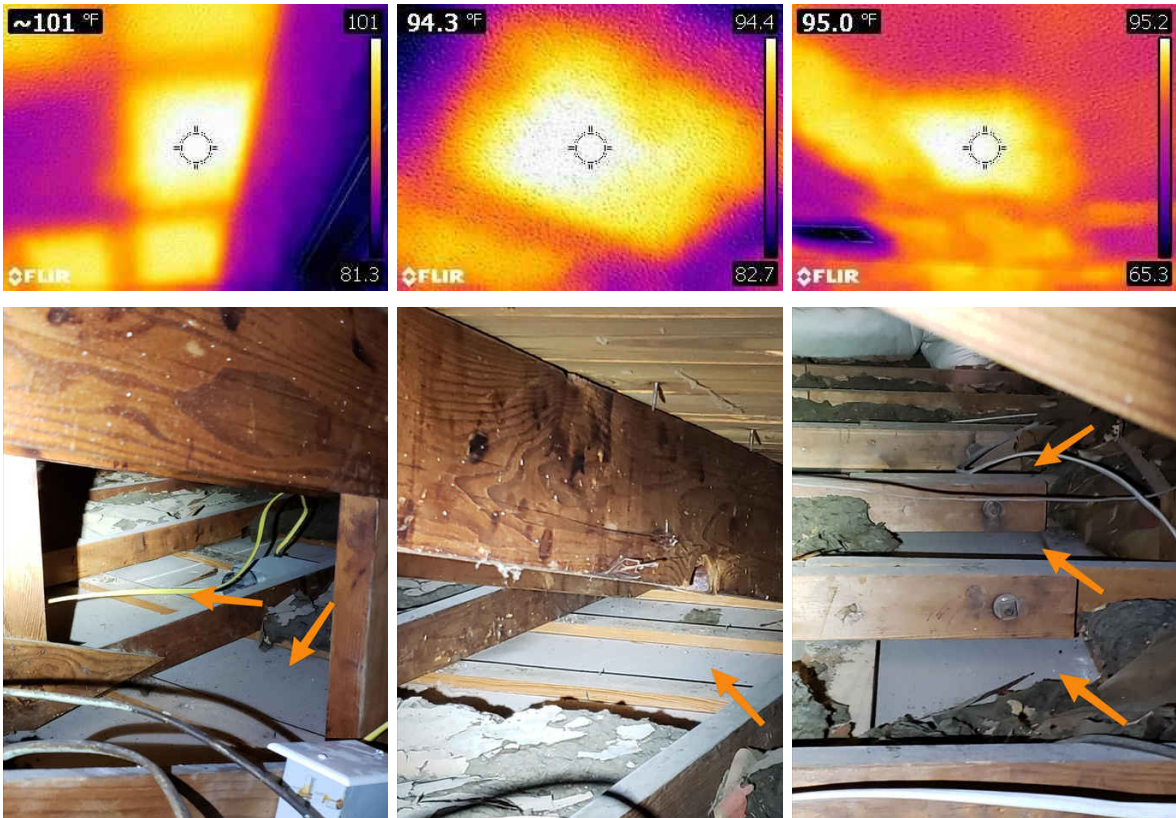
3: Attic Insulation Missing

The attic floor insulation was observed to be missing in some areas.

Recommendation: Contact a qualified insulation contractor.

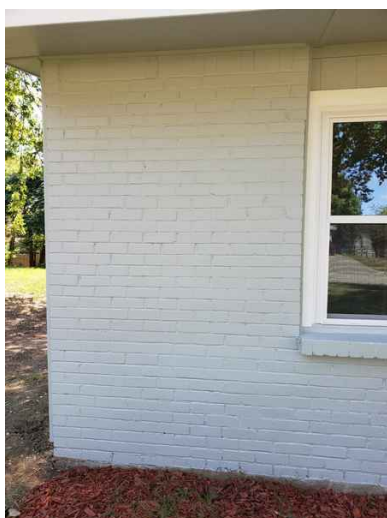
Exterior Brick is Painted:

The exterior masonry veneer has been painted. This condition could limit the Inspectors visual observations and ability to render accurate opinions as to the performance of the structure.

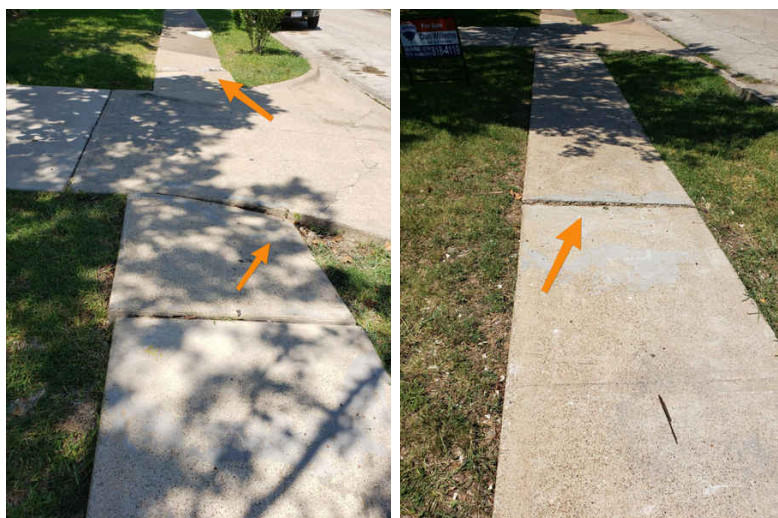
The sidewalk has settled somewhat. If this condition persists or if the sidewalk becomes a trip hazard, improvements should be undertaken.

Recommendation: Contact a qualified concrete contractor.

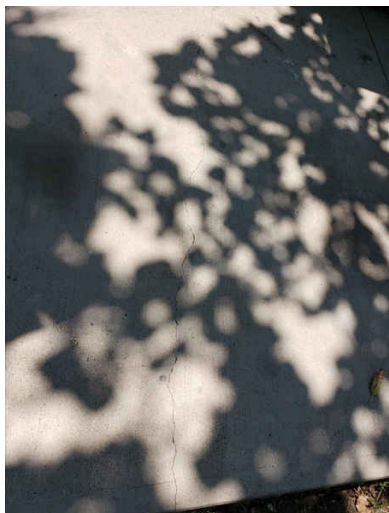
2: Minor Driveway Cracks

Minor cracks and/or deficiencies were observed in the driveway.

Recommendation: Contact a qualified concrete contractor.

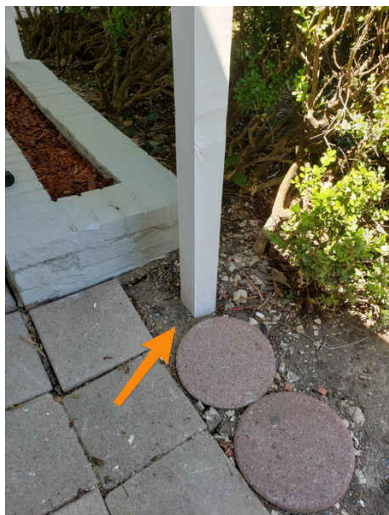
3: Porch Roof Support Post

The porch support posts have been built at grade level (Wood/Ground contact should be avoided). This configuration is prone to rot and insect activity.

Recommendation: Contact a qualified professional.

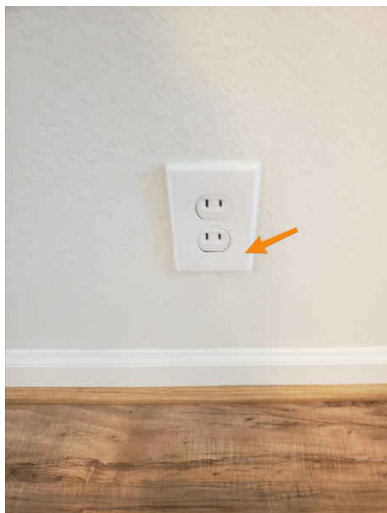
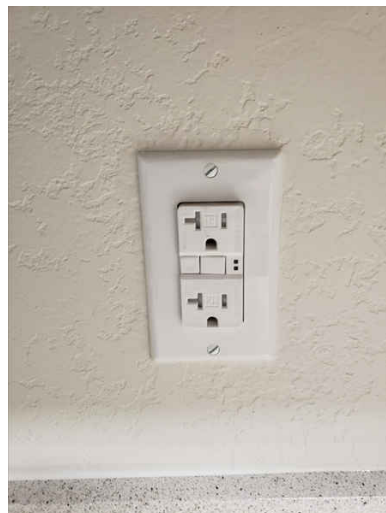
Older two wire system was observed to be mixed with newer 3 wire system. This should be further evaluated by a licensed electrician and corrected as necessary.

Recommendation: Contact a qualified electrical contractor.

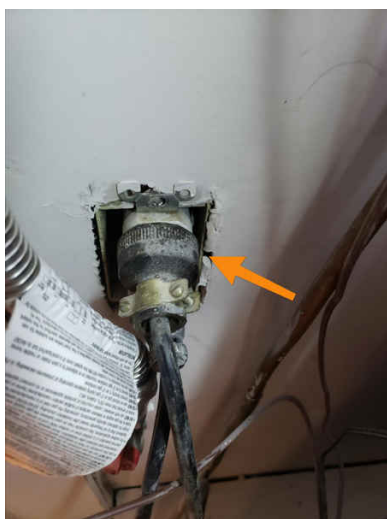
3: Missing / damaged cover plate

One or more of the receptacles was noted to have missing or damaged cover plate.

Recommendation: Contact a qualified electrical contractor.

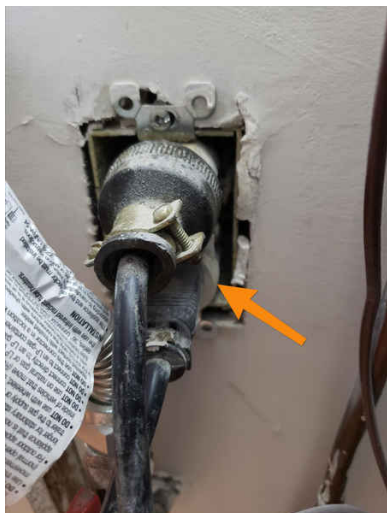
4: Loose Plug

One or more of the receptacles were observed to be loose at the wall mount

Recommendation: Contact a qualified electrical contractor.

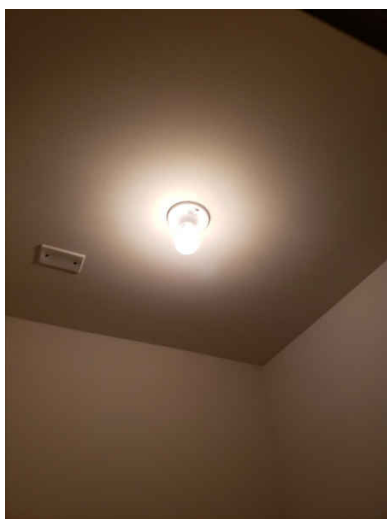
5: Globe damaged or missing

One or more of the light fixture globes and/or covers are damaged or missing.

Recommendation: Contact a qualified handyman.

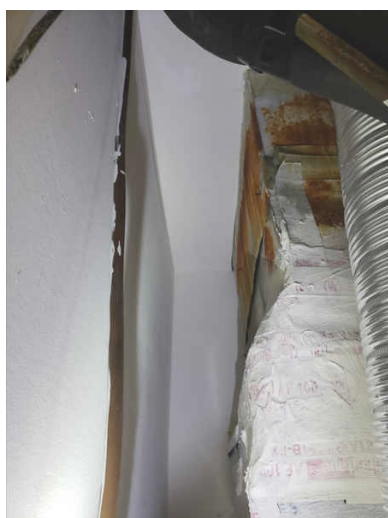
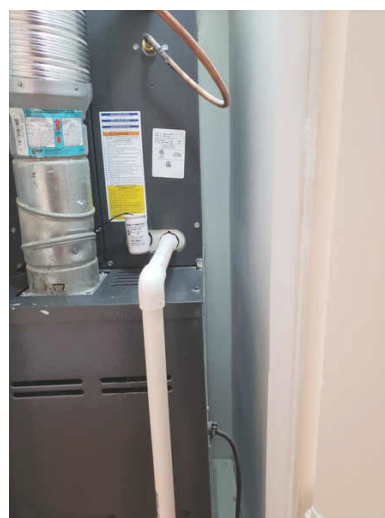
1: Poor Ventilation

The heating unit compartment has inadequate combustion air ventilation. There should be a minimum of 100 square inches of combustion air ventilation provided within 12-inches of the top and bottom of the closet. Combustible air should not come from conditioned air space. This may be an as-built condition but Per TREC standards of practice we are required to report this condition as a deficiency.

Recommendation: Contact a qualified professional.

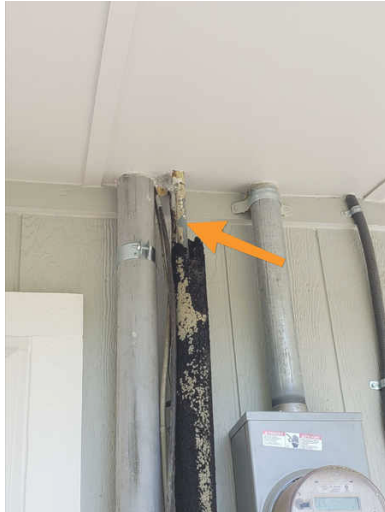
2: Damaged outside

Damaged, deteriorated and/or missing insulation on the refrigerant lines should be repaired or replaced at the outside condenser.

Recommendation: Contact a qualified professional.

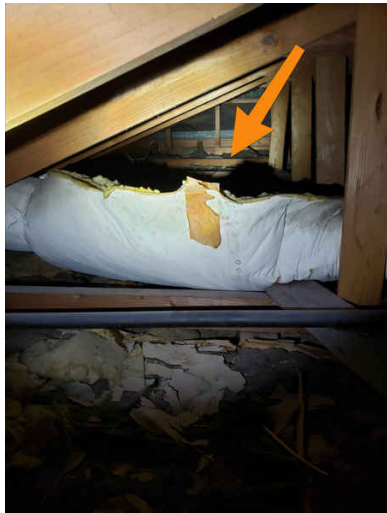
Ductwork insulated covering was observed to be damaged and/or pulling loose.

Recommendation: Contact a qualified professional.

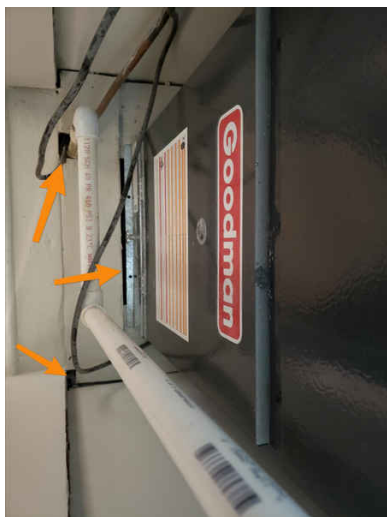
2: Return Chase needs to be sealed

The return Chase has areas that need to be sealed In the HVAC closet.

Recommendation: Contact a qualified professional.

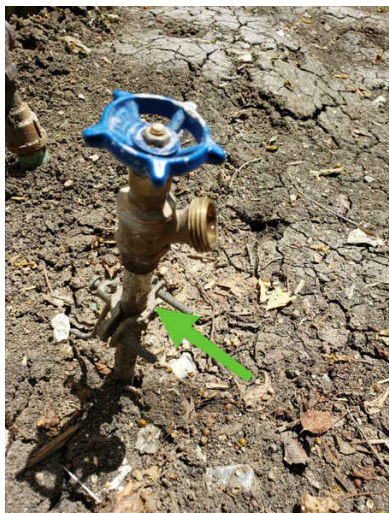
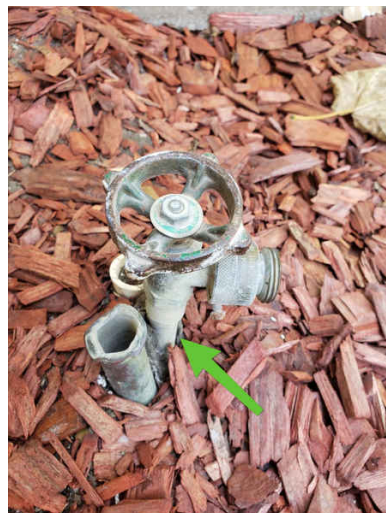
Back & Front

The exterior water hose bibb(s) (faucet) adjacent to the home should be protected from physical damage and/or possible freeze.

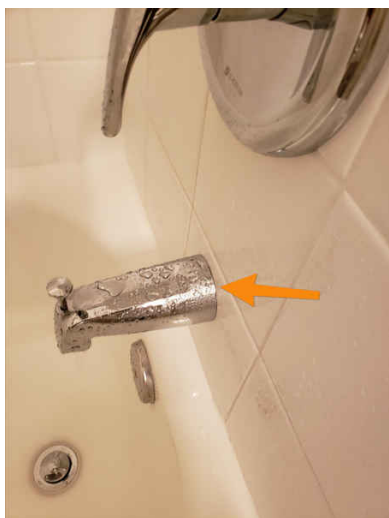
Tub spout should be sealed to avoid water intrusion in the wall.

Recommendation: Contact a handyman or DIY project

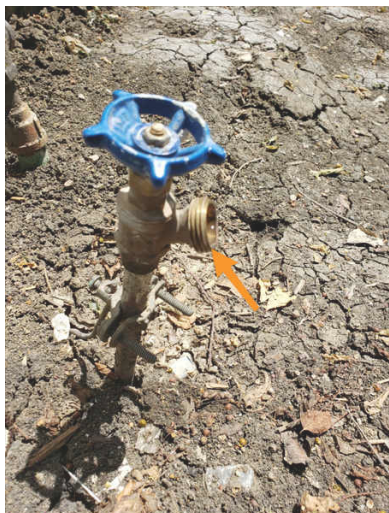
2: Backflow missing

One or more of the exterior water hose bibbs (faucet) do not have a back-flow or anti-siphon device (Vacuum Breakers) in place. Note: This is not uncommon to observe with a home of this age.

Recommendation: Contact a handyman or DIY project

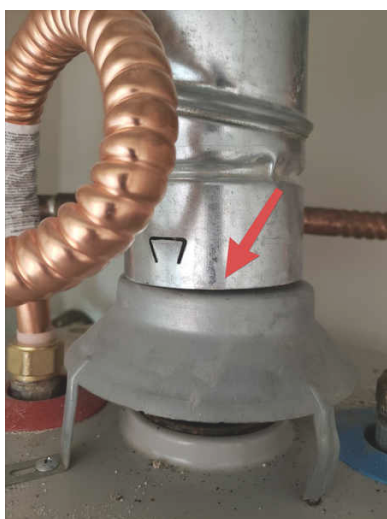
1: mechanical attach flue

The water heater flue should be mechanically attached to the draft hood with a minimum of three sheet metal screws. The improperly attached flue can come loose and emit carbon monoxide a know safety hazard.

Recommendation: Contact a qualified plumbing contractor.

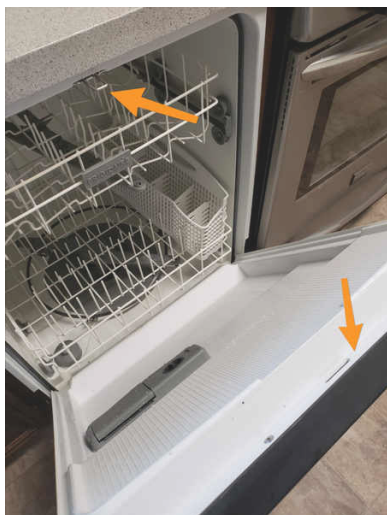
Dishwasher door does not latch properly

Recommendation: Contact a qualified professional.

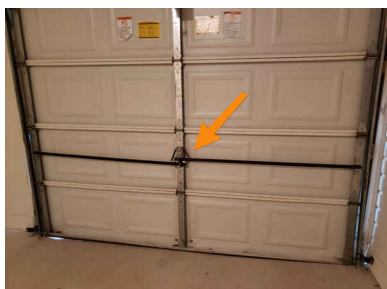
When an automatic garage door opener is in use, the manual lock should be disabled or removed. Per TREC standards of practice we are required to report this condition as a deficiency.

Recommendation: Recommended DIY Project
