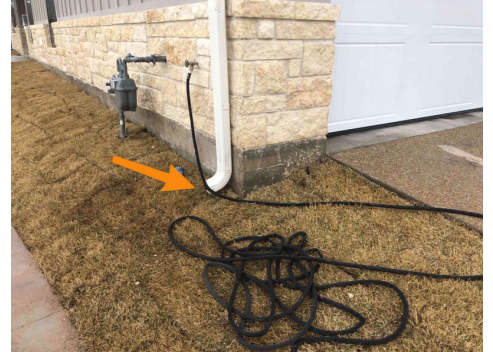
EROSION AT DOWNSPOUTS

Splash blocks or extensions should be installed to the gutter system downspouts where needed to prevent erosion adjacent to the foundation.

Contact a qualified lawn care professional.

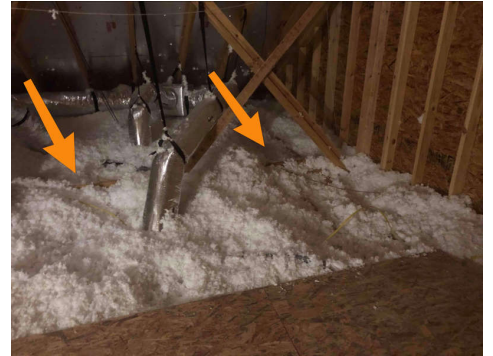
OVER REAR BEDROOM

MISSING ATTIC INSULATION

Gaps in the insulation can cause condensation and heat loss. Add / replace insulation as necessary for adequate thermal protection

Contact a qualified insulation contractor.

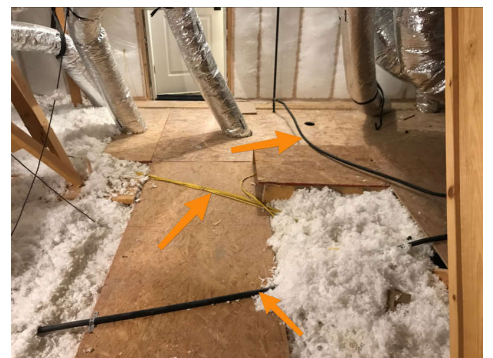
UTILITY OBSTRUCTIONS

Gas and AC drain pipes, and electrical wires crossing the attic walkway floor need to be covered for protection or relocated.

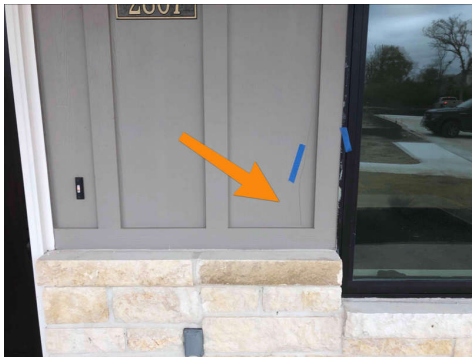
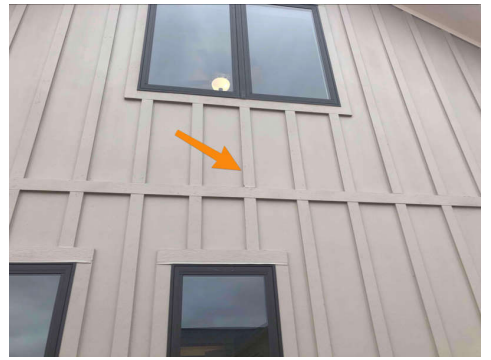
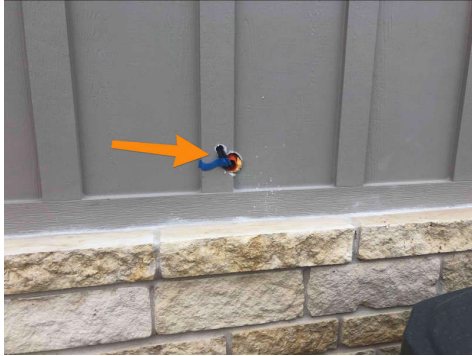
VARIOUS LOCATIONS

BROKEN /CRACKED SIDING

All damaged / cracked siding should be repaired or replaced and any cracks sealed to keep the integrity of the weather envelope provided by exterior wall coverings.

Contact a qualified siding specialist.

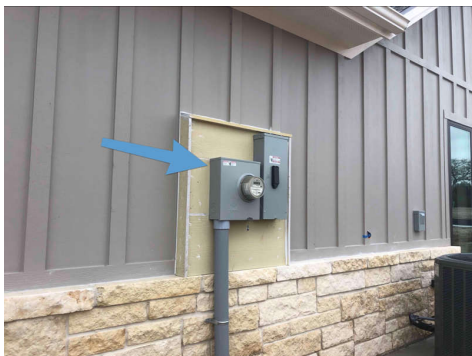
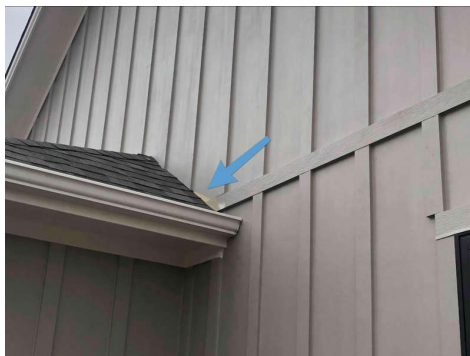
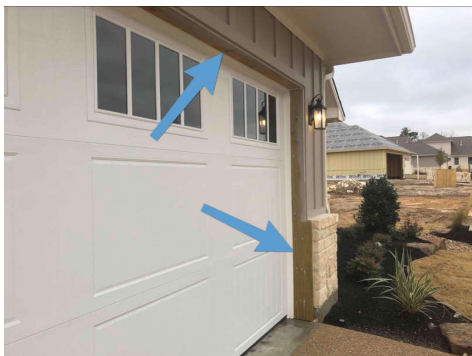
PAINT COVERING NEEDS IMPROVEMENT

Exterior paint is incomplete in several areas.

Contact a qualified painting contractor.

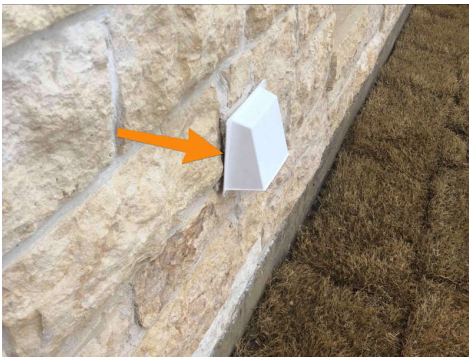
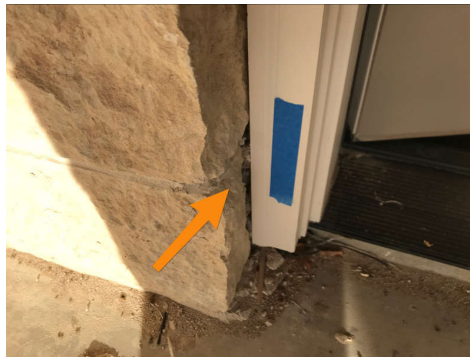
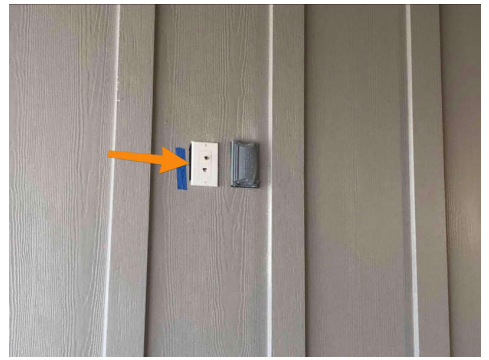
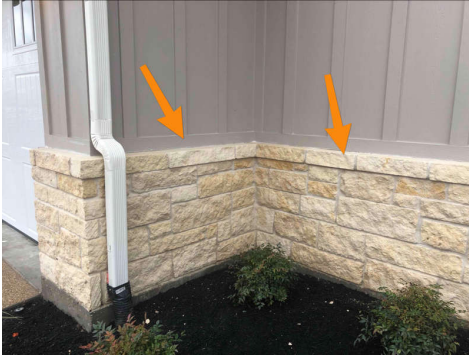
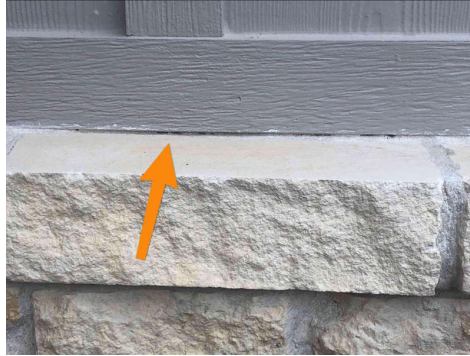
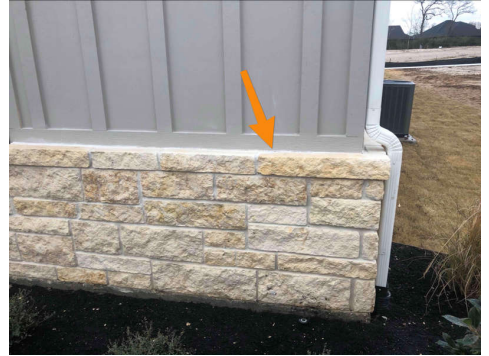
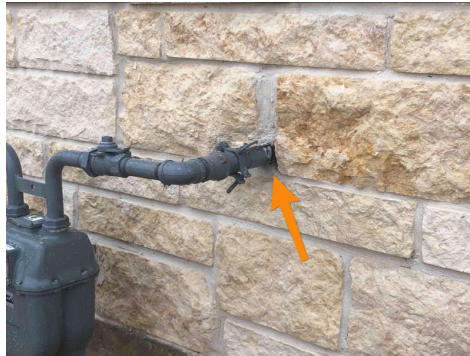
GAPS AT EXTERIOR WALL

Seal all gaps at joints and utility penetrations to prevent moisture and pest intrusion.

Contact a qualified professional.

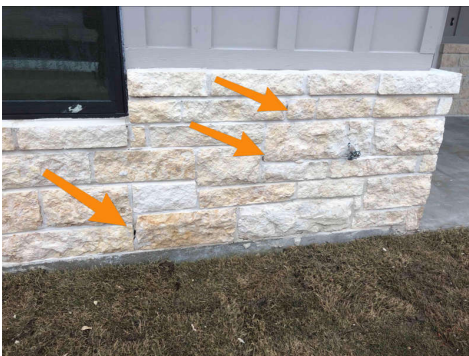
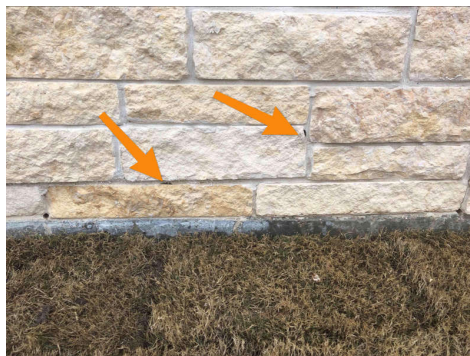
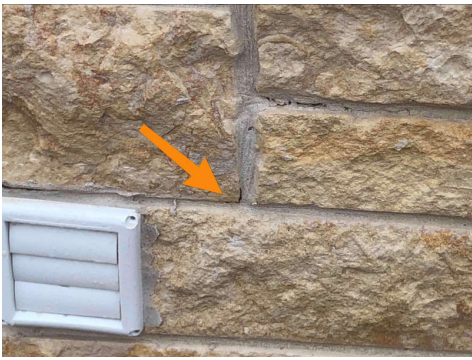
VARIOUS LOCATIONS

VOIDS IN MASONRY MORTAR JOINTS

Mortar is less durable than brick, and can be maintained by "repointing." To repoint, chip the old mortar out to a depth of 1/2-inch to 1-inch. Then dampen the joints with water, and repack with new mortar.

Contact a qualified masonry professional.

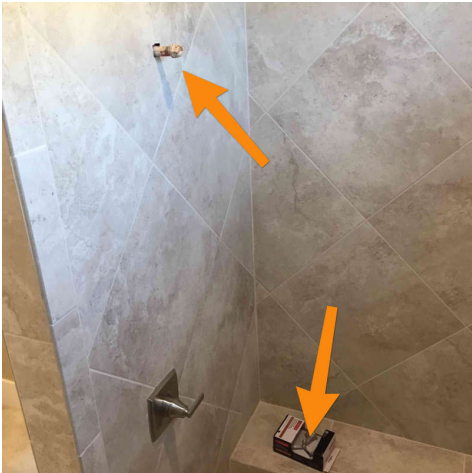
Master Shower

INTERIOR UNFINISHED WORK /COSMETIC REPAIRS

Unfinished work, painting and cosmetic repairs or touch ups are needed.

Recommendation
Contact a qualified professional.

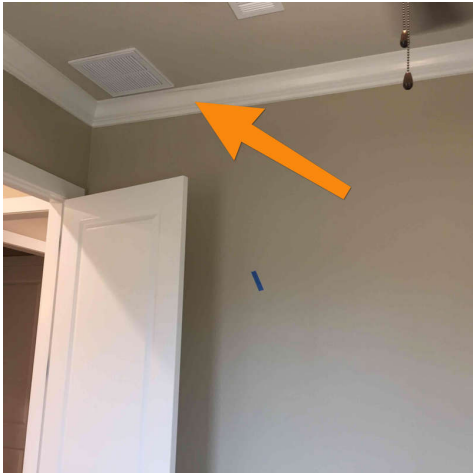
Cracked crown molding

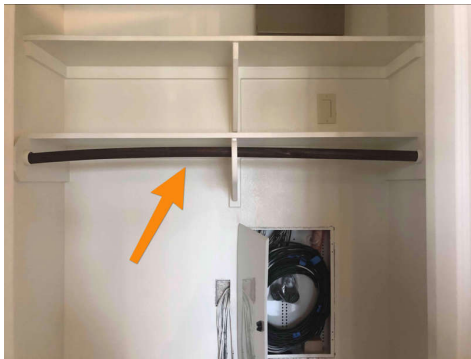
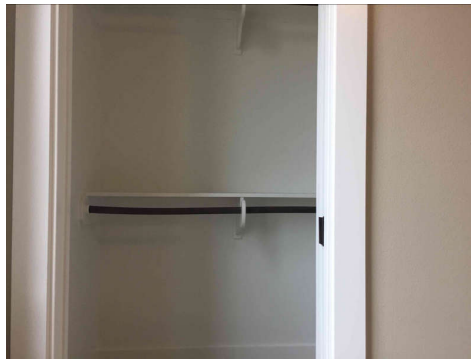
FRONT ENTRY CLOSET, 2ND FLOOR CLOSET

WARPED CLOSET DOWEL RODS

Contact a qualified professional.

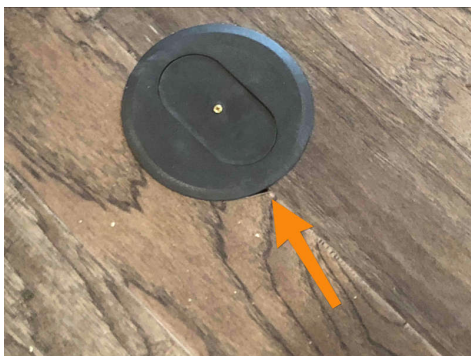
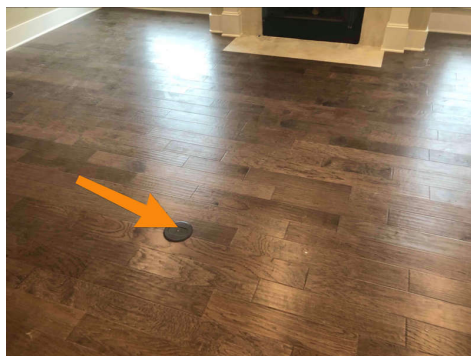
LIVING ROOM

COSMETIC REPAIR NEEDED AT FLOOR COVERING.

Flooring has been over cut at floor receptacle.

Contact a qualified professional.

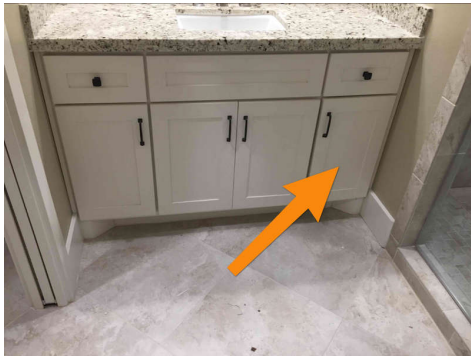
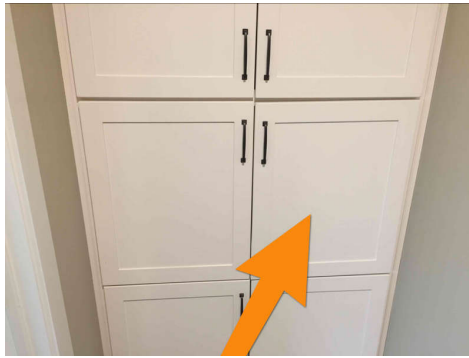
CABINET HINGES NOT PROPERLY INSTALLED.

A few cabinet doors need hinge adjustment to properly function.

Recommended DIY Project

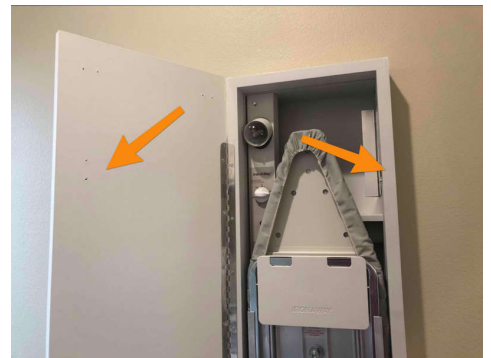
LAUNDRY ROOM IRONING BOARD CLOSET

DOOR DOESN'T LATCH

Latch is missing.

Contact a qualified handyman.

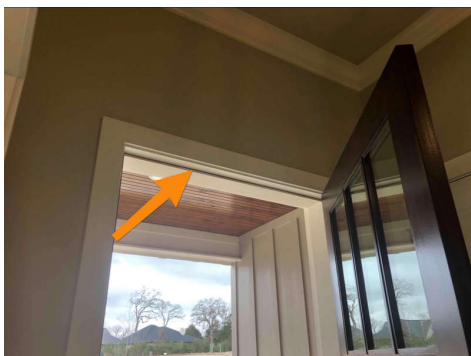
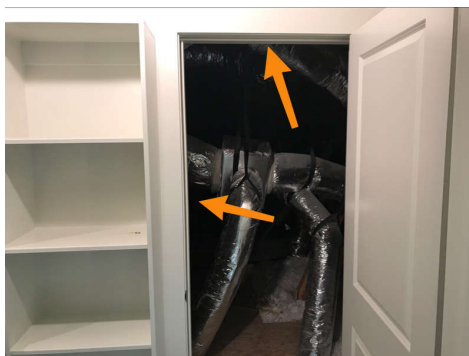
ATTIC ENTRY, FRONT ENTRY

WEATHERSTRIPPING MISSING

No weatherstripping is installed at the door frame.

Recommended DIY Project

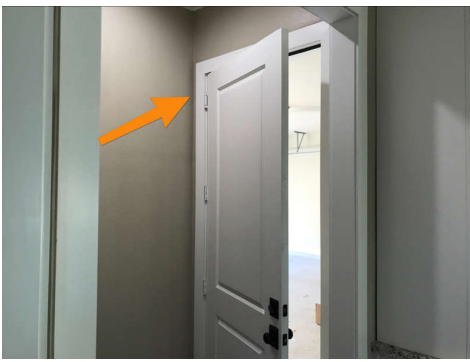
SELF CLOSING HINGES NEED ADJUSTMENT

Self closing hinges do not provide enough tension to fully close the door.

Contact a qualified professional.

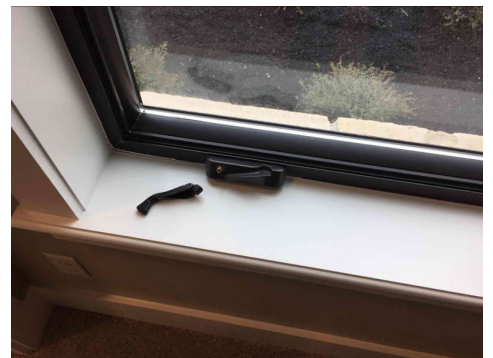
1ST FLOOR REAR BEDROOM

LATCH NOT PROPERLY INSTALLED

Window latches needed to prevent unwanted entry and proper function.

Contact a qualified professional.

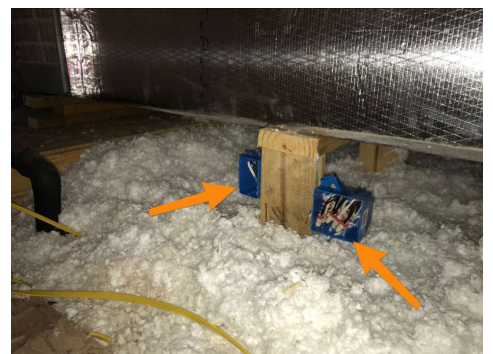
ATTIC SPACE

EXPOSED ENDS & SPLICES

All wire connections & charged wires with exposed ends and splices should be covered in junction boxes for safety. Recommend a qualified electrician correct.

Contact a qualified electrical contractor.

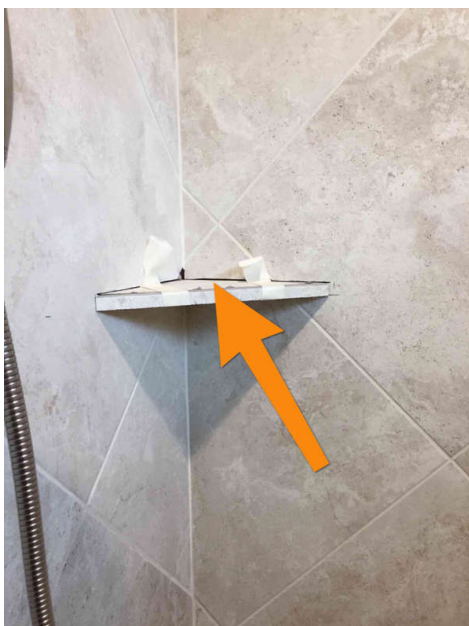
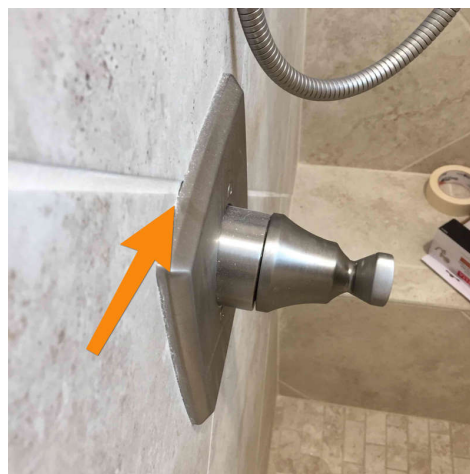
MASTER BATH

TUB - SEAL WALL PENETRATIONS

Tub/shower plumbing penetrations need to be sealed.

Contact a handyman or DIY project

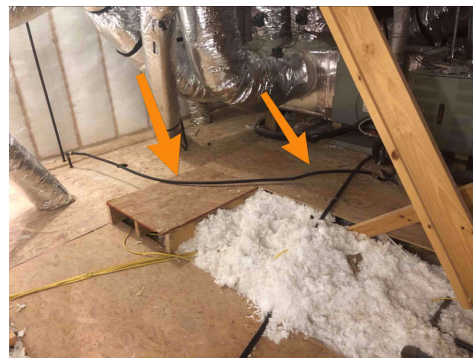
FLEXIBLE GAS PIPE ROUTED ACCROSS WALKWAY IN ATTIC.

Gas piping should be installed in a manor to prevent damage to pipe and tripping hazard.

Contact a qualified professional.

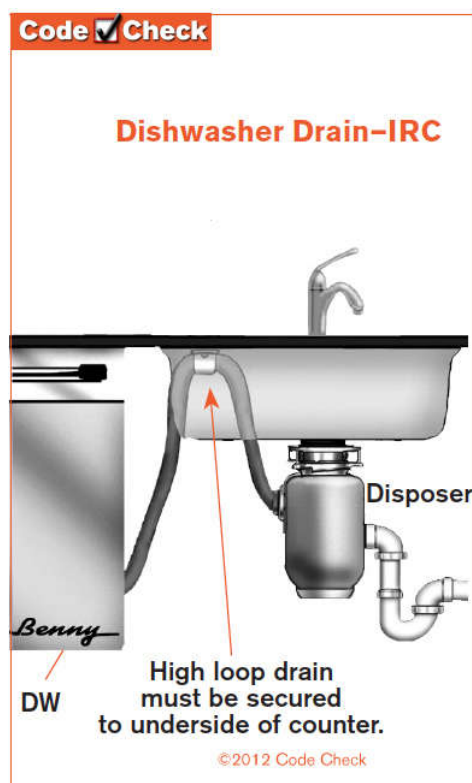
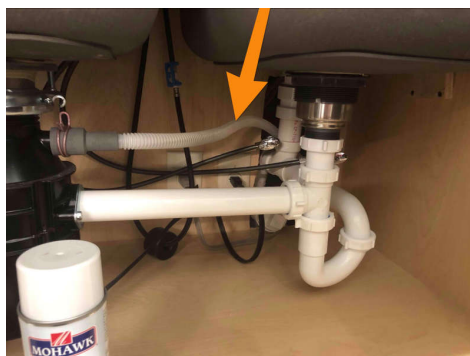
NO AIR GAP

The dishwasher discharge (drain) line needs to be elevated above the inlet to disposal or drain pipe so that it has an air gap to prevent debris and gray water from draining down line from disposal or drain pipe and back into dishwasher.

Recommended DIY Project
