TFHI RESIDENTIAL REPORT

1234 Main St. Union NJ 07083

Buyer Name
12/07/2020 9:00AM

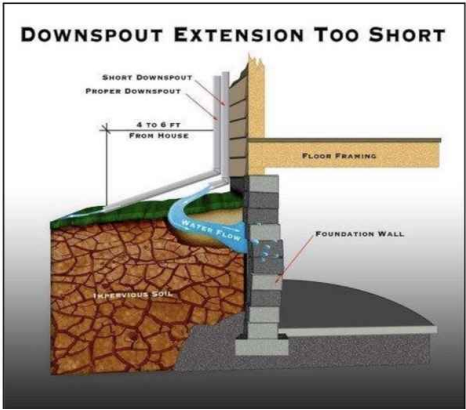
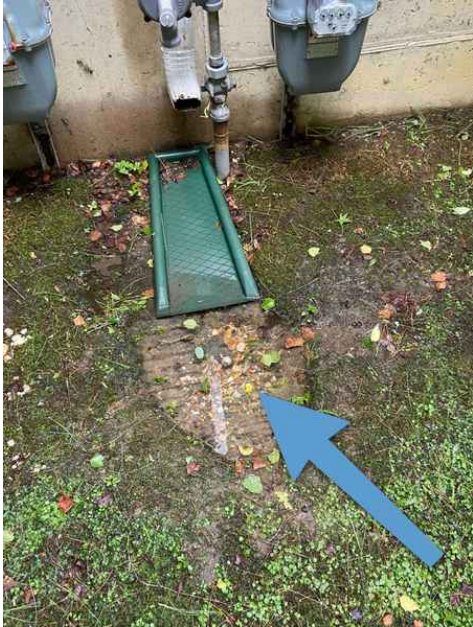
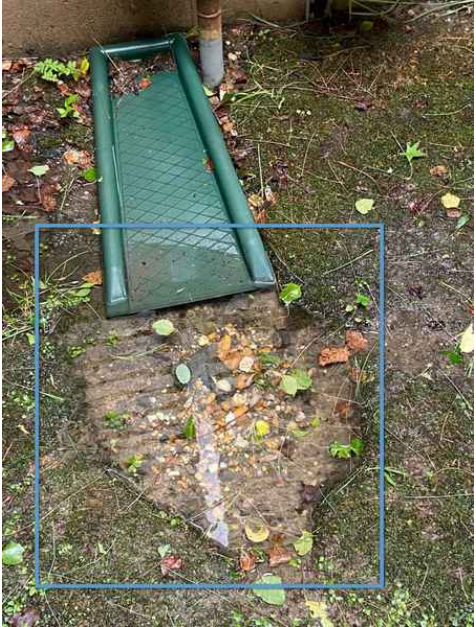
Water is pooling at the end of the splash block. The downspout needs an extension and or a buried drain line to carry water away from the home. This can cause damage to the interior finishes and the foundation of the home. I recommend a qualified licensed contractor repair or replace as needed.

Contact a qualified gutter contractor

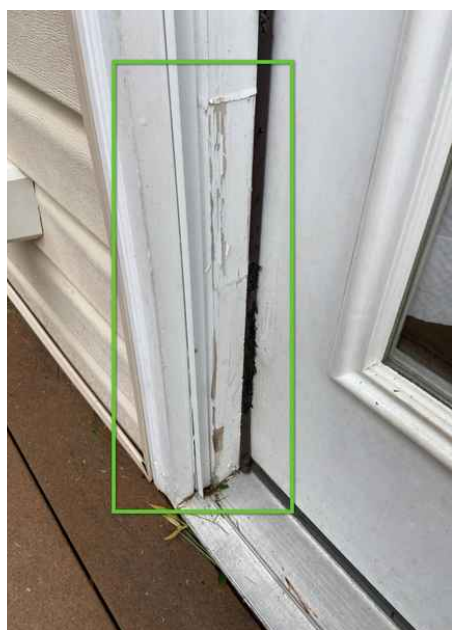
Rear

The exterior trim around doors would benefit from maintenance painting to prevent future weather deterioration of interior materials.

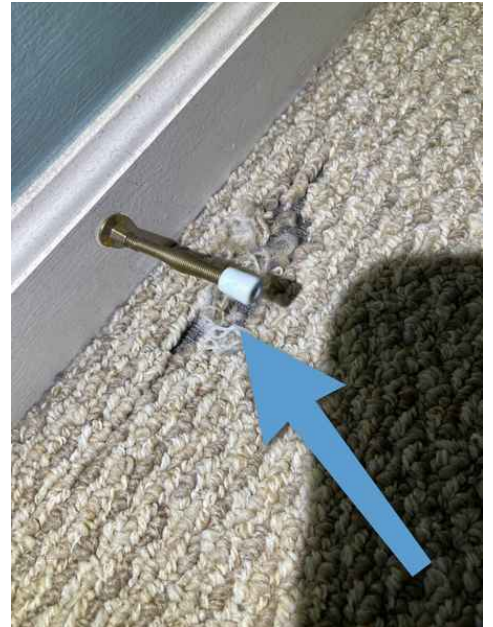
4.3.1 Floors

MINOR CARPET DAMAGE

Minor carpet damage was observed in the master bedroom. This is a cosmetic issue.

Contact a carpet cleaner.

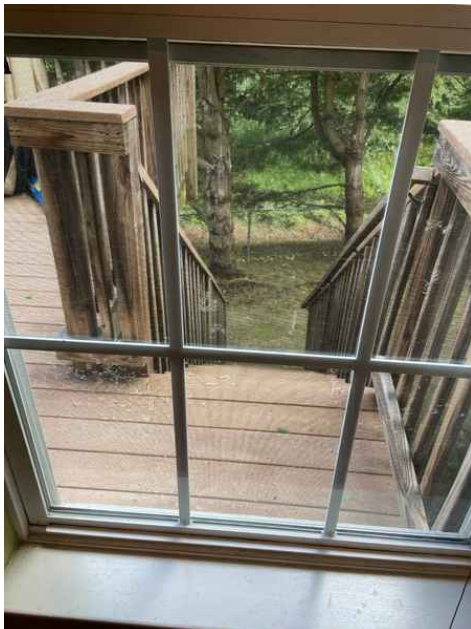
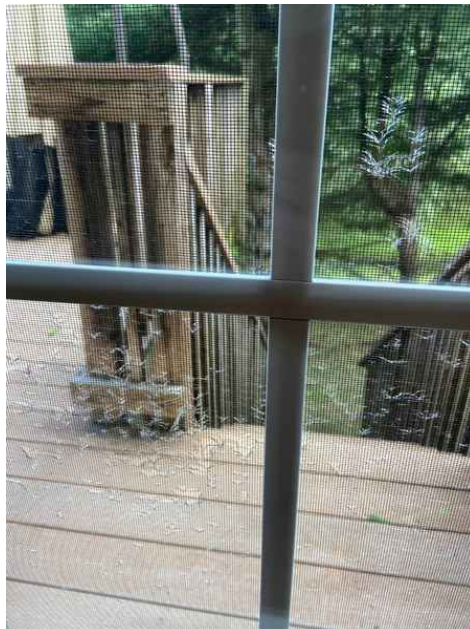
4.5.1 Windows (representative number)

DAMAGED SCREENS

One window screen was observed to be torn and damaged. This is a cosmetic issue. A qualified licensed professional should replace the screen.

Contact a qualified professional.

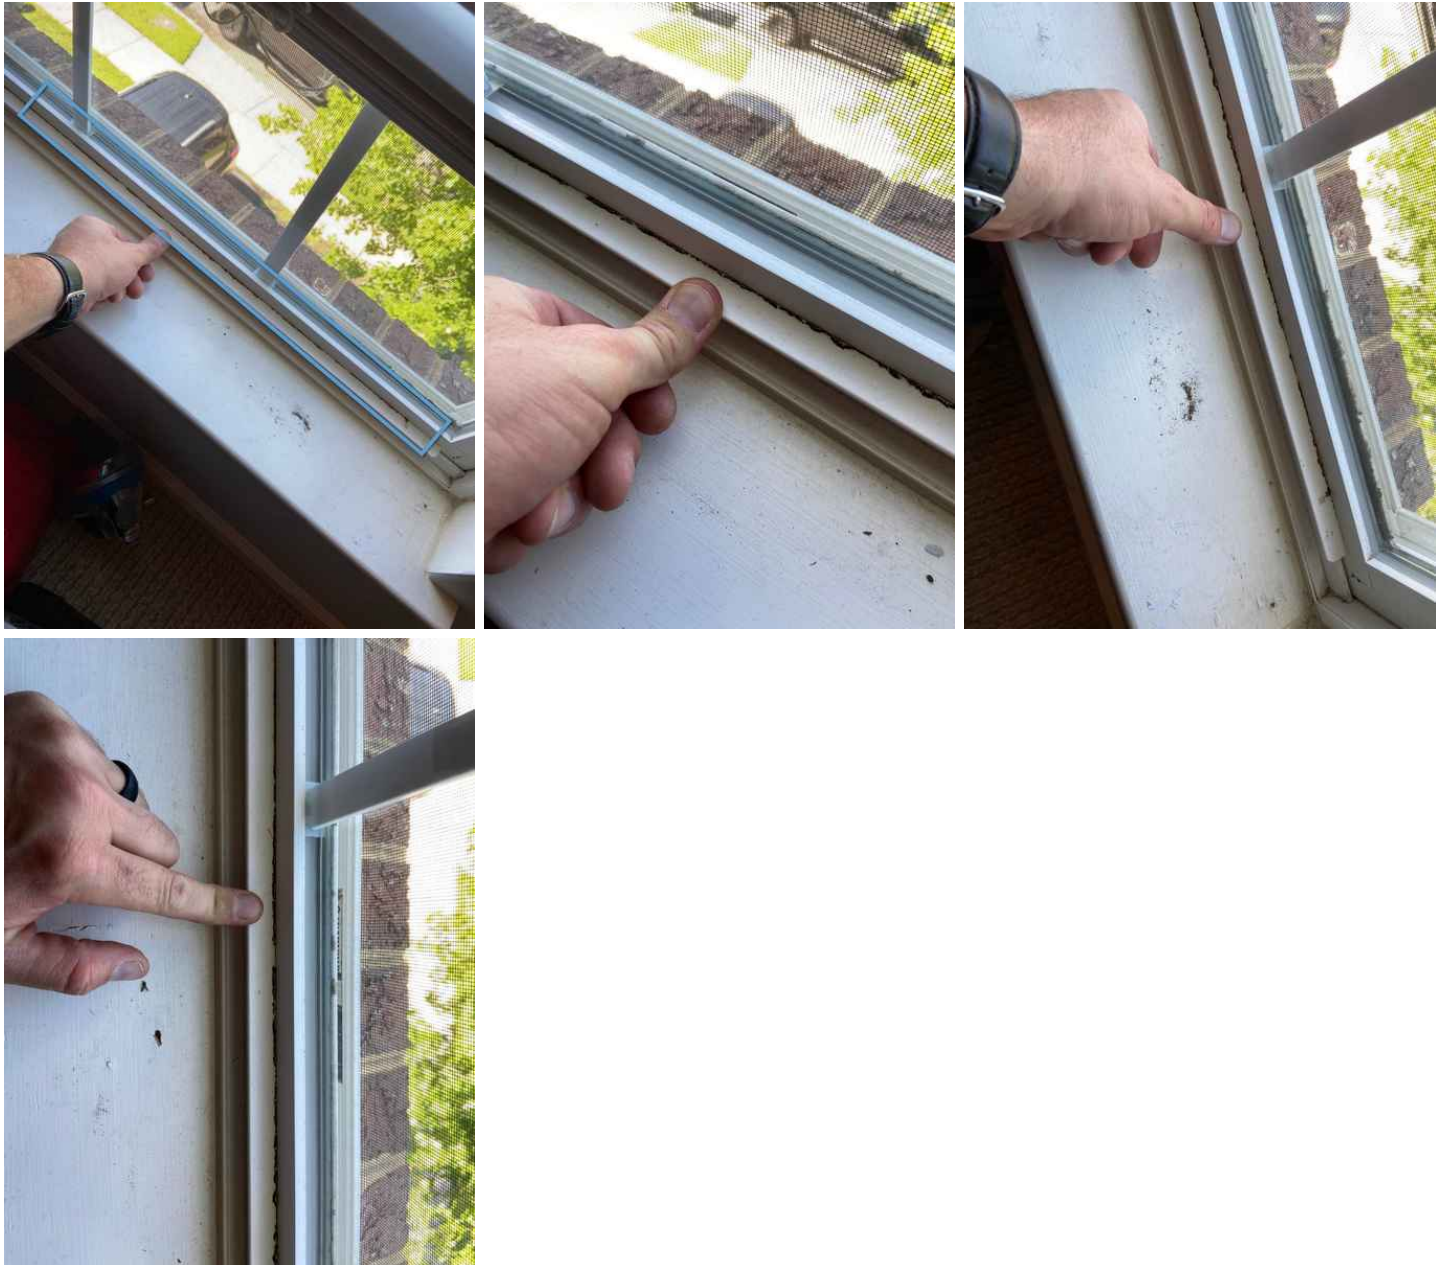
4.5.2 Windows (representative number)

WINDOW LEDGE DETERIORATING

The ledge of the window is damaged, however, the window is still operable. This is a maintenance issue. A qualified licensed professional should repair and replace as necessary.

Contact a qualified professional.

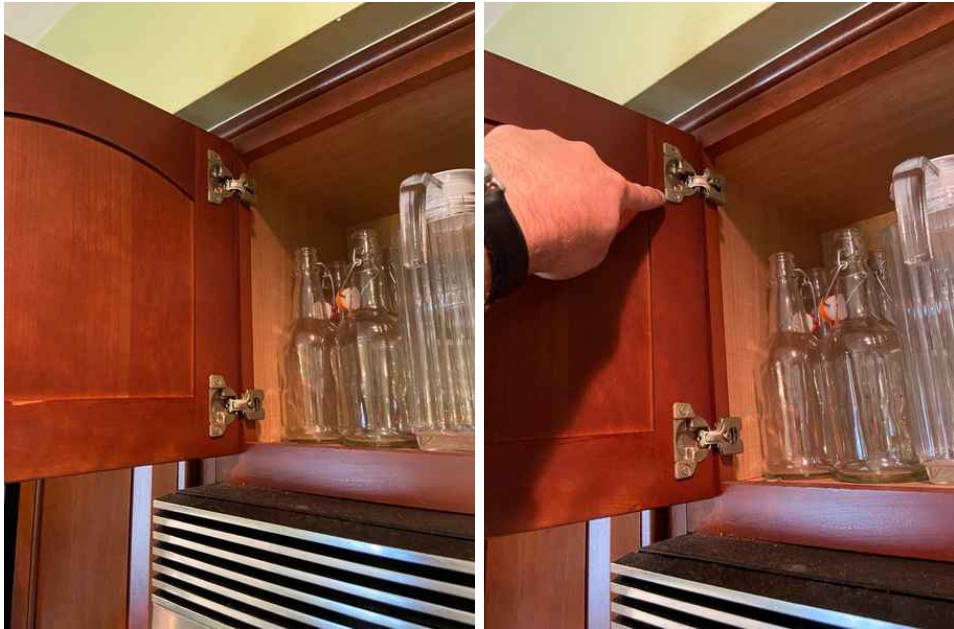
4.7.1 Countertops & Cabinets (representative number)

CABINET HINGE LOOSE

One or more cabinet hinges were loose at the time of the inspection. This is a maintenance issue. A qualified licensed contractor should repair and replace as necessary.

Contact a qualified carpenter.

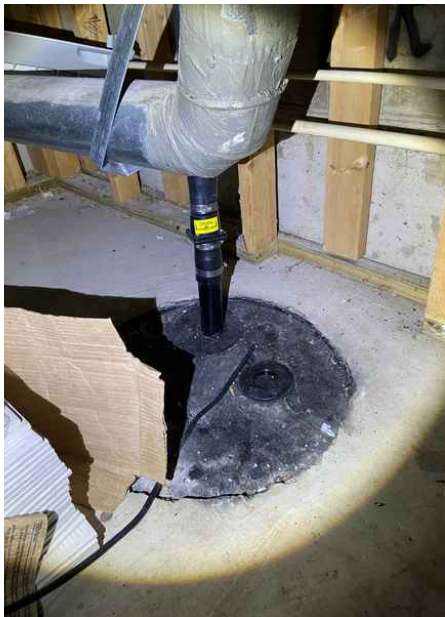
Sump Pump: Operational

The sump pump was operational at the time of inspection.

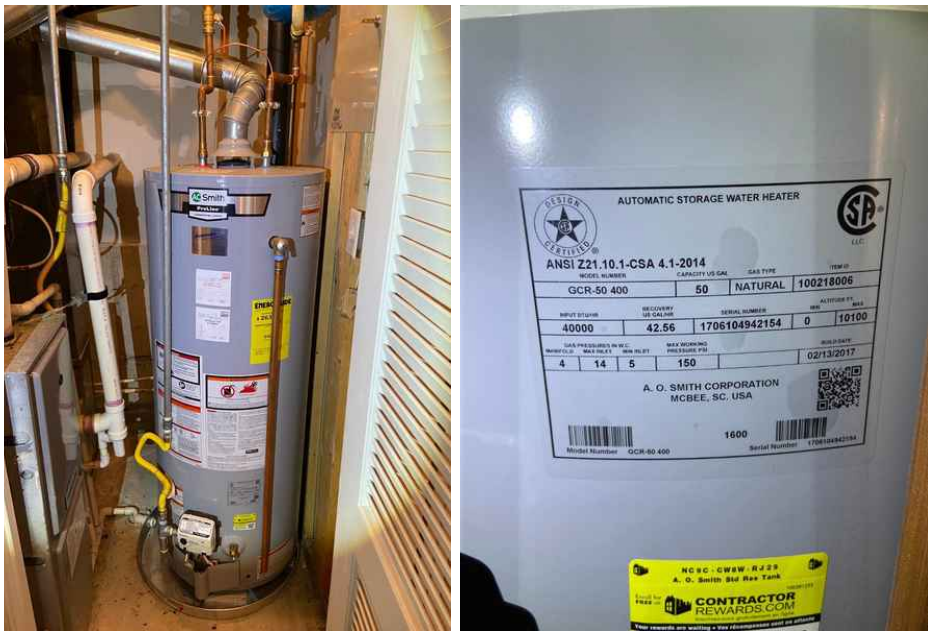
Hot Water Systems, Controls, Flues & Vents: Water Heater System

At this time, the water heater appears to be operating as expected. The Water heater Serial Number is (Please see image) and model number is (Please see image). The water heater was manufactured in 2017 and has a life expectancy of 7-12 years.

I recommend flushing & servicing your water heater tank annually for optimal performance. Water temperature should be set to at least 120 degrees F to kill microbes and no higher than 130 degrees F to prevent scalding.
[Here is a nice maintenance guide from Lowe's to help.](#)

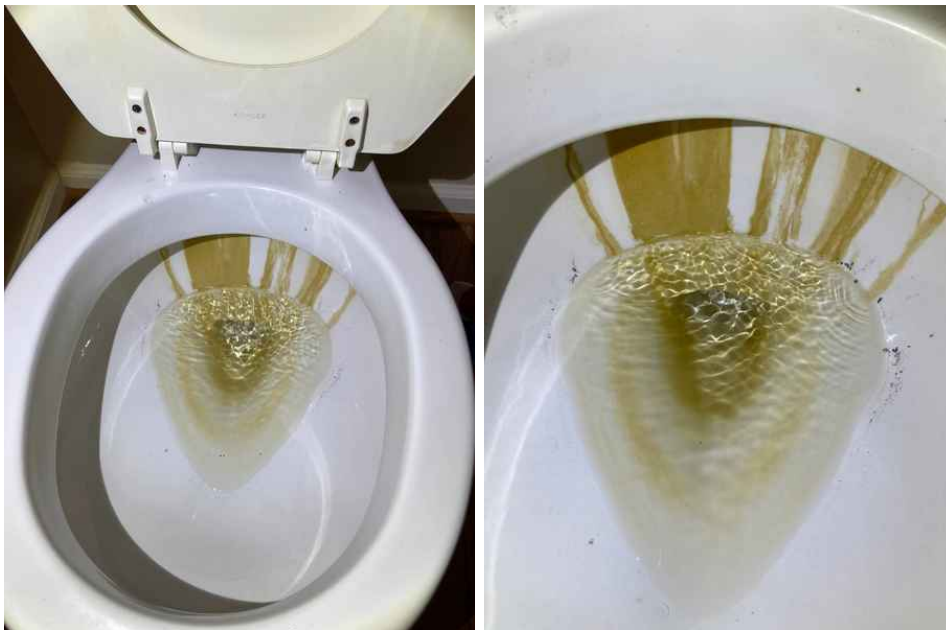
I observed that the toilet in the first floor bathroom was running water continuously, causing wear and stain of the porcelain. This is a maintenance issue. A qualified licensed plumber should evaluate, and repair and replace as necessary.

Contact a qualified plumbing contractor.

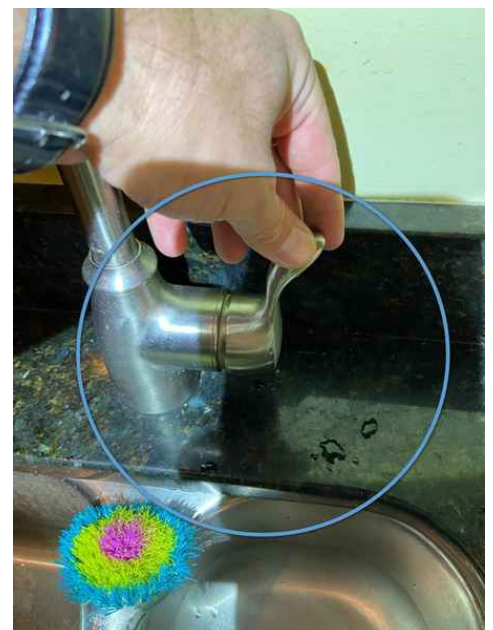
5.6.1 Sinks, Tubs & Showers

LOOSE FIXTURE HANDLE

I observed that the fixture handle is loose. This is a maintenance issue. A qualified licensed plumber should repair and replace as necessary.

Contact a qualified plumbing contractor.

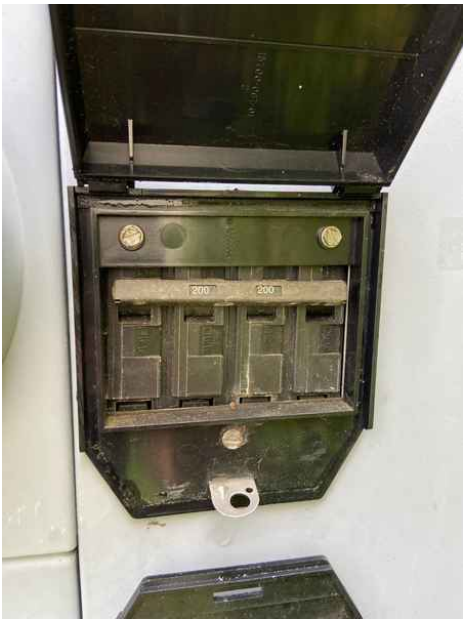
Main & Subpanels, Service &
Grounding, Main Overcurrent
Device: Main Service Disconnect
Exterior
200 AMP

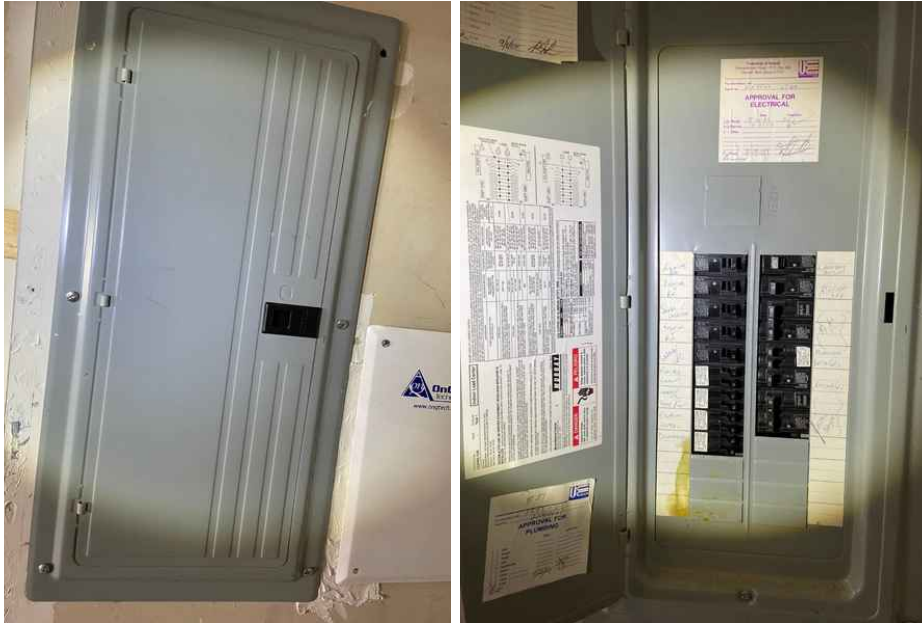
Main & Subpanels, Service & Grounding, Main Overcurrent Device: Sub Panel Location Garage

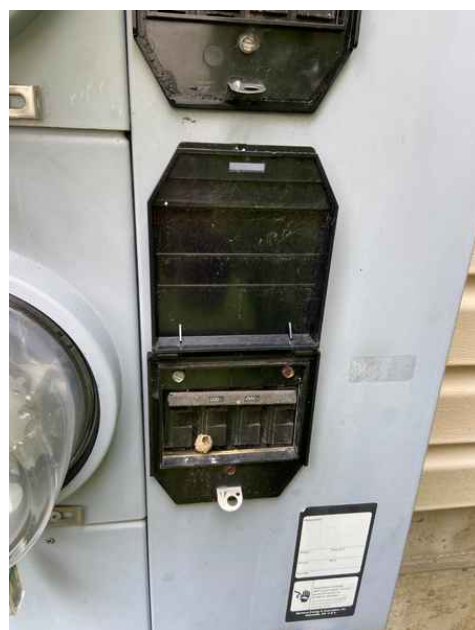
MAIN SHUTOFF MISSING LABEL

Contact a qualified professional.

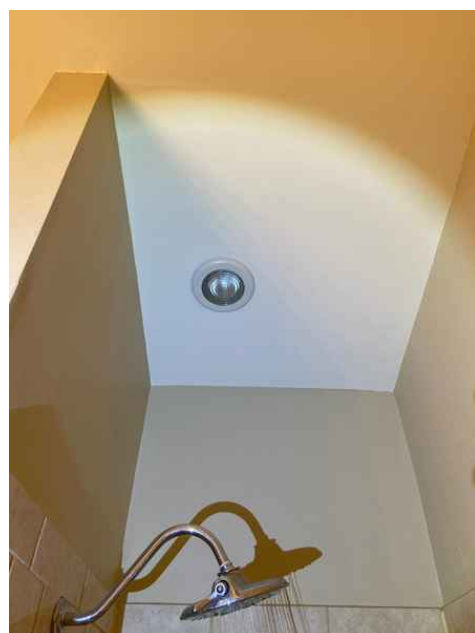
6.4.1 Lighting Fixtures, Switches, Wiring &
Receptacles

The light is not operating properly. A qualified licensed electrician should repair and replace as necessary.

Contact a qualified electrical contractor.

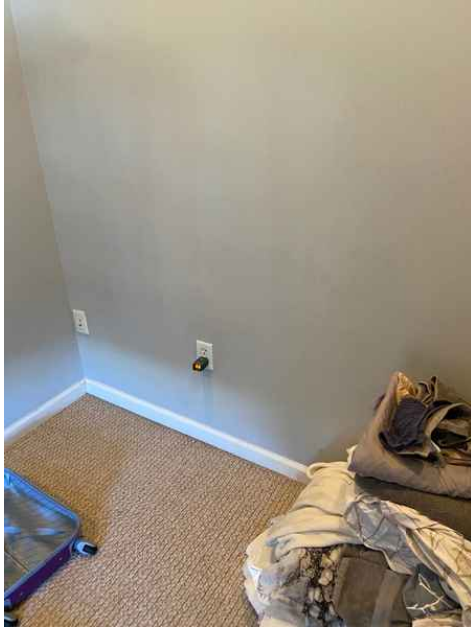
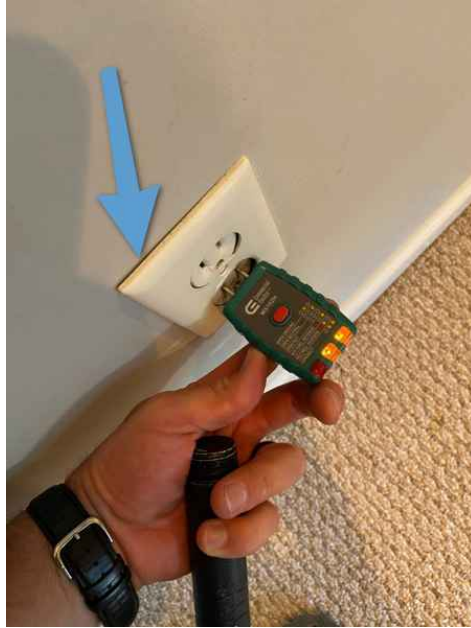
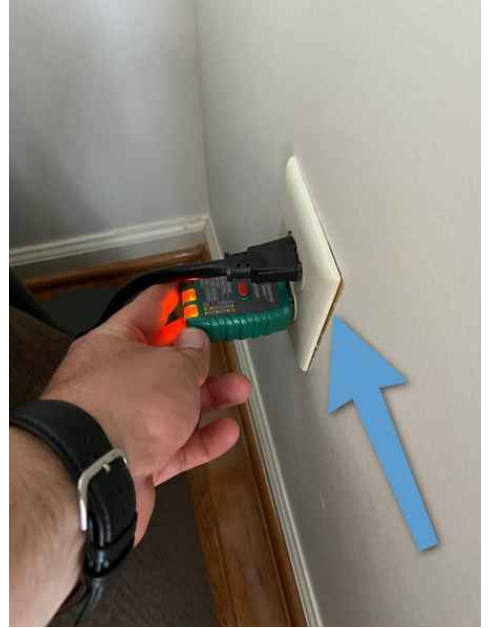
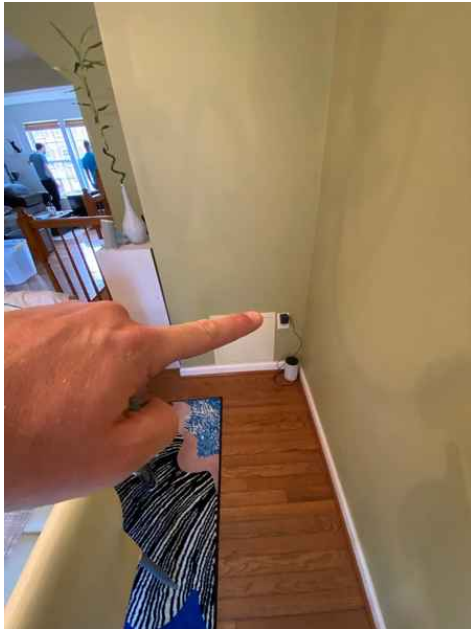
6.4.2 Lighting Fixtures, Switches, Wiring & Receptacles

LOOSE RECEPTACLE

One or more outlets are loose and need to be tightly secured. This is a maintenance issue. A qualified licensed professional should repair and replace as necessary.

Contact a qualified electrical contractor.

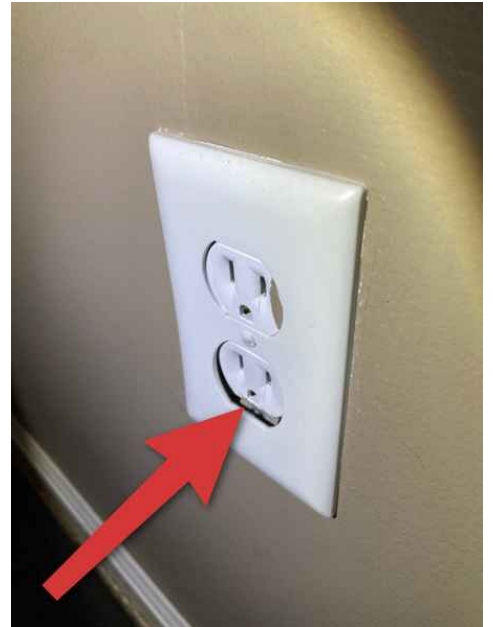
6.4.3 Lighting Fixtures, Switches, Wiring & Receptacles

EXPOSED RECEPTACLE

One receptacle has an opening that leaves the receptacle wiring accessible to small children to stick something in. This is a safety hazard. A qualified licensed professional should repair and replace as necessary.

Contact a qualified electrical contractor.

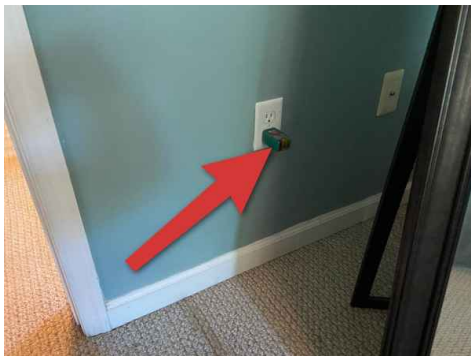
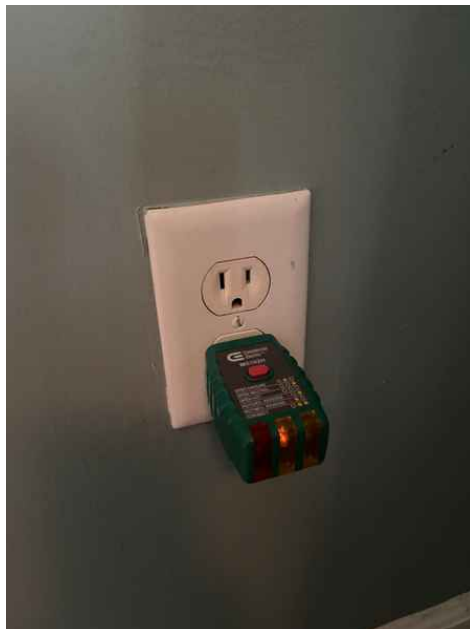
6.4.4 Lighting Fixtures, Switches, Wiring & Receptacles

OPEN GROUND

One of more of the receptacles in the home are indicating an "open ground". To eliminate safety hazards, all receptacles in the home should be wired properly and grounded. A qualified licensed electrician should repair and replace as necessary.

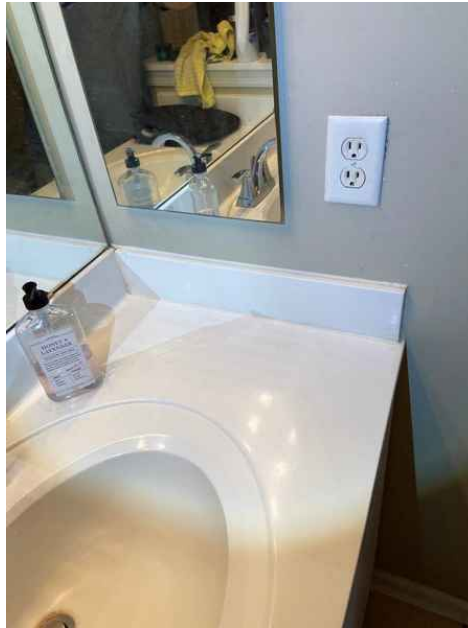
6.5.1 GFCI & AFCI

NO GFCI PROTECTION INSTALLED

No GFCI protection was present. This is a safety hazard. A qualified licensed electrician should upgrade by installing ground fault receptacles in all locations near water supplies.

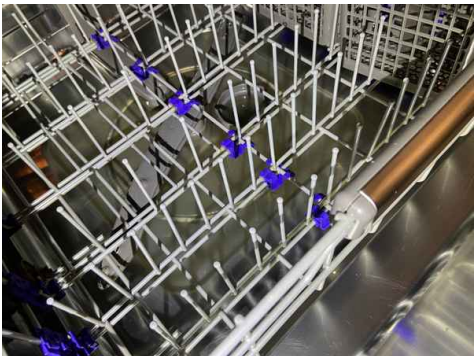
LEAKING

Dishwasher leaks and was not draining when cycle was ran. This can damage the home. A qualified licensed plumber or contractor should evaluate then advise as necessary.

Contact a qualified appliance repair professional.

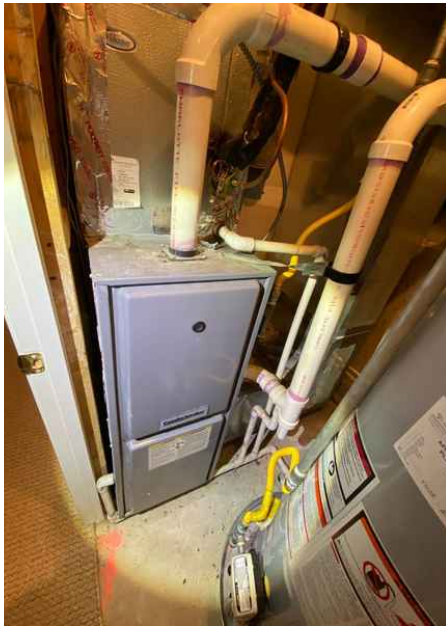
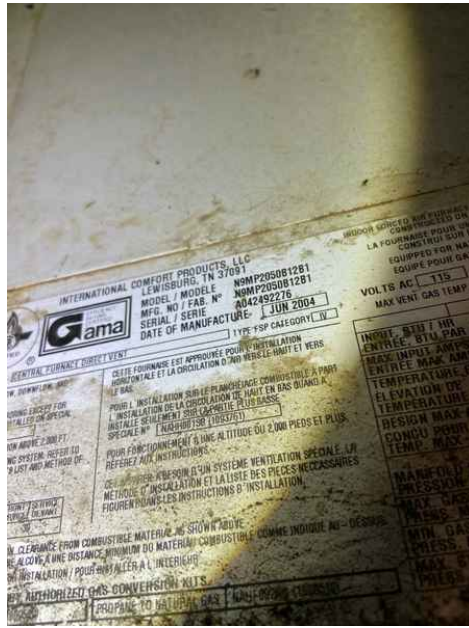
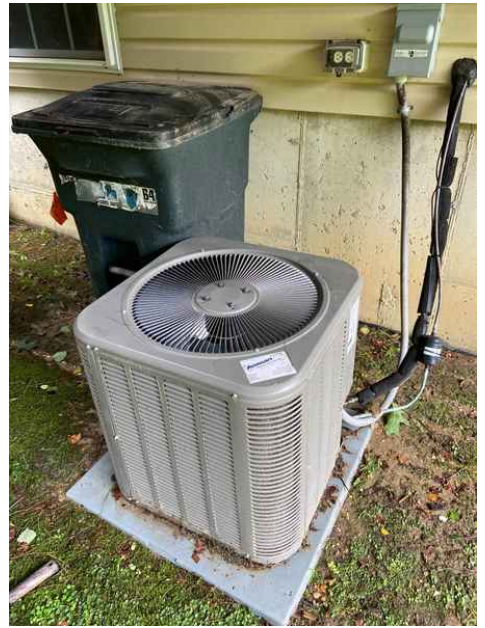
Lennox, ComfortMaker

The a/c and heating system (ComfortMaker) was manufactured in 2004. The serial number is (Please see image) and model number is (Please see image) and has a 15-25 year life expectancy. The condenser unit (Lennox) was manufactured in 2015. The serial number is (Please see image) and model number is (Please see image) and has a life expectancy of 8-15 years.

Furnace should be cleaned and serviced annually. A qualified licensed HVAC professional should clean, service and certify furnace annually

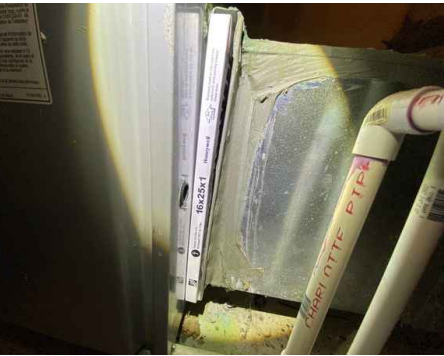
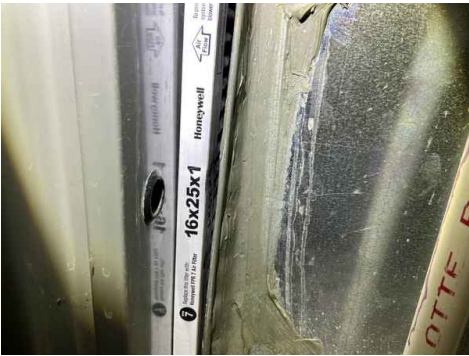
Distribution System: Filter
16x25x1

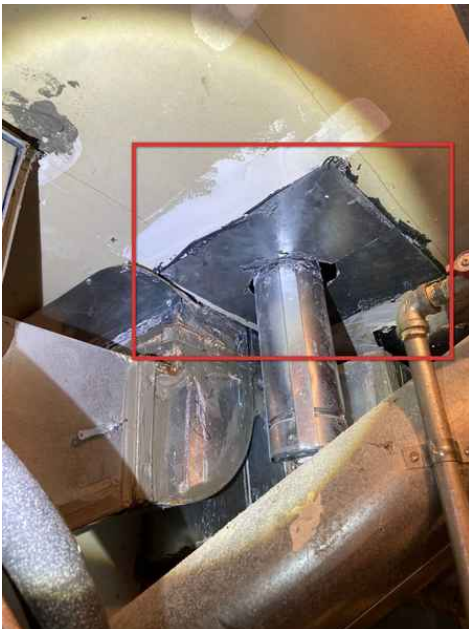
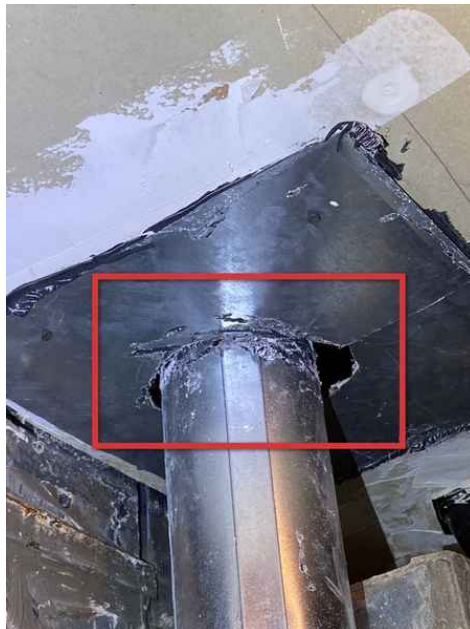
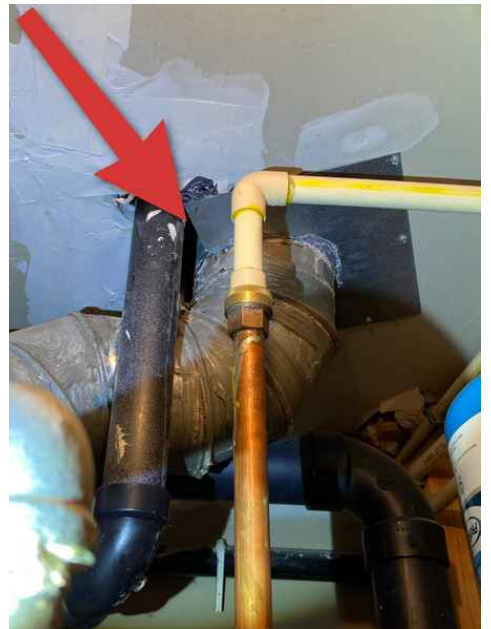
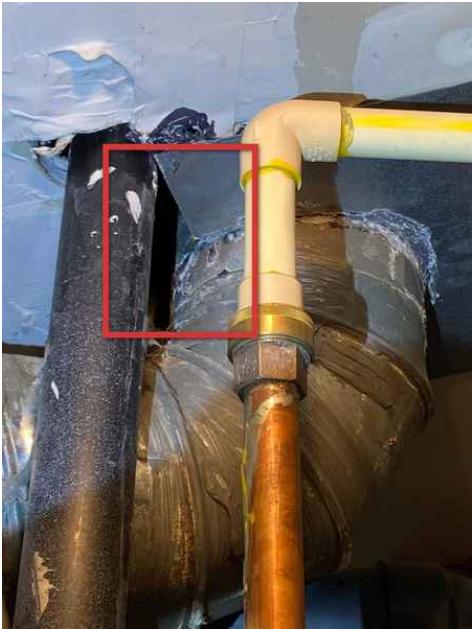
8.4.1 Vents, Flues & Chimneys

AREAS OF THE EXHAUST FLUES NEED TO BE SEALED

Safety Hazard

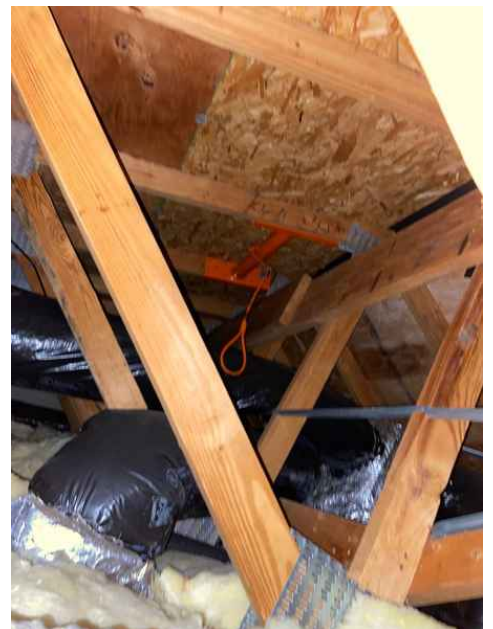
LIMITED ACCESS

Due to lack of floor boards and the design of the roof framing, not all of the roof structure, insulation and framing could be inspected. Therefore, consideration should be given to having further evaluation by a roofing contractor as deemed necessary. Pictures are representative of the readily available and accessible sections of attic at time of inspection.

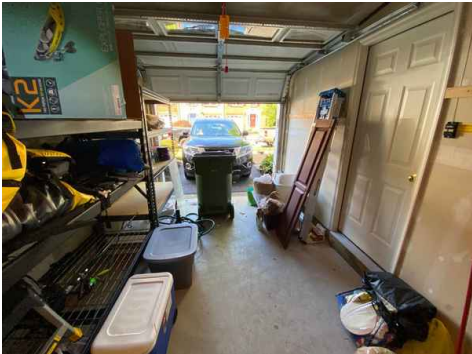
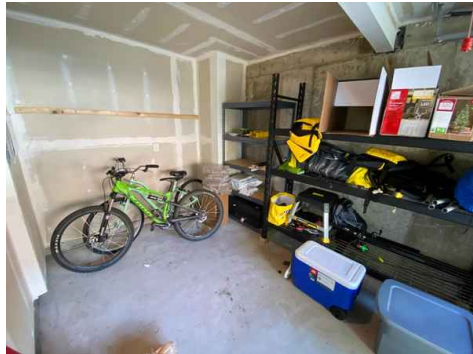
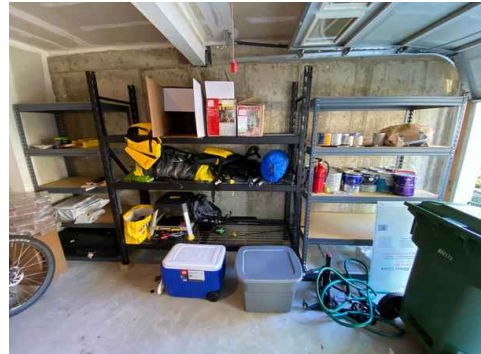
LIMITATIONS AND CONSIDERATIONS

Stored personal items prevented a full, visual examination of all wall cladding and flooring materials, some of the electrical outlets, window operations, and/or heating ductwork located behind or under the stored items. Be sure to re-check any concealed areas during your final walk-through
