TFHI RESIDENTIAL REPORT

1234 Main St. Union NJ 07083

Buyer Name
07/21/2020 9:00AM

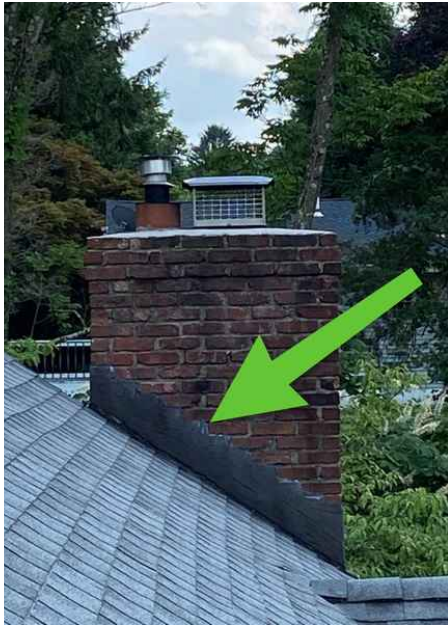
Skylights, Chimneys & Other Roof Penetrations: Maintenance Caulking around Chimney Flashing

Please be sure as a maintenance item to keep the flashing caulked/silicone sealed to prevent moisture intrusion behind the flashing.

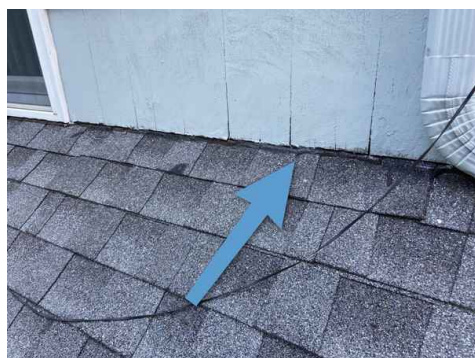
Exposed nail heads were observed to not be sealed. Any exposed nail heads should be sealed with tar to prevent moisture intrusion. A qualified licensed roofer should repair and replace as necessary.

Contact a qualified professional.

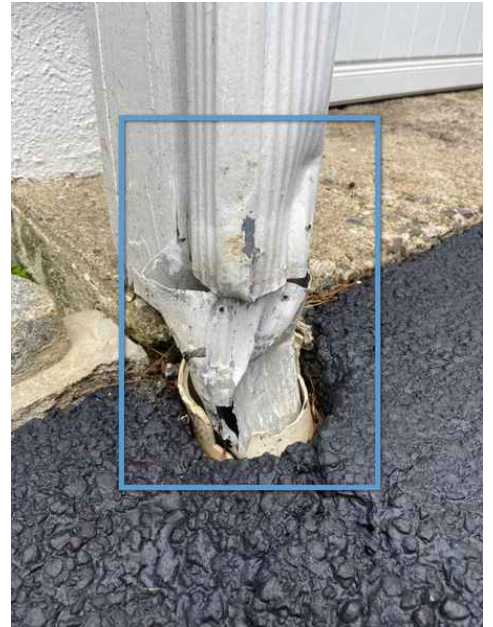
2.2.1 Roof Drainage Systems

DOWNSPOUTS DAMAGED

Downspouts were damaged. This can result in excessive moisture in the soil at the foundation, which can lead to foundation/structural movement. A qualified licensed contractor should repair and replace as necessary.

Repair and Replace

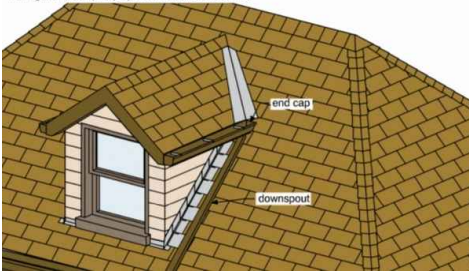
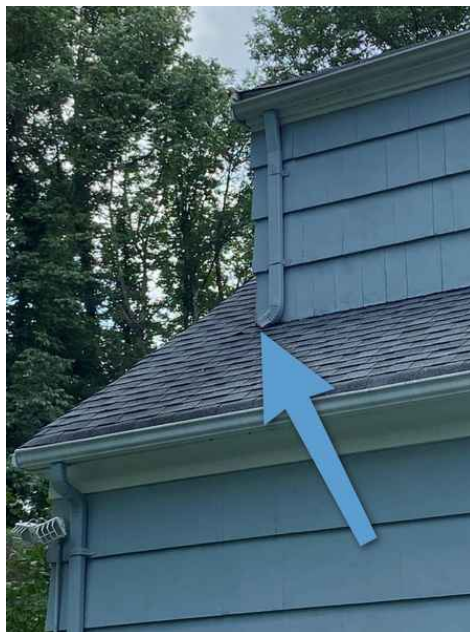
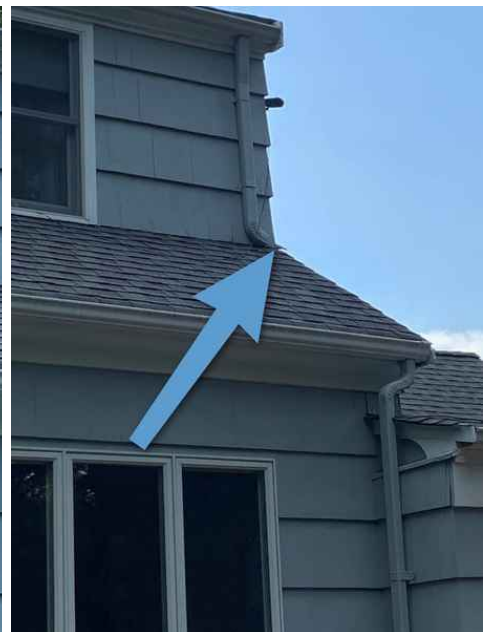
2.2.2 Roof Drainage Systems

EXTEND DOWNSPOUTS TO LOWER GUTTERS

I recommend continuing the downspout into the lower gutter. Always try to alleviate discharge onto lower roof when possible. Without these extensions, excess water can damage the roofing materials, causing penetration of water, and damage to the home. A qualified licensed professional should install downspouts to lower gutters.

Downspout running across roof
installing a downspout (from the secondary roof to the main gutter below) helps prevent localized roof wear

Repair and Replace

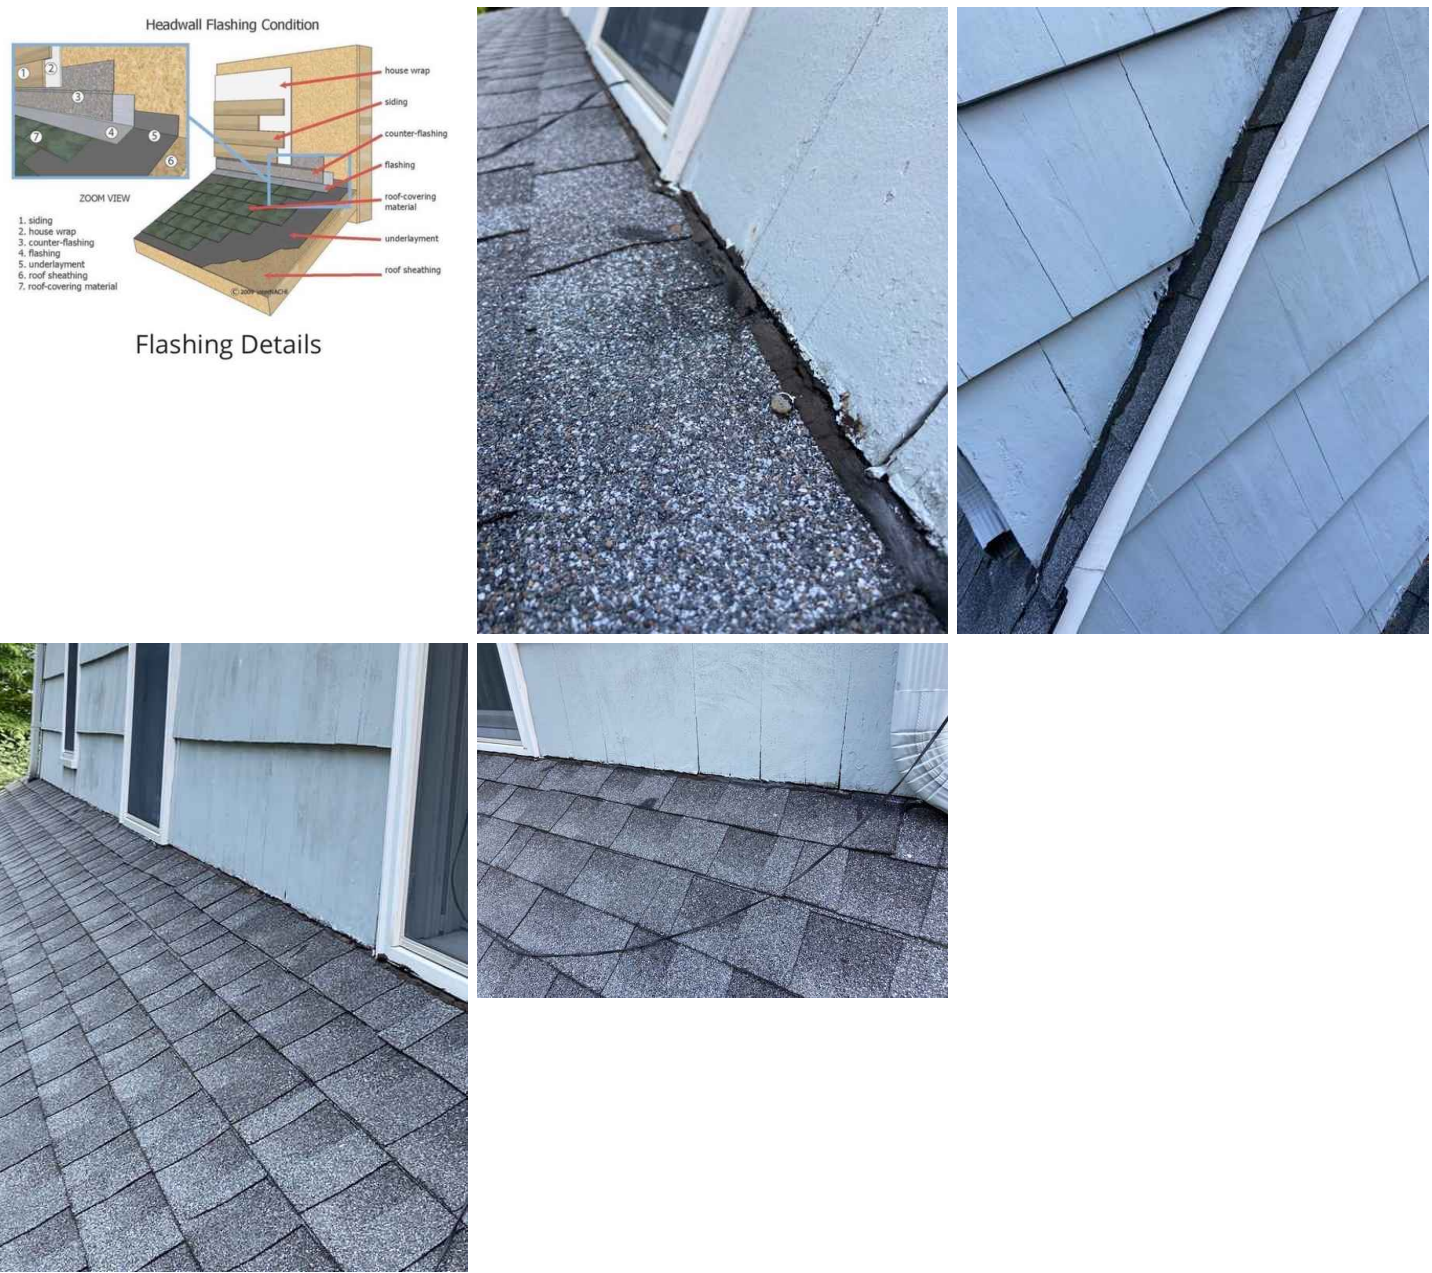
2.3.1 Flashings

MISSING

I observed areas where the cap flashing was missing and/or damaged. These areas of missing flashing are prone to water penetration and have contributed to the deterioration of the fascia board. Flashing is installed to provide protection against roof leaks and to divert water away from certain areas. A licensed qualified roofer should repair or replace as necessary.

Contact a qualified roofing professional.

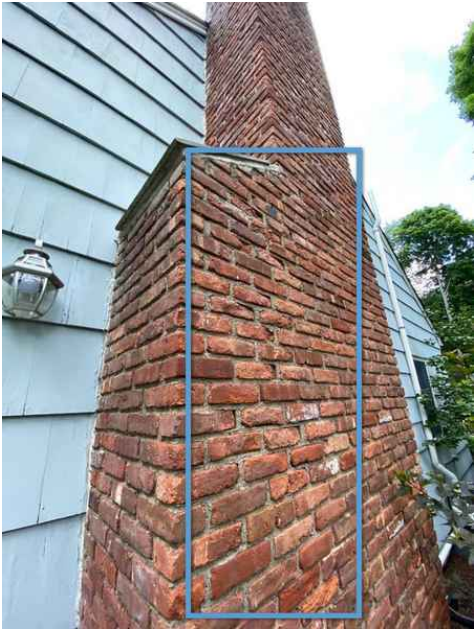
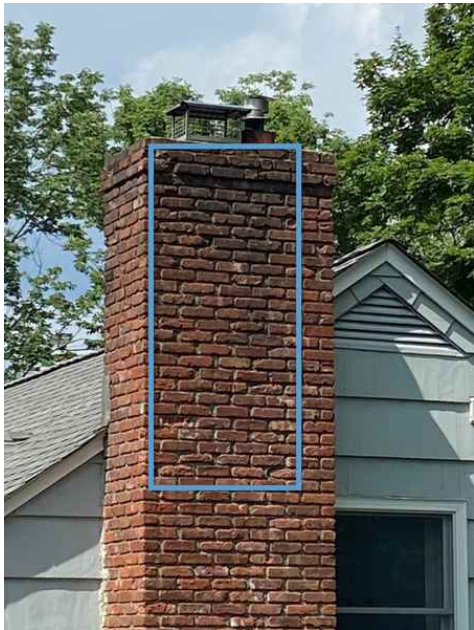
2.4.1 Skylights, Chimneys & Other Roof Penetrations

CHIMNEY MASONRY DAMAGED

One or more bricks of the masonry chimney are damaged. This can allow moisture penetration into the structure. A qualified licensed contractor should repair and replace as necessary.

Contact a qualified professional.

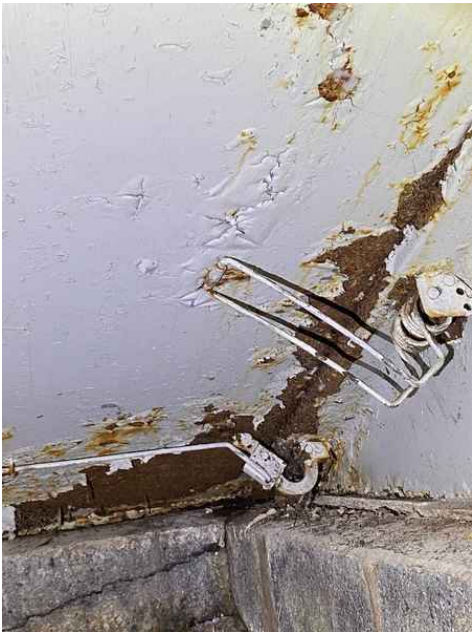
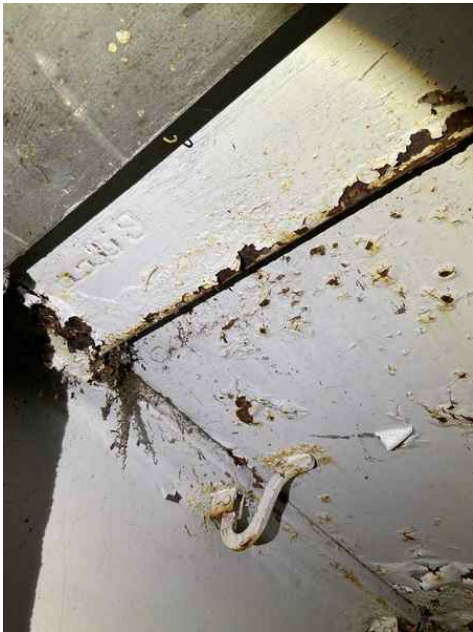
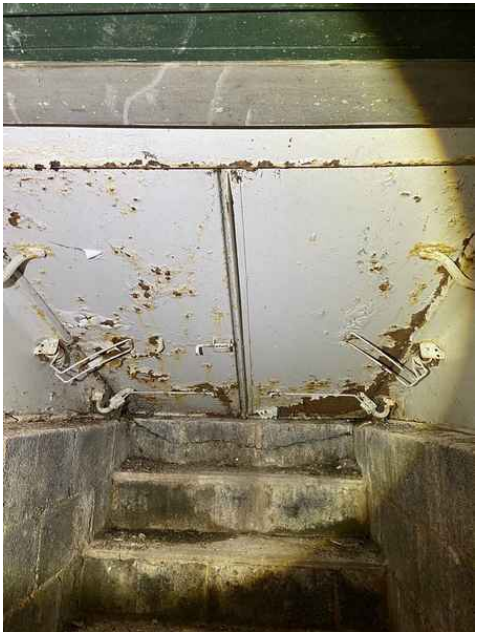
BASEMENT WALKOUT DOOR CHIPPING PAINT/RUSTING

The basement walkout hatch door is showing signs of damage and areas that are not sealed with maintenance painting. A qualified licensed professional should repair and replace by scraping away all old peeling paint, and repainting the surface of the door.

Contact a qualified professional.

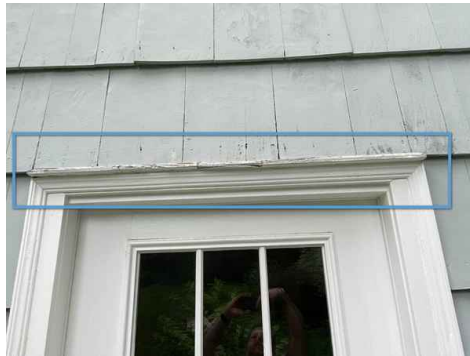
3.2.2 Exterior Doors

DOOR IMPROPERLY FLASHED

The door has improper flashing at the top. This is a maintenance issue. A qualified licensed contractor should repair and replace as needed.

Contact a qualified professional.

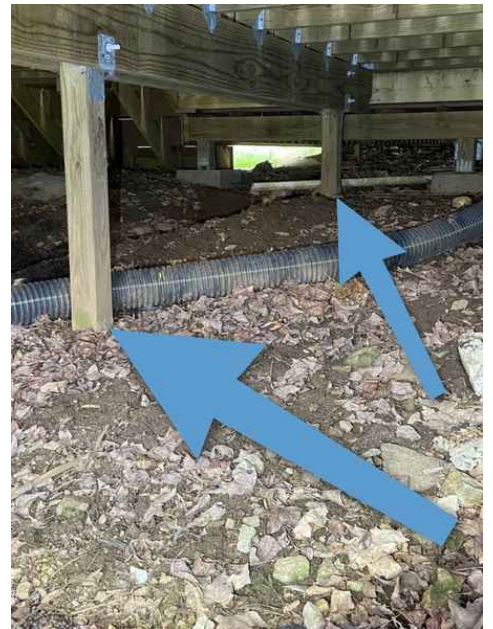
3.6.1 Decks, Balconies, Stoops, Porches, Railings & Steps

The bottom of the deck support is in contact with the soil of the exterior. This wood soil contact will facilitate and accelerate damage and rot to the wood decking as it comes in contact with the soil and moisture. A qualified licensed professional should install the proper landing area material and/or end caps on the wood to help keep moisture from damaging the end grain of the wood.

Contact a qualified professional.

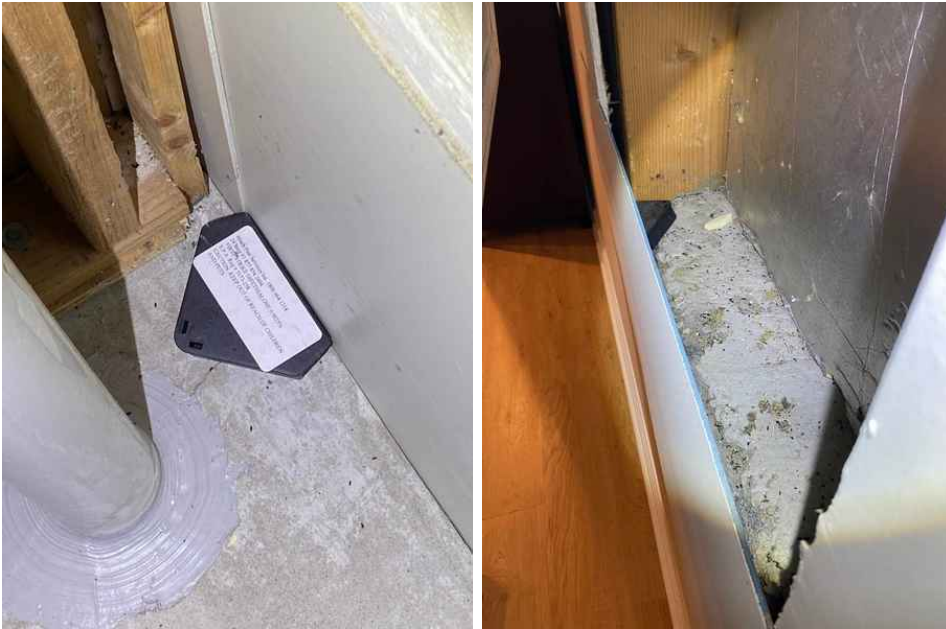
Pest traps and droppings were observed in the home. A qualified licensed pest control company should evaluate, and advise as necessary.

Contact a qualified pest control specialist.

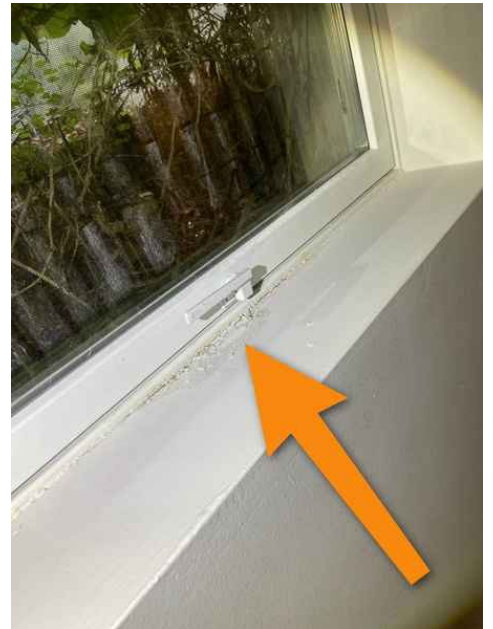
4.5.1 Windows (representative number)

MOISTURE INTRUSION AT WINDOW

Moisture intrusion was observed at the basement window. This is a maintenance issue. A qualified licensed professional should evaluate and advise on the cause.

Contact a qualified professional.

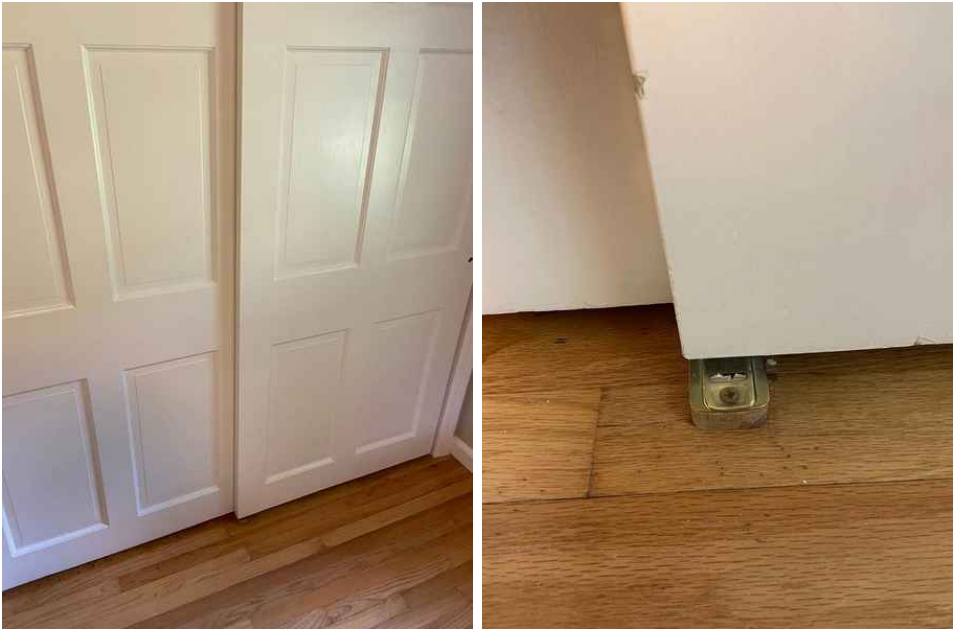
4.6.1 Doors (representative number)

SLIDING DOOR TRACK DAMAGED

The closet sliding doors have a damaged track on the bottom. This helps guide the door and prevents them from swinging inward and outward. This is a maintenance issue. A qualified licensed professional should install the proper track for the sliding doors to function properly.

Contact a qualified professional.

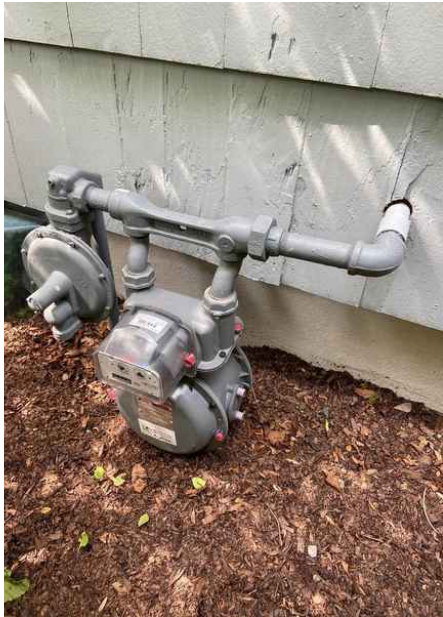
Gas Meter, Exterior

The main fuel shut off is at gas meter.

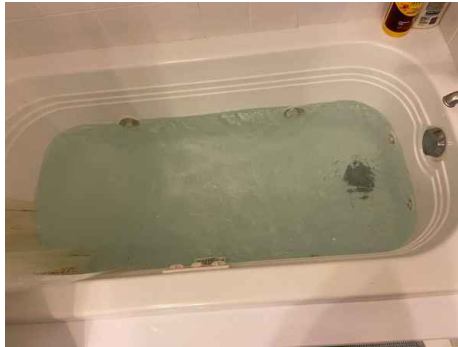
**Hydromassage Bathtub: Tub
Filled and Turned On**

I filled the tub and turned on the jets.

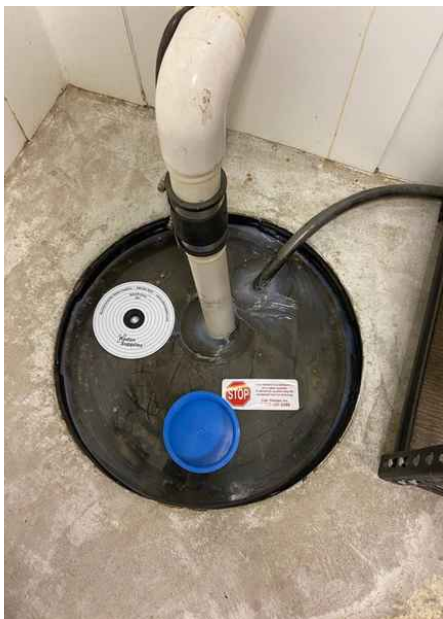
**Sump Pump: Location
Basement****Sump Pump: Operational**

The sump pump was operational at the time of inspection.

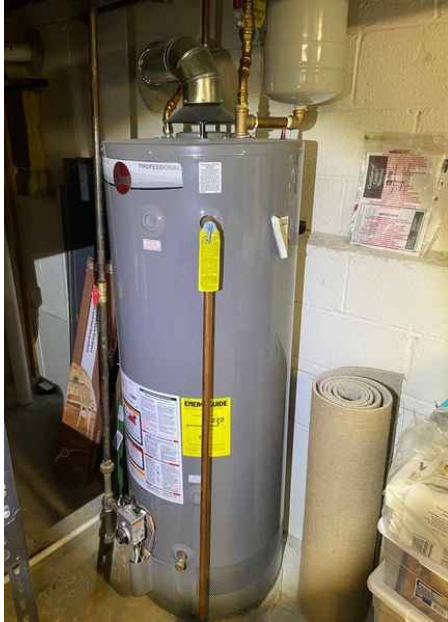
Hot Water Systems, Controls, Flues & Vents: Water Heater System

At this time, the water heater appears to be operating as expected. The Water heater Serial Number is (Please see image) and model number is (Please see image). The water heater was manufactured in 2015 and has a life expectancy of 7-12 years.

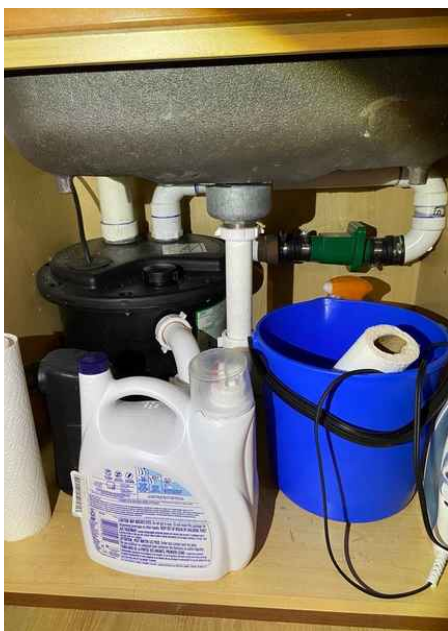
Sewage Ejector Pump: Location

The sewage ejector pump was located in the basement under the laundry sink. It is sealed due to sewer gases, and operates to drain the sewage from the basement bathroom.

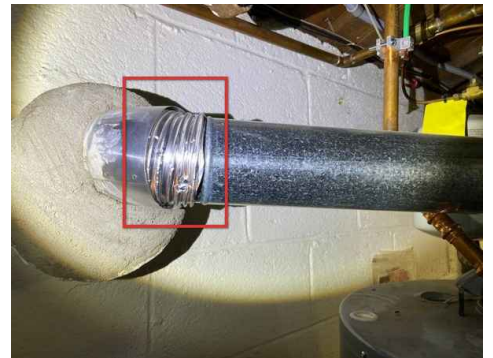
5.3.1 Hot Water Systems, Controls, Flues & Vents

VENT IMPROPERLY INSTALLED

Safety Hazard

Contact a qualified professional.

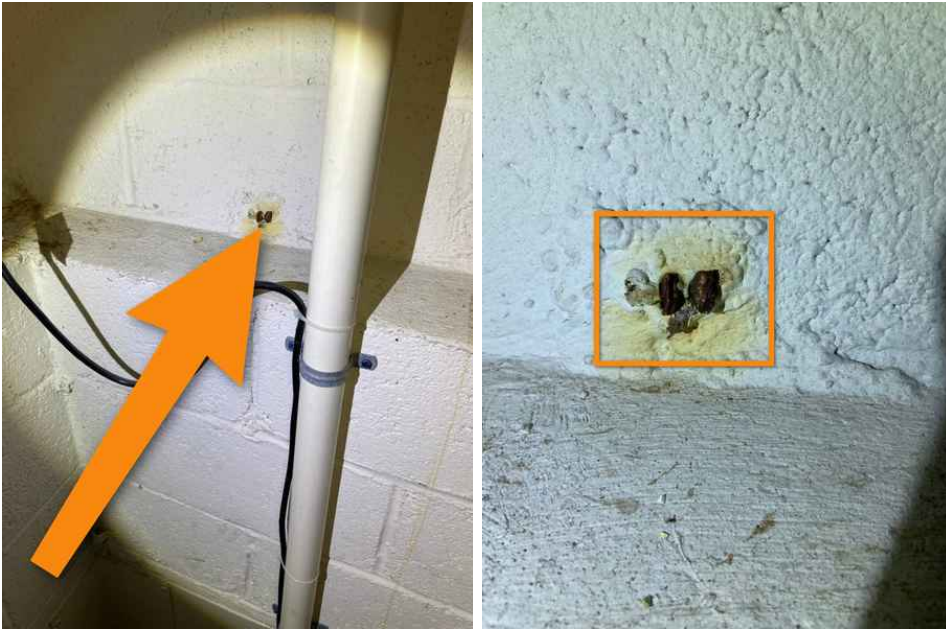
5.4.1 Fuel Storage & Distribution Systems

UNDERGROUND OIL TANK LINES PRESENT IN BASEMENT

Contact a qualified professional.

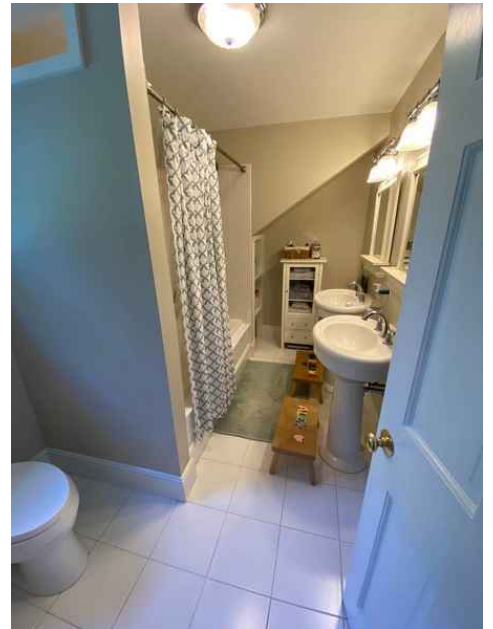
5.8.1 Hydromassage Bathtub

MISSING ACCESS AT HYDROMASSAGE TUB

Safety Hazard

I observed missing access to the electrical equipment for the hydromassage bathtub.

Contact a qualified electrical contractor.

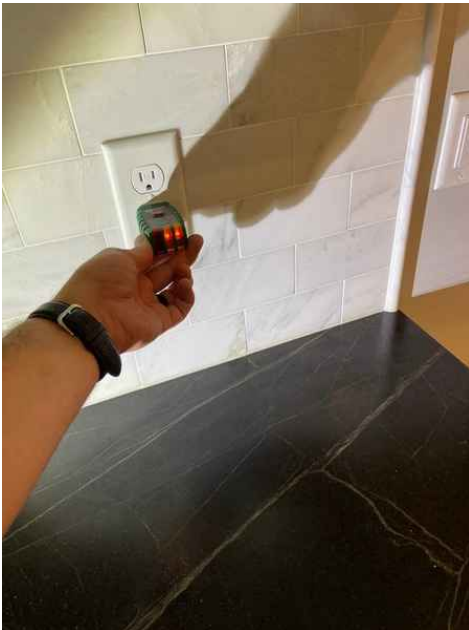
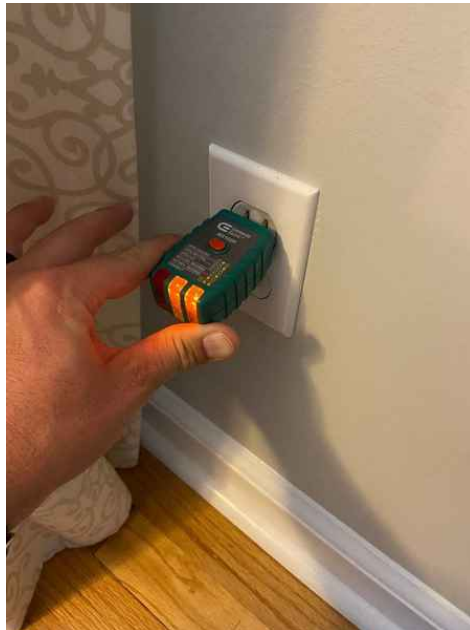
6.4.2 Lighting Fixtures, Switches, Wiring & Receptacles

LOOSE RECEPTACLE

Contact a qualified electrical contractor.

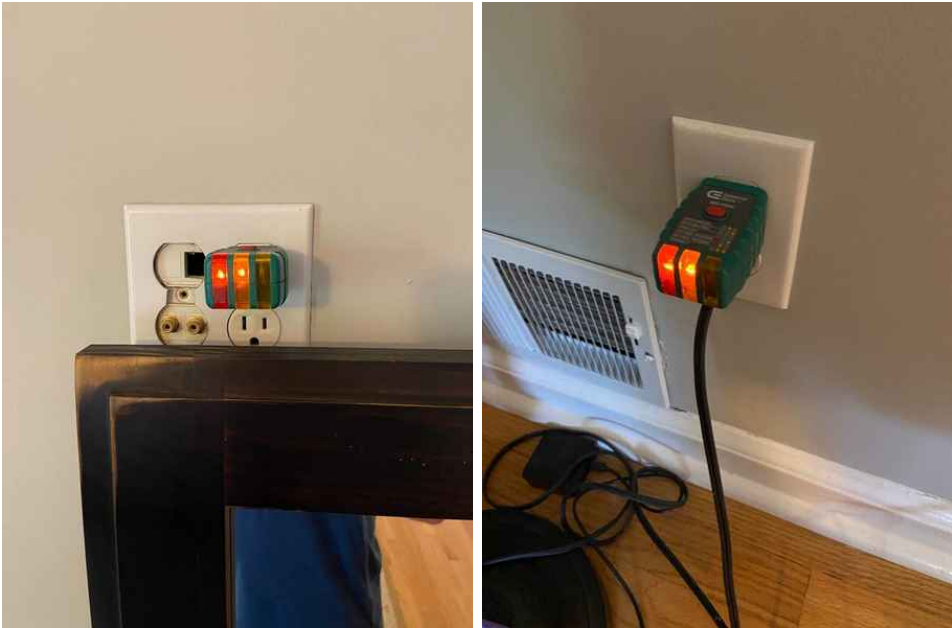
6.4.3 Lighting Fixtures, Switches, Wiring & Receptacles

REVERSE POLARITY

One or more receptacles have been wired with reverse polarity. This can create a shock hazard. A qualified licensed electrician should repair and replace as necessary.

Recommendation
Contact a qualified electrical contractor.

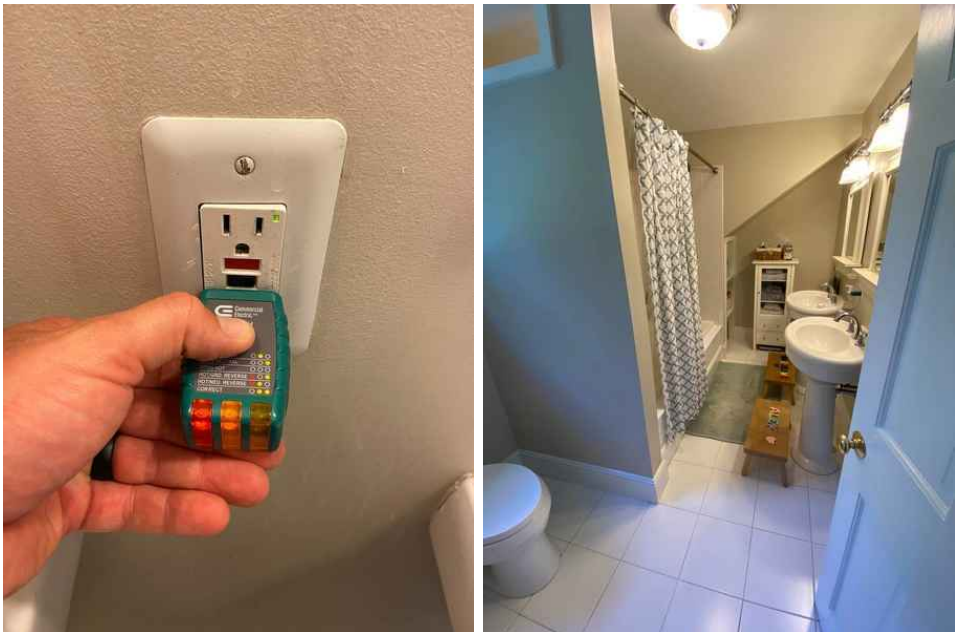
6.5.1 GFCI & AFCI

GFCI NOT TESTING AS FUNCTIONAL

I observed a defect at the GFCI outlet. It was not testing properly, nor functioning. This is a safety hazard. A qualified licensed electrician should evaluate, repair and replace as necessary.

Recommendation
Contact a qualified electrical contractor.

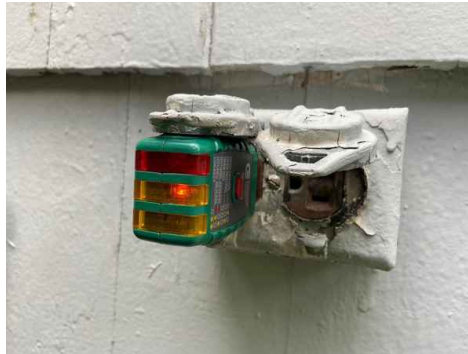
6.5.2 GFCI & AFCI

NO GFCI PROTECTION INSTALLED

the GFCI circuitry within the outlet checks constantly for a difference between the current in the black and white wires. If there is a difference of at least 5 milliamperes, there is a current leak and the GFCI shuts off the outlet and all outlets downstream.

note:
if the GFCI is in the panel, the entire circuit will be shut down

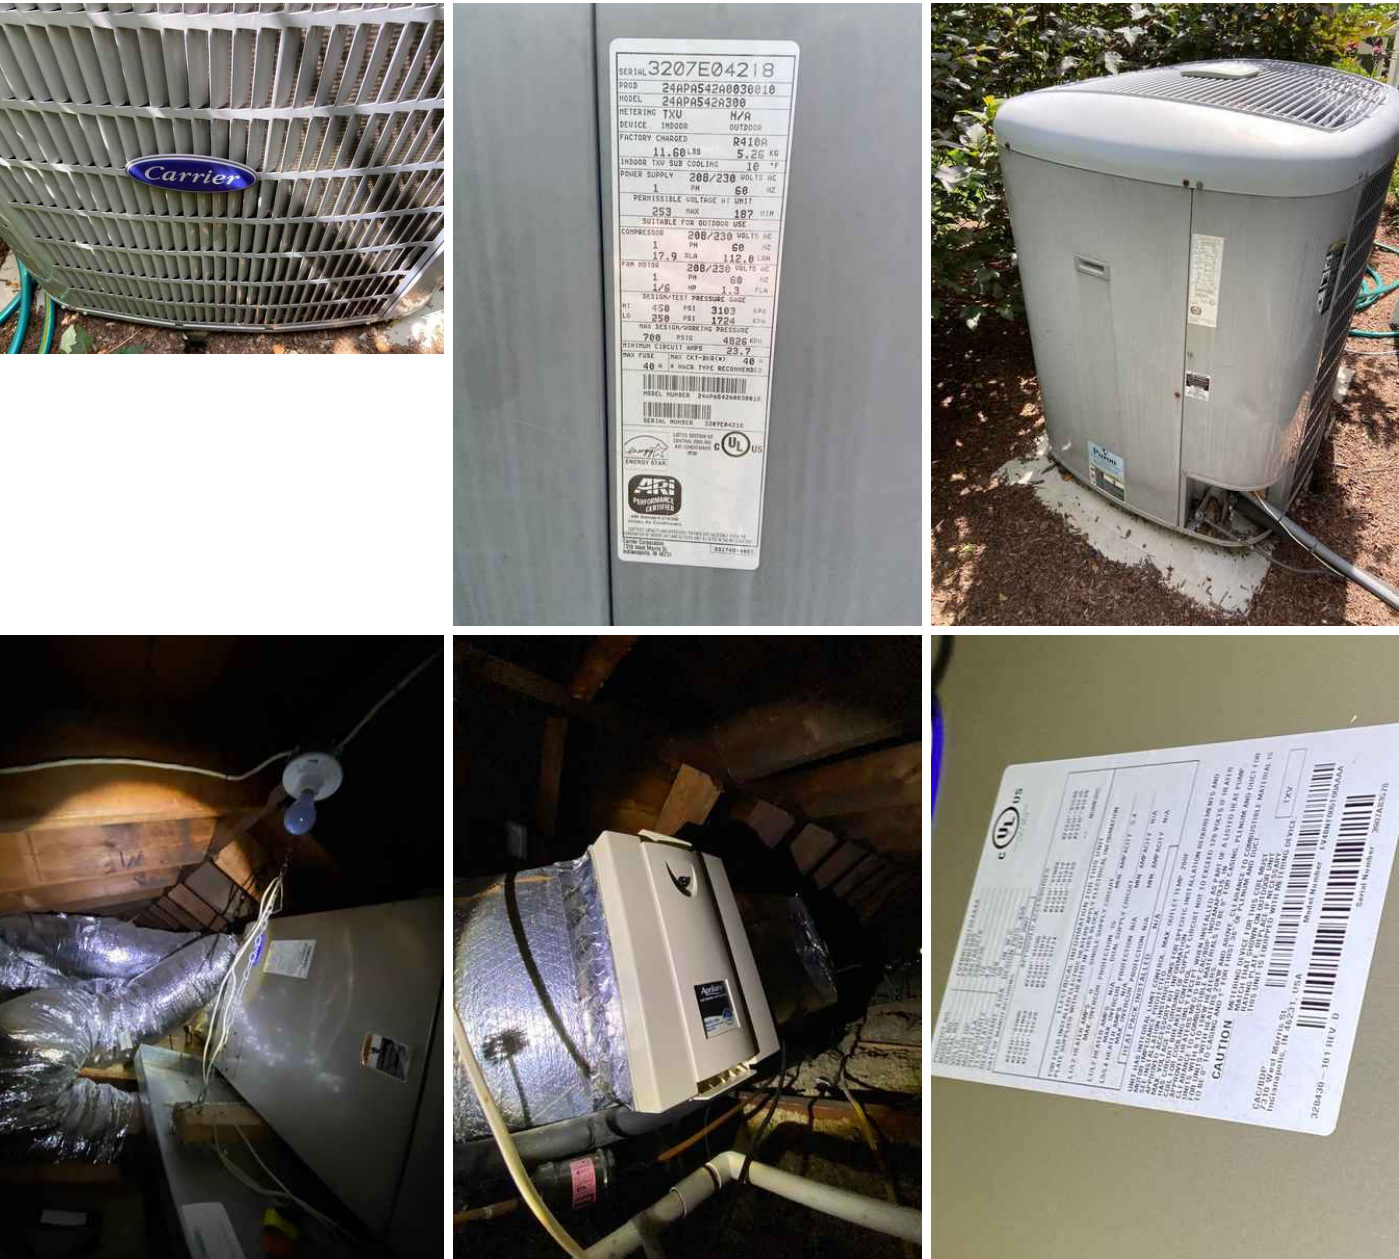
Equipment: Cooling System
Carrier

The a/c system was manufactured in 2007. The serial number is (Please see image) and model number is (Please see image) and has a 15-25 year life expectancy. The condenser unit was manufactured in 2007. The serial number is (Please see image) and model number is (Please see image) and has a life expectancy of 8-15 years.

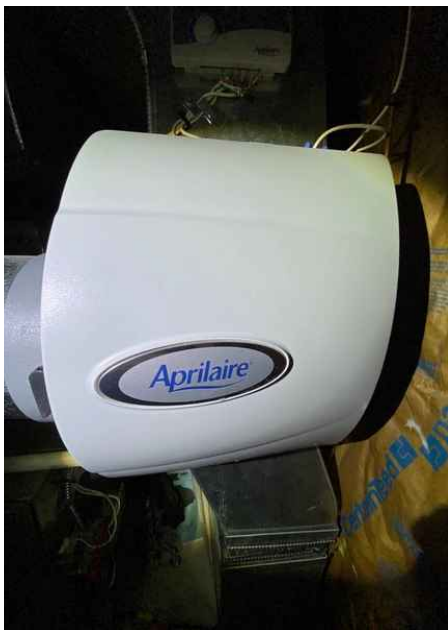
Basement

Please be sure to follow the manuals guidelines on monitoring, maintaining and cleaning the filter inside the humidifier. Winter is "open" and summer is "closed".

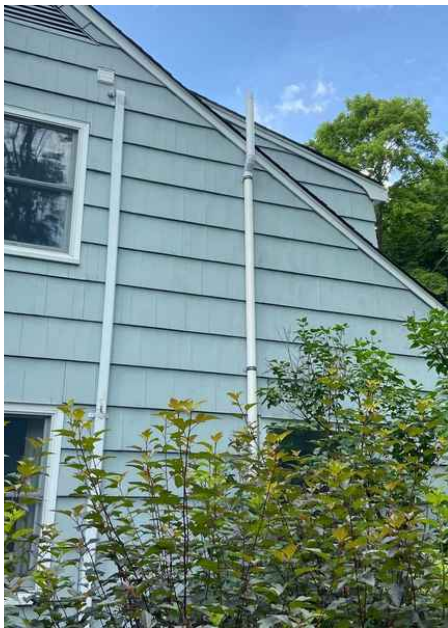
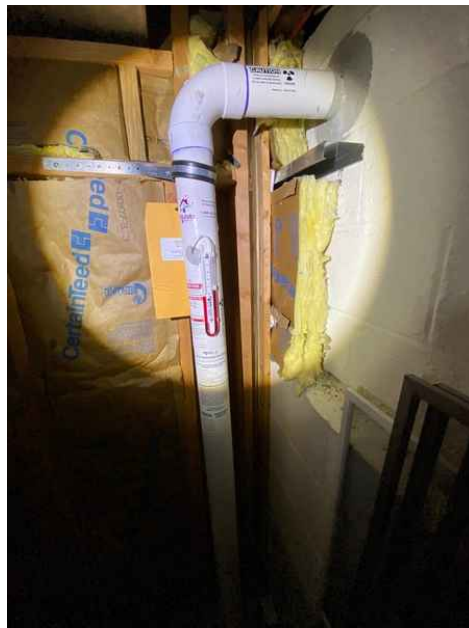
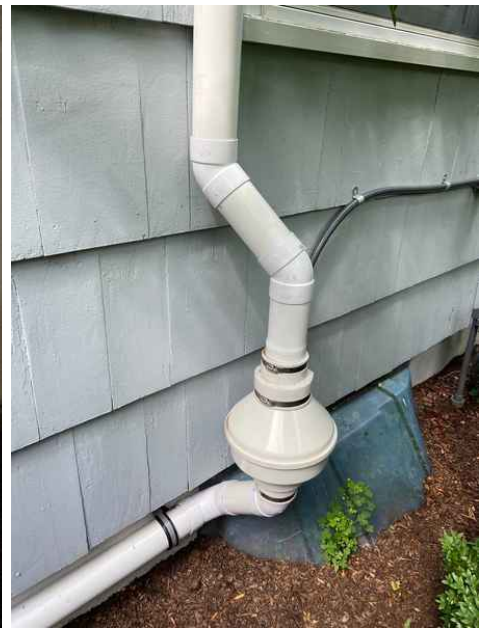
Radon Mitigation System: Operational

The radon system was observed to be operational at this time. The tube indicates if the fan is actually operating, by sucking the fluid up making a backwards J shape. If you observe the fluid to become liquid, this means the fan is not operating. I recommend annually contacting the company noted on the install for yearly maintenance and service. Frequent radon level testing to ensure the system is functioning is also recommended annually.

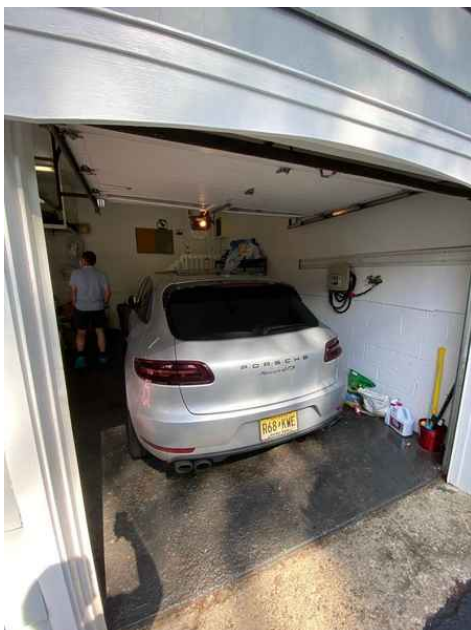
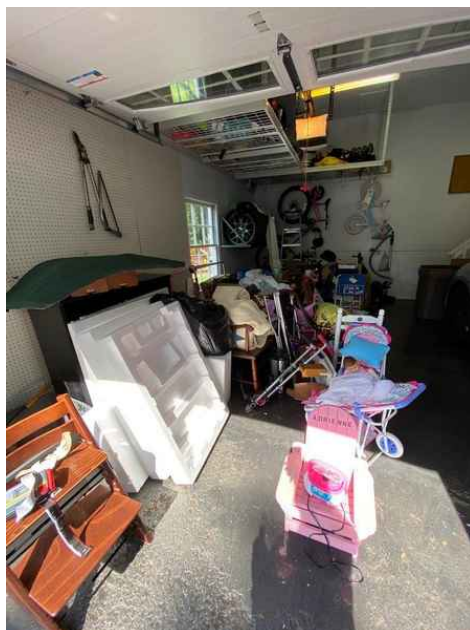
Stored personal items prevented a full, visual examination of all wall cladding and flooring materials, some of the electrical outlets, window operations, and/or heating ductwork located behind or under the stored items. Be sure to re-check any concealed areas during your final walk-through

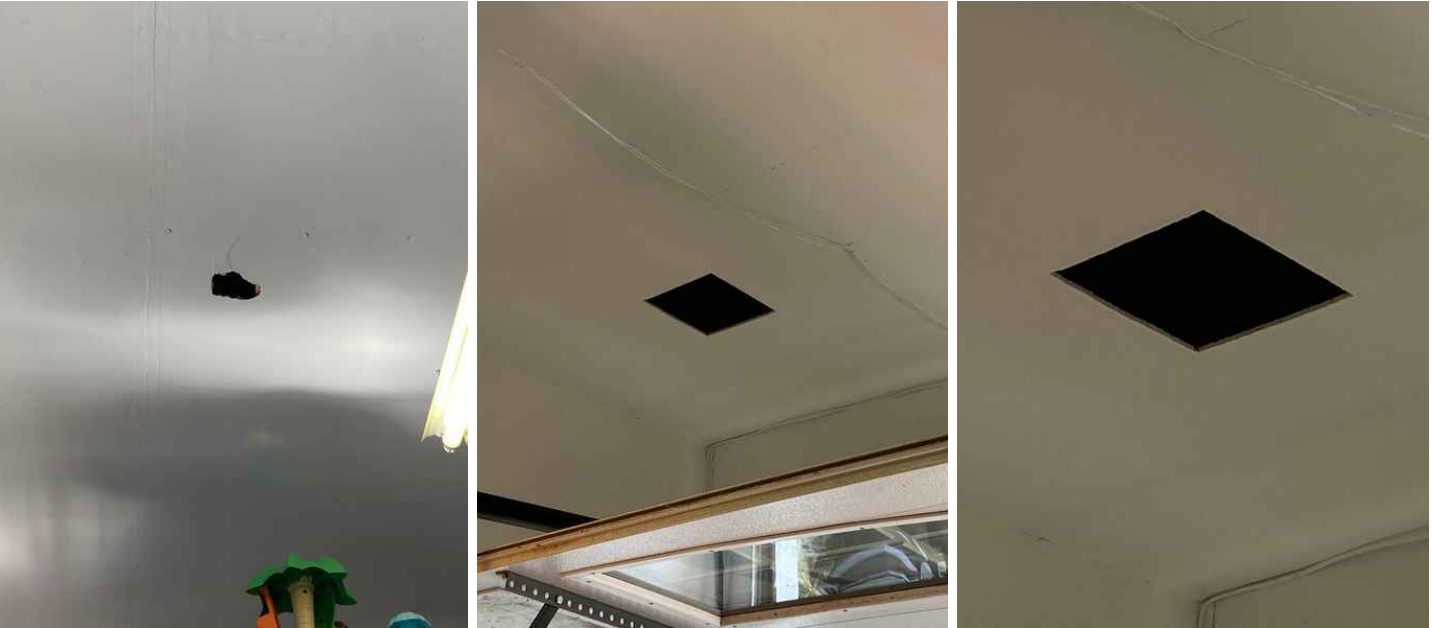
OPENING IN DRYWALL DEFECT

I observed an opening in the drywall or gypsum board of the garage. Defect.

There must not be any openings in the drywall of the garage. All openings must be patched and repaired properly.

A qualified licensed professional should repair and replace as necessary.

Contact a qualified general contractor.

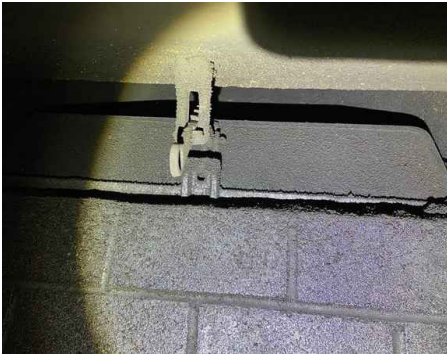
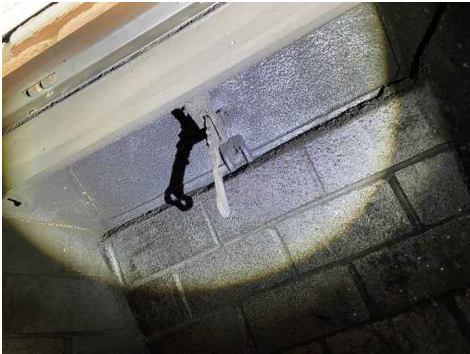
Damper Doors: Operational
The damper door closes and opens.
