KEY INSPECTION SERVICES, LLC
#1 Home Education and Inspection Company

1234 Main St.
Renton WA 98058

10/04/2018 9:00AM

Approximate age of building New Construction	In Attendance Client, Client's Agent	Occupancy Vacant
Temperature (approximate) 70 Fahrenheit (F)	Type of Building Single Family	Weather Conditions Cloudy

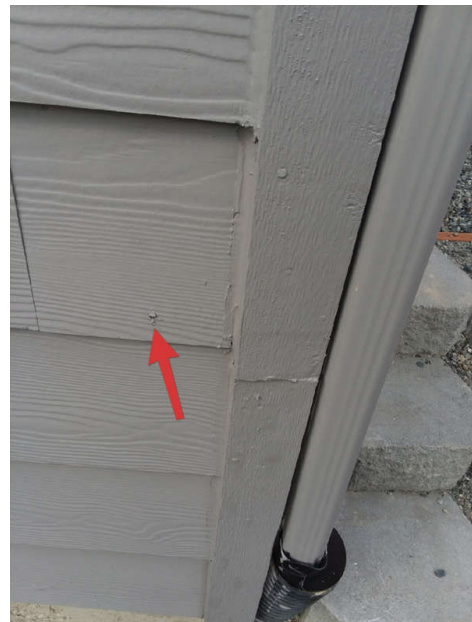
2.1.1 Siding, Flashing & Trim

NAIL HEADS

Under driven bails observed in siding on rear of home. I recommend builder evaluate and repair as needed.

Contact a qualified siding specialist.

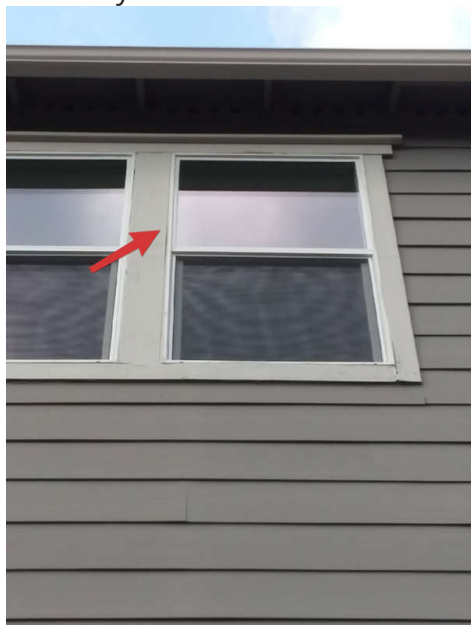
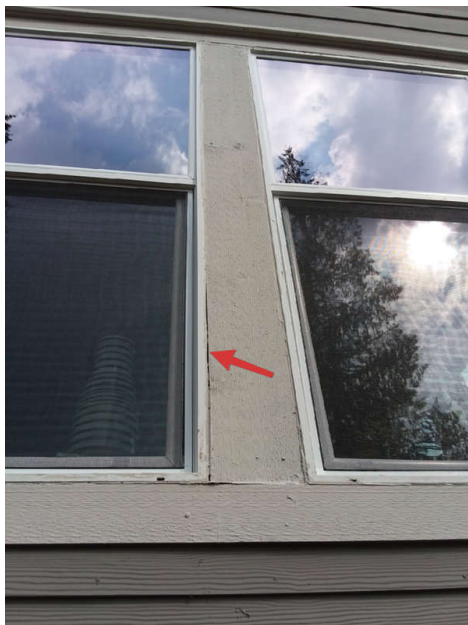
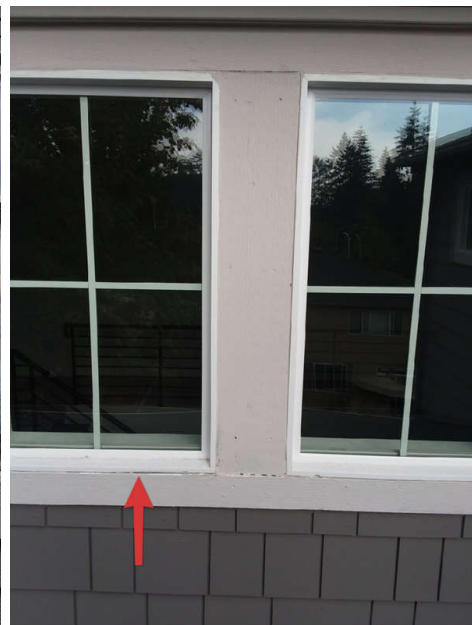
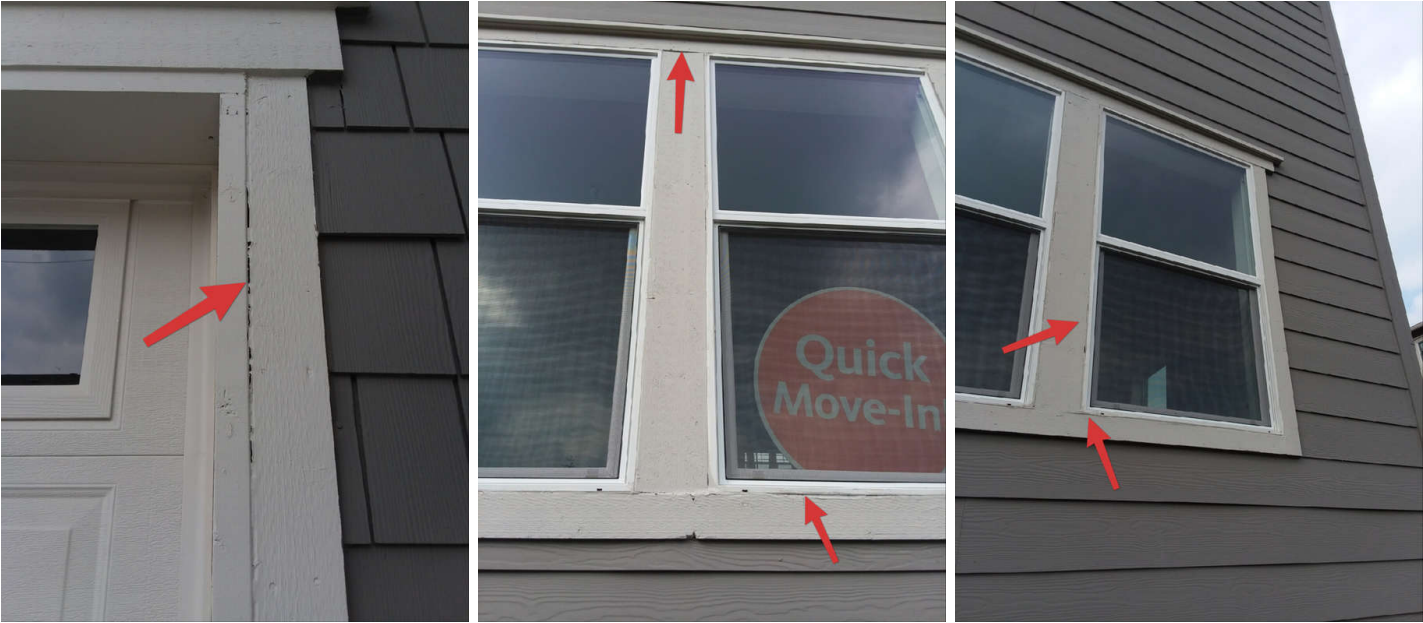
2.1.2 Siding, Flashing & Trim

CRACKED CAULKING

Numerous areas of cracked caulking around windows and penetrations through siding. I Recommend caulking to help prevent moisture intrusion. I recommend builder evaluate all caulk lines and repair/replace as necessary.

Contact your builder.

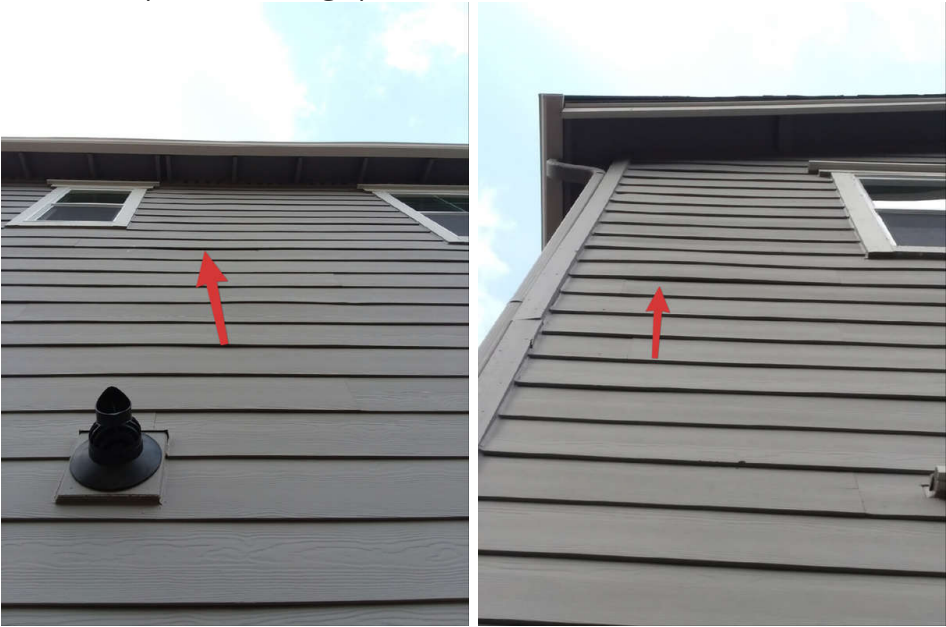
2.1.3 Siding, Flashing & Trim

TIGHT SIDING

Cement siding installed very tight throughout the home. The installation does not appear to conform with present day cement siding installation standards. This can become problematic should the siding expanding during freezing temperatures. We recommend referring to builder or contractor warranty to ensure the siding installation will comply with manufacturer's specifications.

Recommendation
Contact a qualified siding specialist.

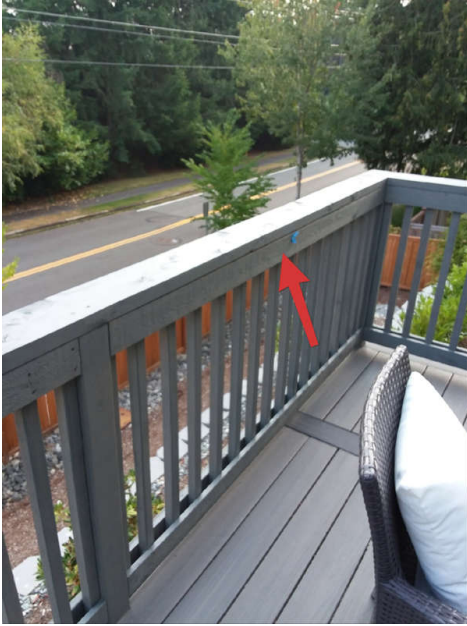
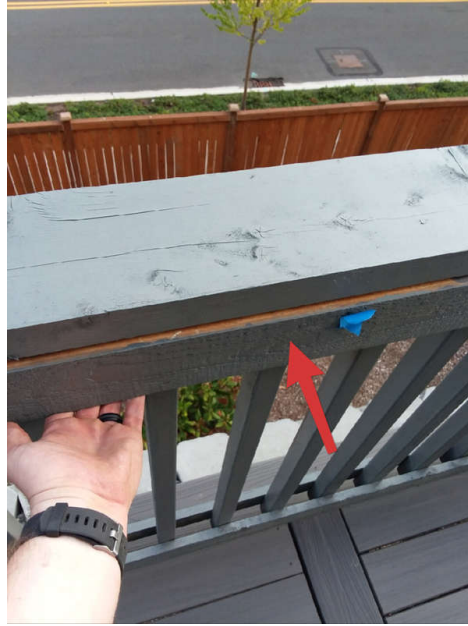
2.4.1 Decks, Balconies, Porches & Steps

LOOSE HAND RAIL

The hand rail on the rear deck appears to be loose, I recommend repair for increased safety.

Recommendation
Contact your builder.

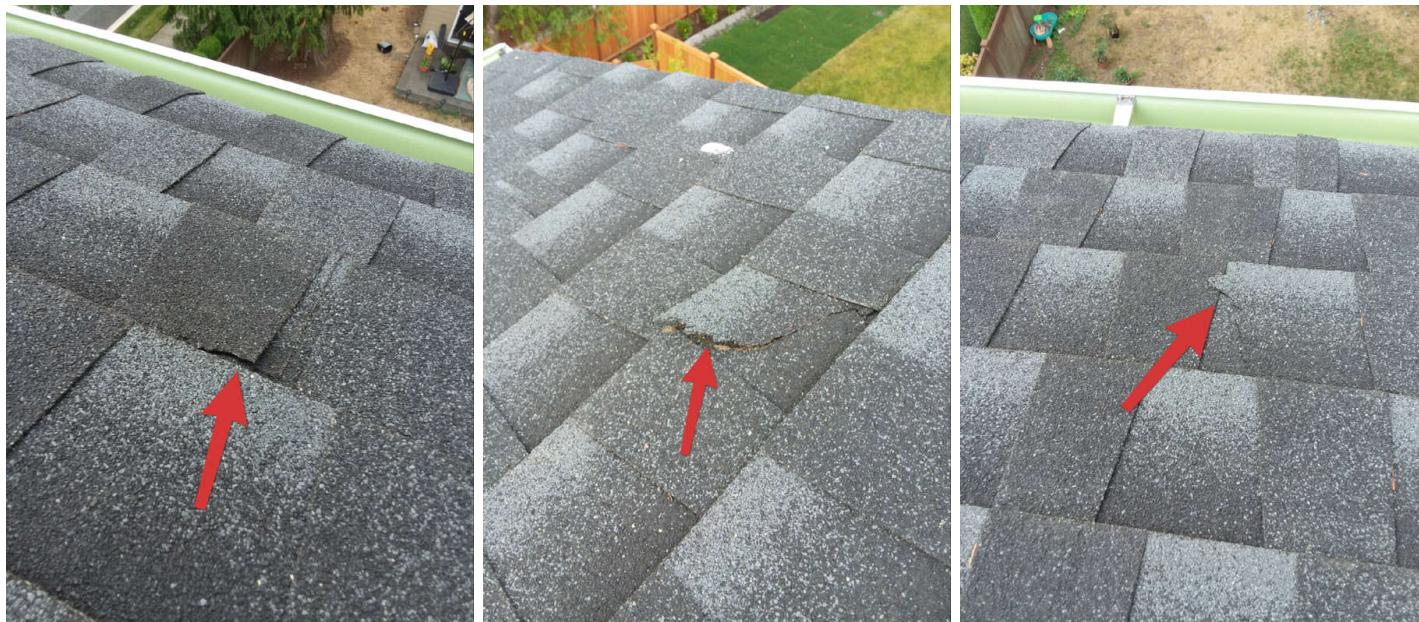
3.1.1 Coverings

DAMAGED SHINGLES

There appears to be multiple areas of damage to the roof covering. I recommend a qualified roofer to repair/replace to prevent any potential leaks. No obvious elevated moisture at the time of inspection.

Contact a qualified roofing professional.

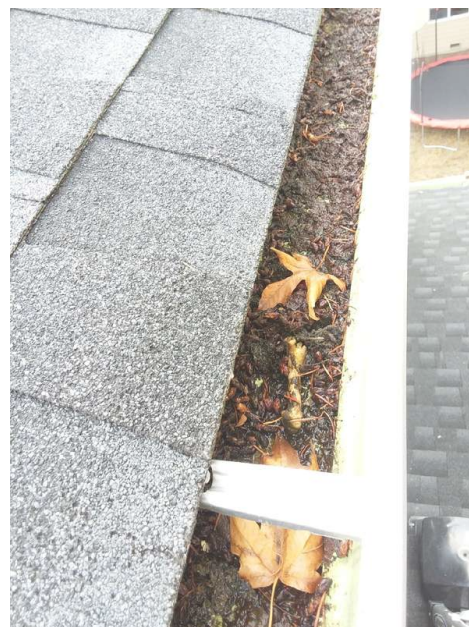
3.2.1 Roof Drainage Systems

DEBRIS

Debris has accumulated in the gutters. Recommend cleaning to facilitate water flow.

Contact a handyman or DIY project

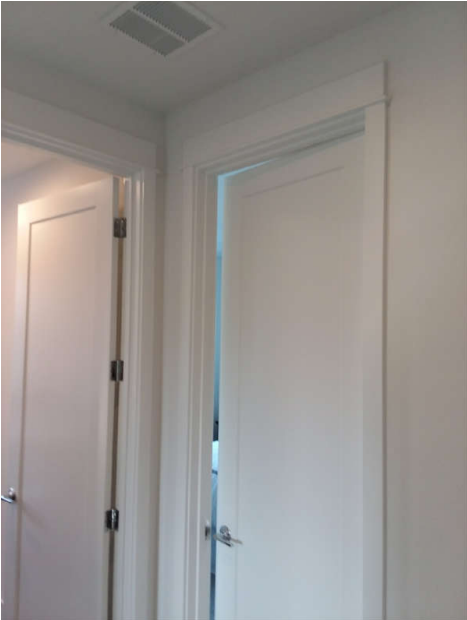
Bedroom near laundry room

DOOR RUBS ON FRAME

The master bedroom door and the bedroom door near the laundry room appears to rub on the frame. Recommend minor repairs and or hinge adjustment as needed.

Contact your builder.

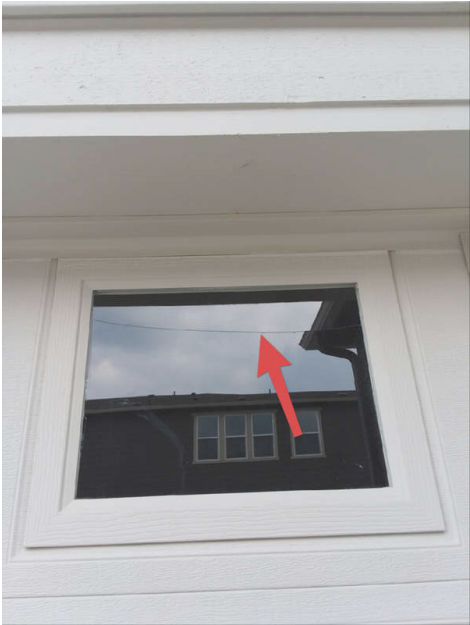
5.2.1 Windows

BROKEN WINDOW

A window in the garage door appears to be broken. I recommend evaluation and repair as needed by a qualified professional.

Recommendation
Contact a qualified professional.

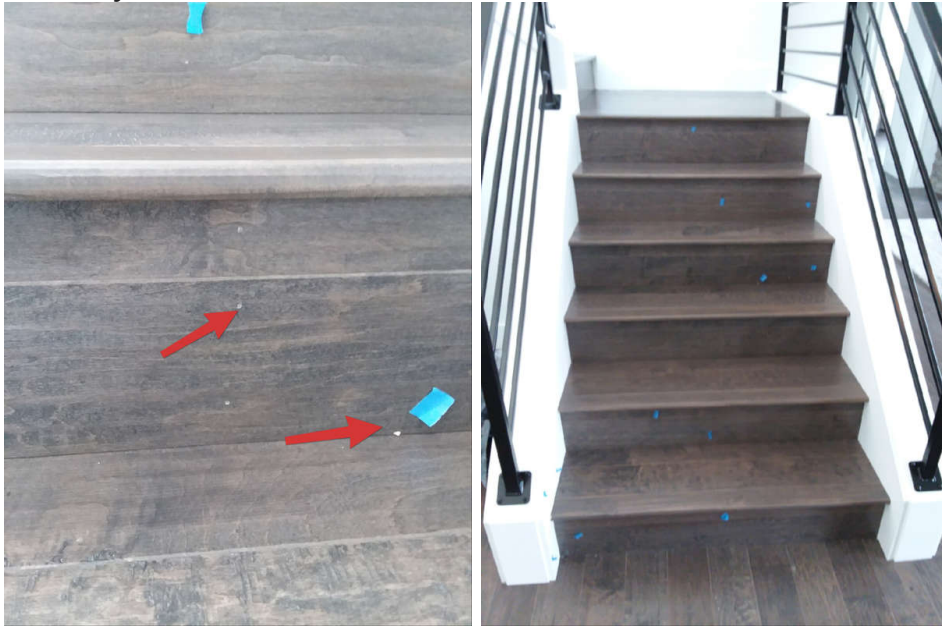
5.4.1 Steps, Stairways & Railings

NAIL HOLES

The nail holes on the staircase haven't been puttied or painted. I recommend repair.

Contact your builder.

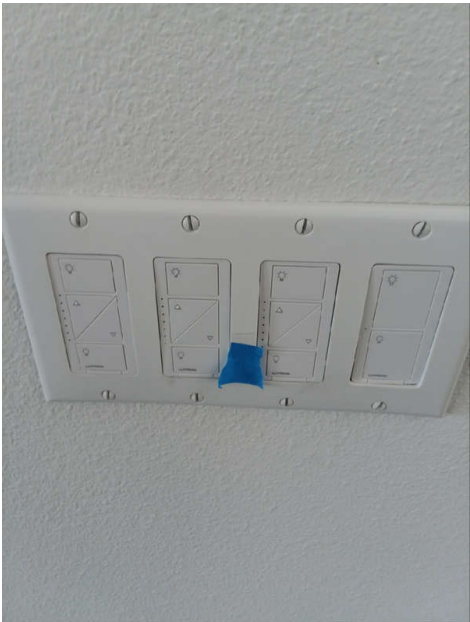
6.4.1 Lighting Fixtures, GFCI, AFCI, Switches & Receptacles

COVER PLATE DAMAGED

Cover plate is damaged at living room light switches. I Recommend replacement.

Contact a qualified electrical contractor.

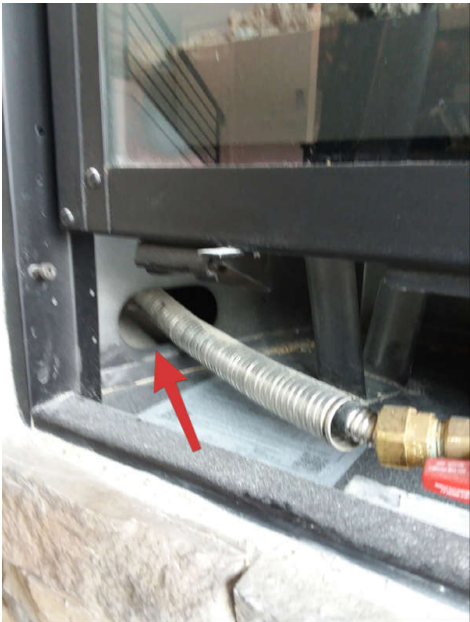
7.5.1 Gas/LP Firelogs & Fireplaces

MISSING HEAT SHIELD

The metal heat shield around the gas line entering below the fireplace is missing.

Contact a qualified general contractor.

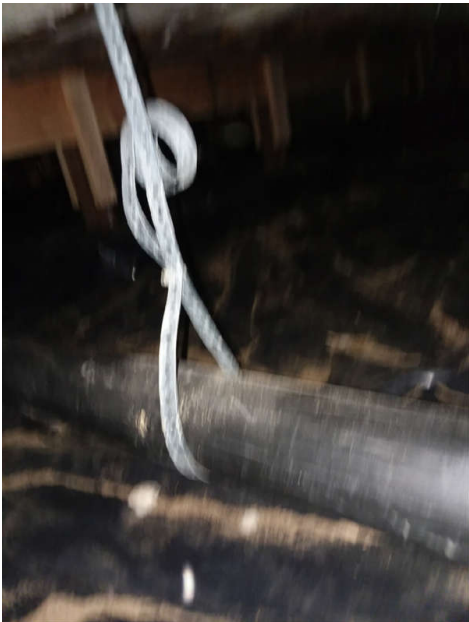
8.1.1 Drain, Waste, & Vent Systems

PLUMBER TAPE

Recommendation
Contact a qualified plumbing contractor.

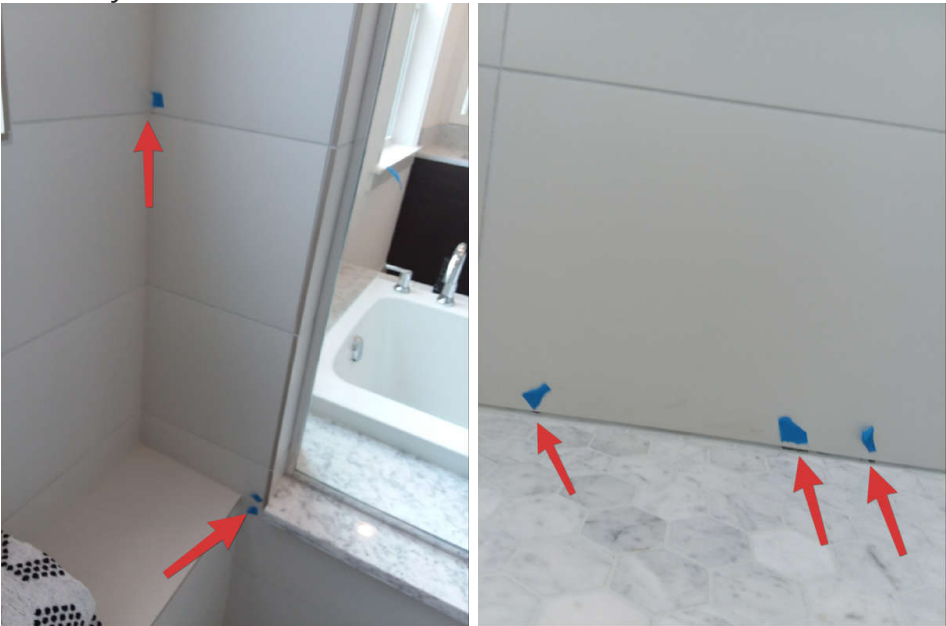
8.2.1 Water Supply, Distribution Systems & Fixtures

MISSING GROUT IN SHOWER

Several areas of missing grout observed in master shower, I recommend evaluation and repair as needed to prevent moisture intrusion in to the walls.

Recommendation
Contact your builder.

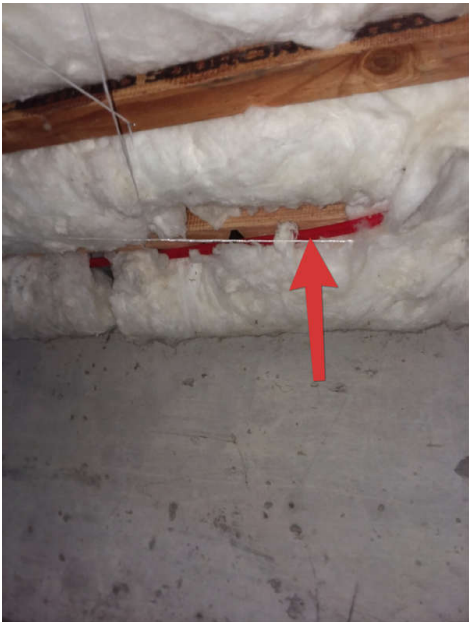
Insulate plumbing lines in crawlspace to help prevent freeze potential. Generally, a simple repair, but can be expensive if pipes burst. Recommend insulating all exposed plumbing by a qualified professional to prevent freeze hazard.

Contact a qualified plumbing contractor.

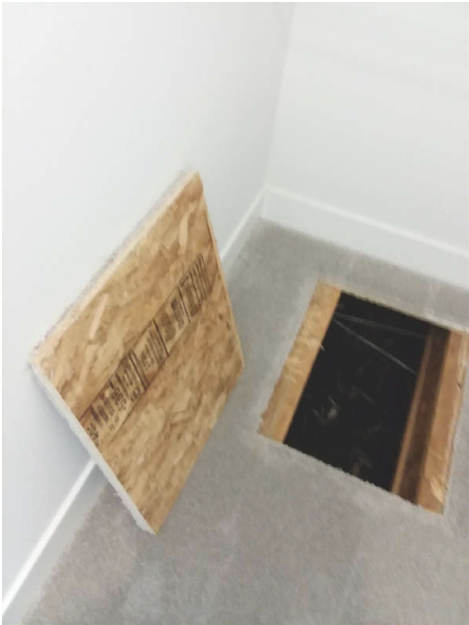
9.2.2 Floor Insulation

CRAWL SPACE HATCH IS UNINSULATED

The crawlspace hatch is uninsulated, I recommend insulating the hatch for increased energy efficiency In conformance with modern standards.

Recommendation
Contact your builder.

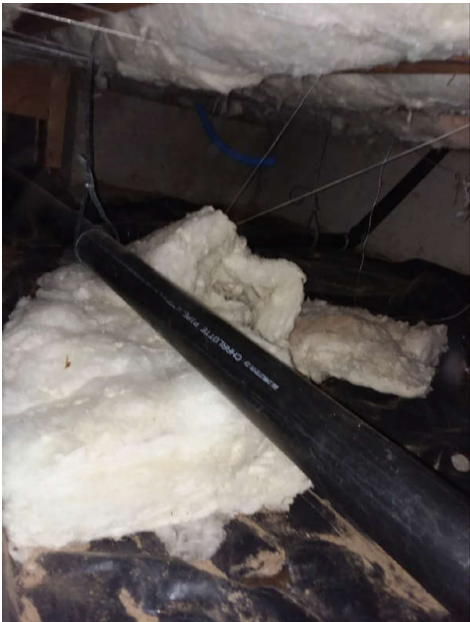
9.2.3 Floor Insulation

INSULATION DEBRIS IN CRAWLSPACE

Unused insulation observed in crawlspace. I recommend removal of all insulation debris in crawlspace.

Recommendation
Contact your builder.

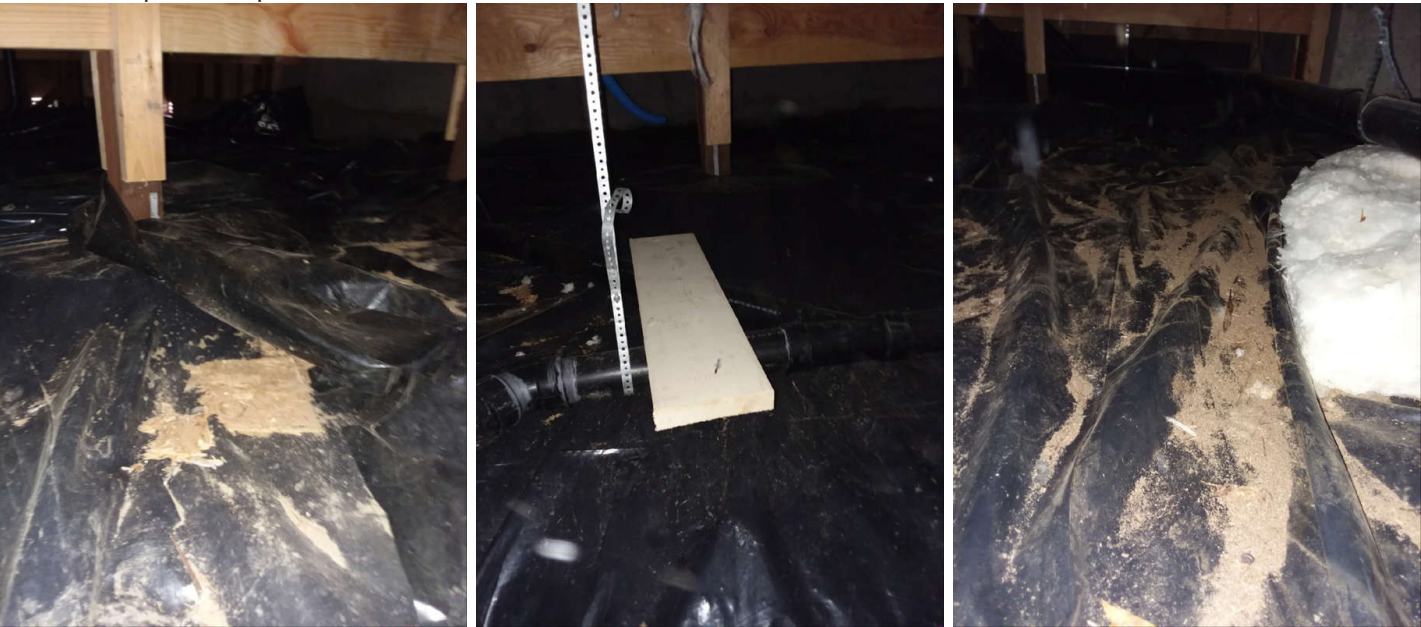
9.3.1 Vapor Retarders (Crawlspace or Basement)

DEBRIS

Wood debris in crawlspace; I recommend removal of all cellulose debris and wood to soil contact as this is considered a conducive condition for wood destroying organisms.

Recommendation
Contact a qualified professional.

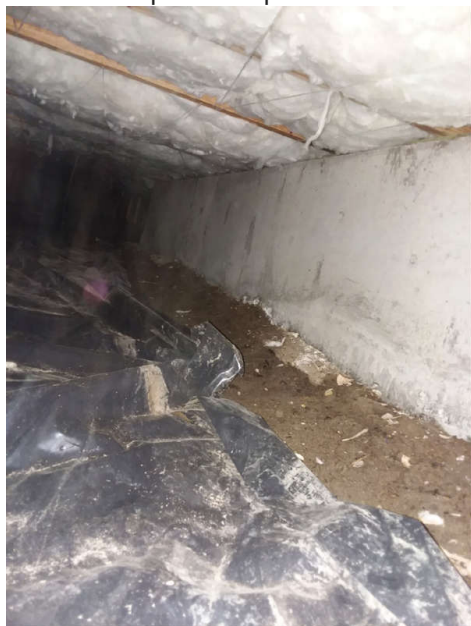
Front left of crawlspace

DISPLACED VB

The vapor barrier is displaced in some areas of the crawlspace. A vapor barrier provides added protection to the floor system from moisture or dampness that can enter from the ground. Recommend leveling the vapor barrier and being sure the barrier covers all exposed soil in the crawlspace. I recommend a qualified professional evaluate for minor repairs.

Contact a qualified professional.
