HAWKEYE HOME INSPECTIONS

HOME INSPECTION REPORT

1234 Main St. Bel Air Maryland 21014

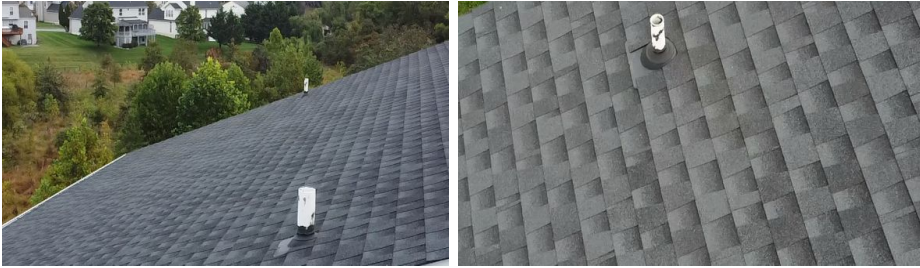
Plumbing Vent Pipes: Plumbing Vent Pipes Inspected

I looked at DWV (drain, waste and vent) pipes that pass through the roof covering. There should be watertight flashing (often black rubber material) installed around the vent pipes. These plumbing vent pipes should extend far enough above the roof surface.

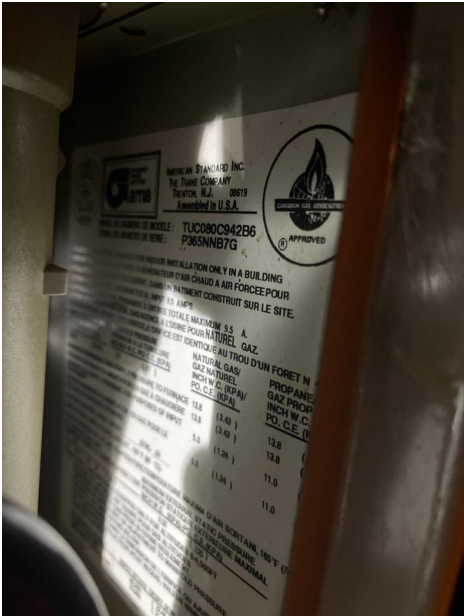
Heating System Information:
Picture Of Data Plate
See data plate for serial and model number.

Heating System Information:
Date of Manufacture
1999

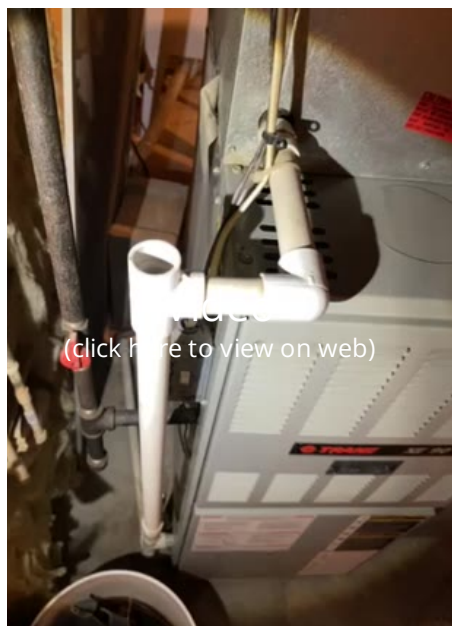
Cooling: Condensate Discharge Confirmed

I observed a discharge pipe apparently connected to the condensate pump installed at the cooling system.

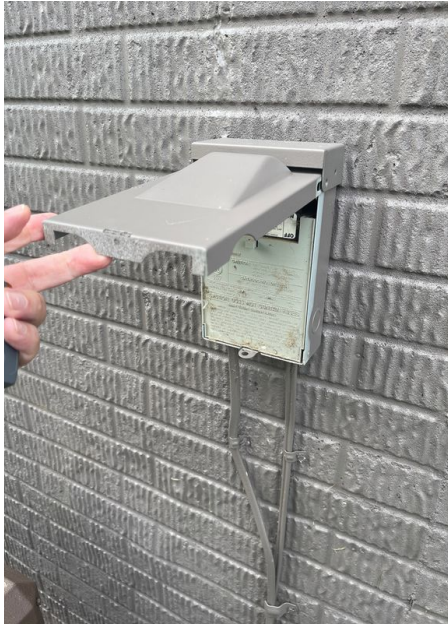
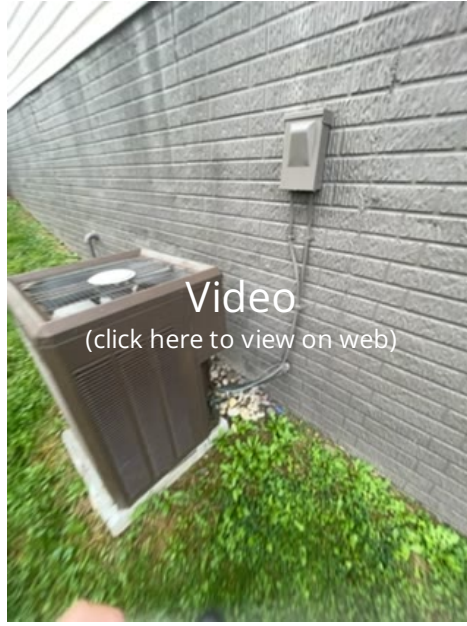
Cooling: AC compressor unit: disconnect OK

Although it was not operated, the electrical disconnect for the condensing unit appeared to be properly located and installed and in serviceable condition at the time of the inspection.

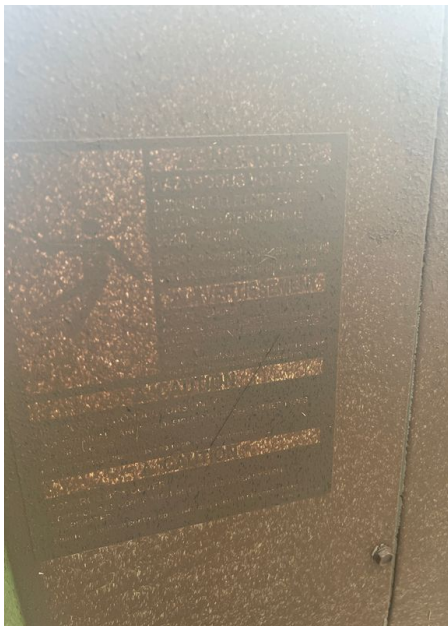
**Cooling: AC: old but functional**

The air-conditioning system appeared to be old but functioning as designed at the time of the inspection.

I observed during my inspection that the system appeared to be older and may be nearing the end of its service life. It may not be reliable. Regular maintenance and monitoring of its condition is recommended. Budgeting for repairs and future replacement is recommended. [InterNACHI's Standard Estimate Life Expectancy Chart for Homes](#)

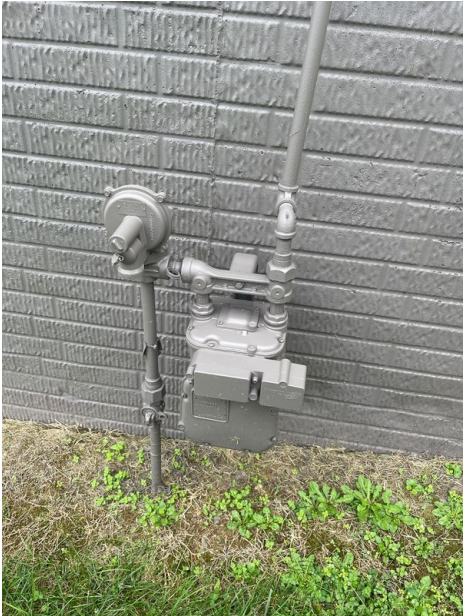
Main Fuel Supply Shut-Off Valve: Location of Main Shut-Off Valve Side of House

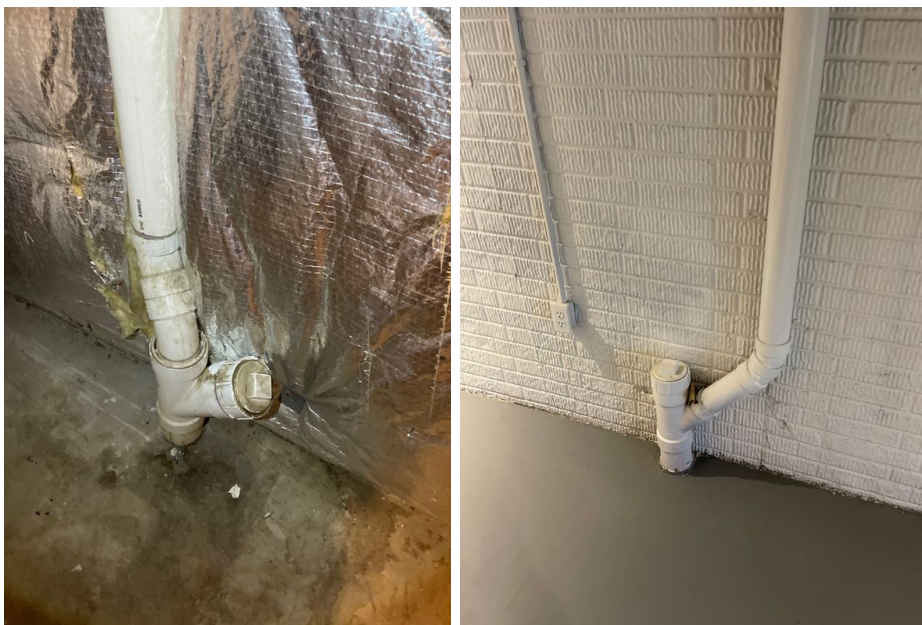
Drain, Waste, & Vent Systems: Inspected Drain, Waste, Vent Pipes

I attempted to inspect the drain, waste, and vent pipes. Not all of the pipes and components were accessible and observed. Inspection restriction. Ask the homeowner about water and sewer leaks or blockages in the past.

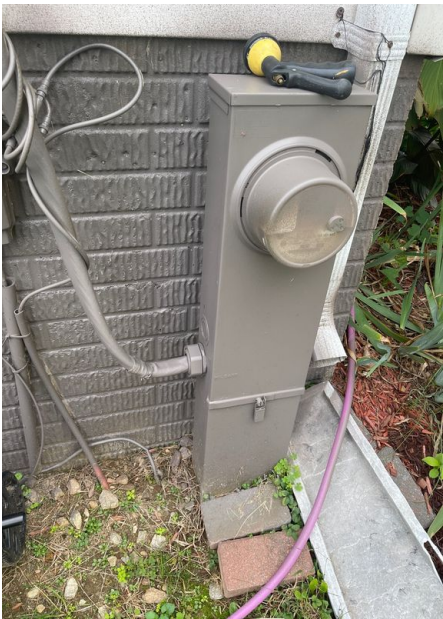
Electric Meter & Base: Inspected the Electric Meter & Base

I inspected the electrical electric meter and base.

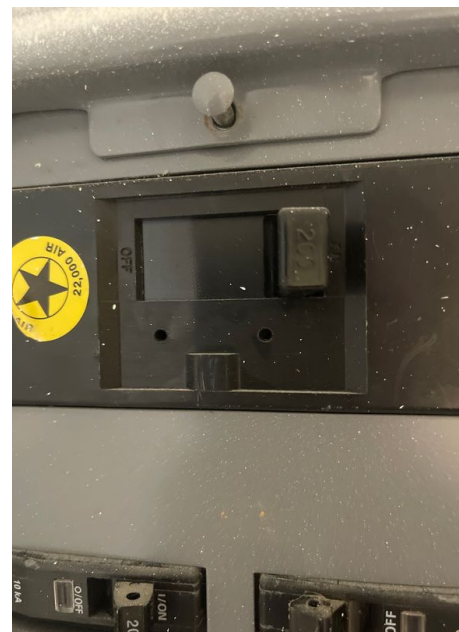
I observed indications of the main service disconnect's amperage rating. It was labeled.

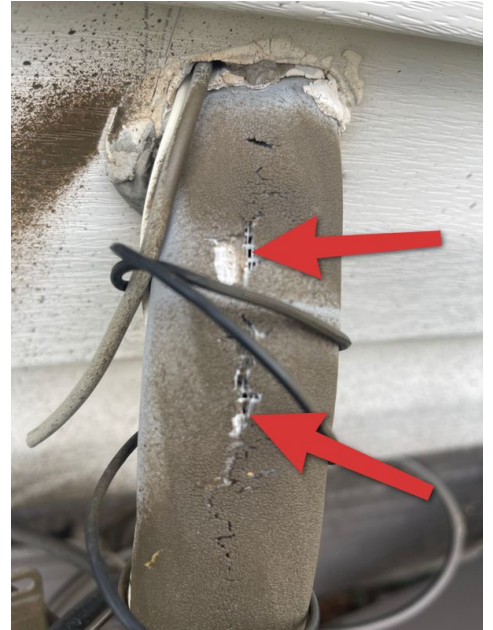
SHEATH DEFECT AT SERVICE-ENTRANCE CONDUCTORS

I observed indications of deficiencies in the integrity of the service-entrance conductors exterior protective sheath. Could potentially allow water to penetrate the line, recommend replacement.

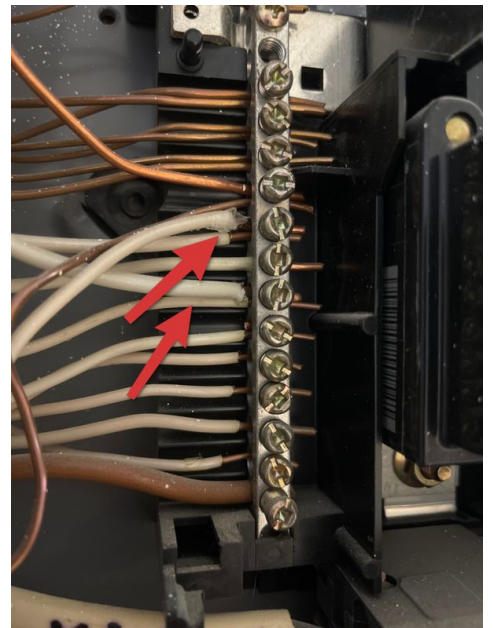
7.5.1 Panelboards & Breakers

DOUBLED NEUTRALS

I observed doubled neutral wires connected under the same single lug. This is a defective condition. The Inspector recommends correction by a qualified electrical contractor.

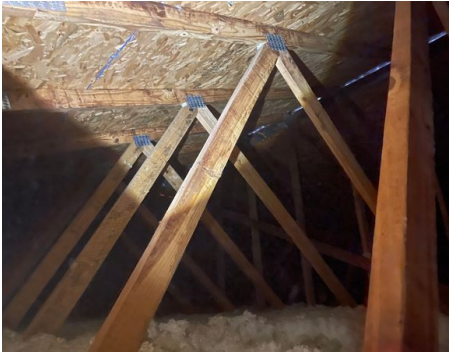
Insulation in Attic: Type of Insulation Observed
Mineral Wool

Structural Components & Observations in Attic: Structural Components Were Inspected
Structural components were inspected from the attic space according to the [Home Inspection Standards of Practice](#).

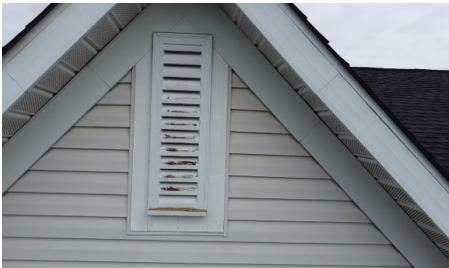
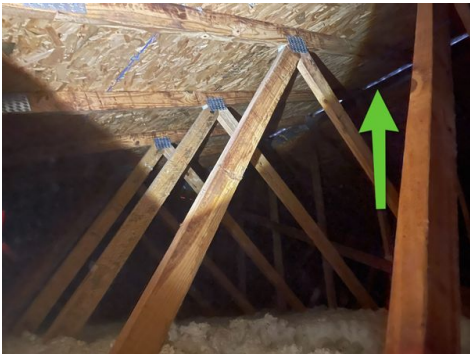
Ventilation in Attic: Ventilation Inspected

During the home inspection, I inspected for ventilation in unfinished spaces, including attics, crawlspaces and foundation.

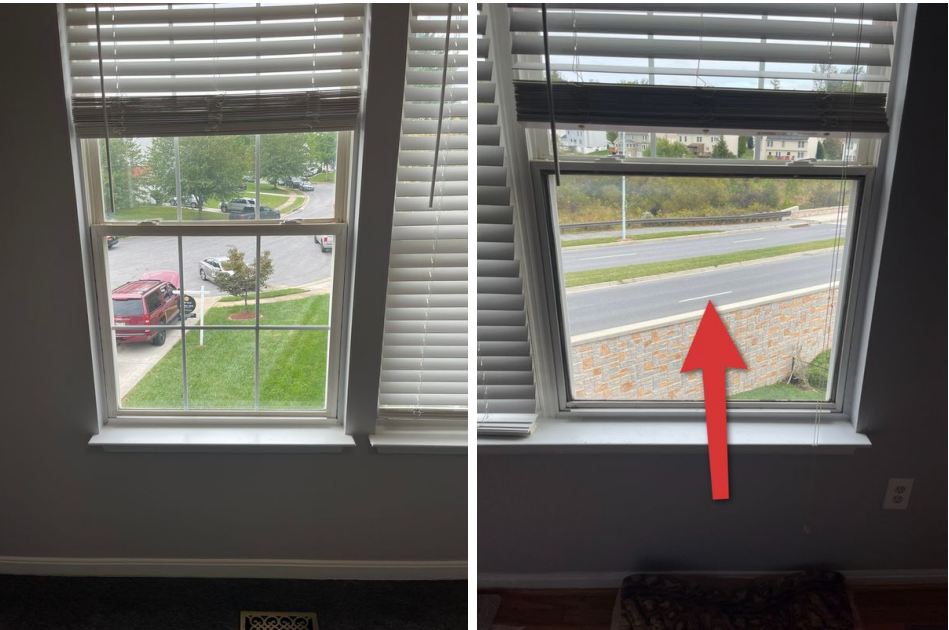
The client should be aware that several windows were difficult to open. They were also missing screens in several locations. This is likely due to the age and hardware may need to be adjusted.

Contact a qualified window repair/installation contractor.

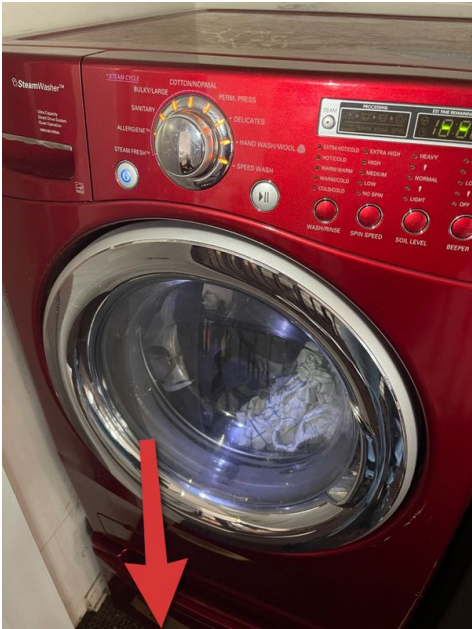
MISSING CATCH PAN

I observed a missing water catch pan that should be installed under the clothes washer. This is to catch water in the event of a leak.
Recommend installing.

Recommendation
Recommended DIY Project

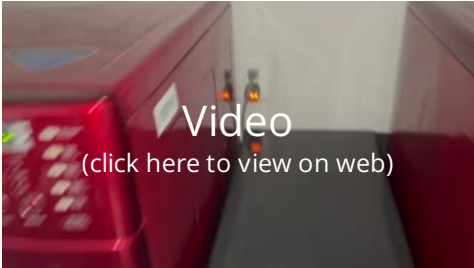
11.3.1 Laundry Room, Electric, and Tub
MISSING GFCI PROTECTION

I observed that there is missing GFCI protection at the receptacles in the laundry room.

All 120-volt, 15- and 20-amp outlets in laundry rooms must be AFCI and GFCI protected. 2014 NEC 210.8(A)(10) & 210.12(A)

Recommendation
Contact a qualified electrical contractor.
