SUMMARY REPORT

Inspection Report

Mr. Home Buyer

Property Address:
150 Peabody Place
Memphis Tennessee 38103

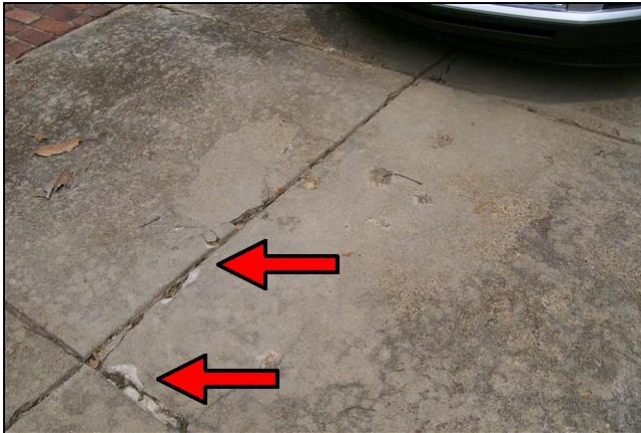
1.0 Item 1(Picture)

Driveway cracking and surface deterioration observed, recommend regular maintenance and repairs to prolong the useful life of the surface.

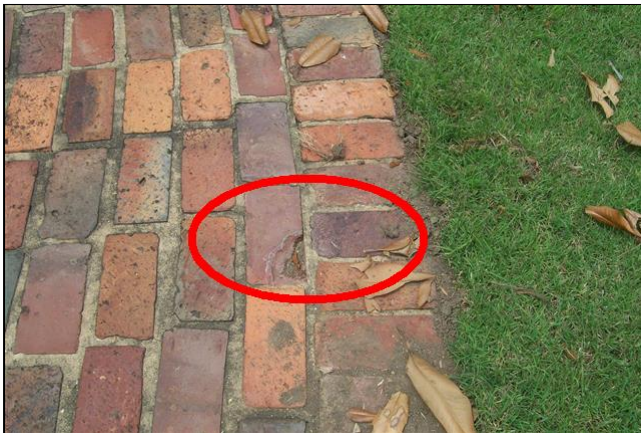
1.1 Item 1(Picture)

Possible trip hazard noted at front entry. This is a safety concern. We suggest repair/replacement as needed to ensure safety.

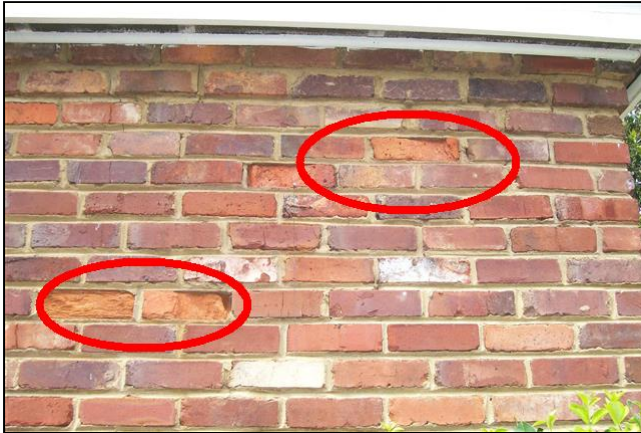
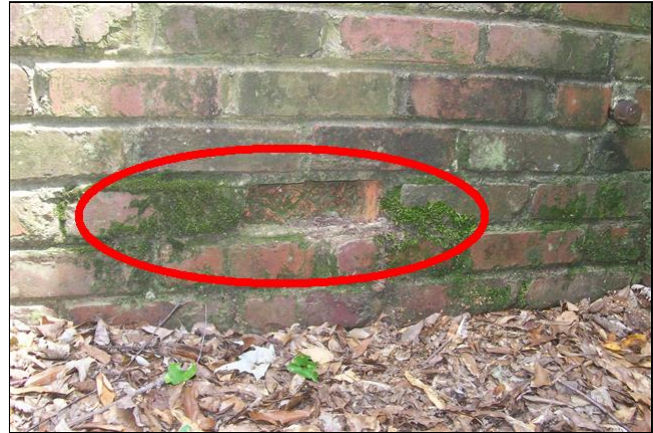
1.2 Item 1(Picture)

Spalling brick, evidence of brick failure, observed at various locations. Recommend review for repair or replacement as necessary.

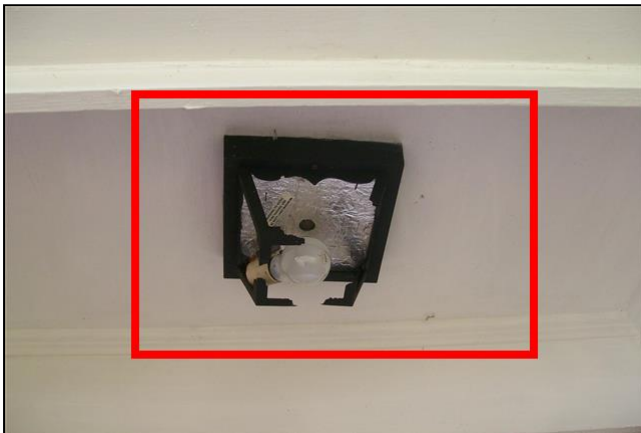
1.7 Item 1(Picture)

(1) Damaged light fixture(s) observed at front entry of home; recommend review by qualified repair person for repairs/ corrections as needed.

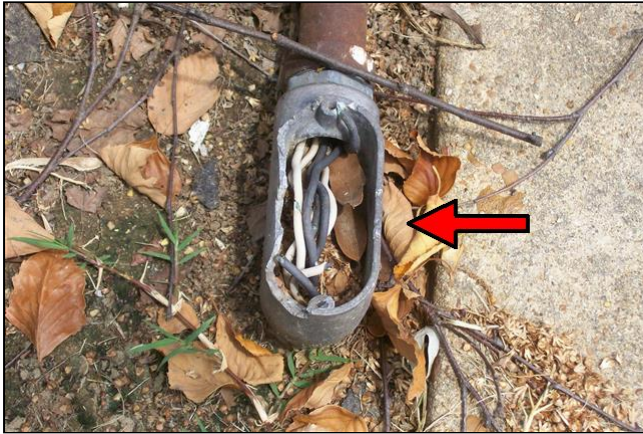
1.7 Item 2(Picture)

(2) Open junction box was observed at rear of home. Whenever an electric wire is cut and reconnected, the 'splice' should be encased in a covered junction box to prevent shocks and separation of the splice. Recommend cover be installed to ensure safety.

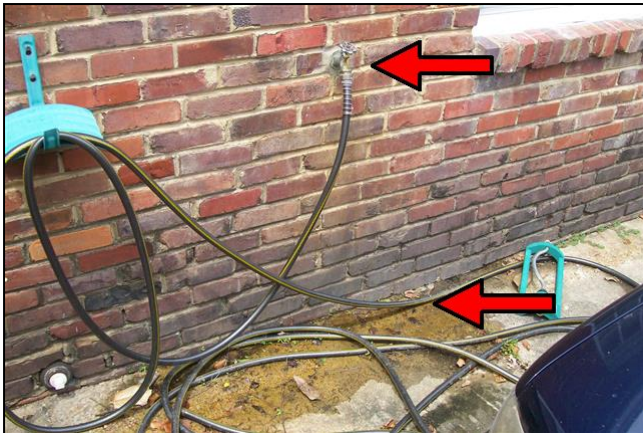
1.9 Item 1(Picture)

Stem packing leak observed at left side exterior faucet, recommend review for repairs as needed.

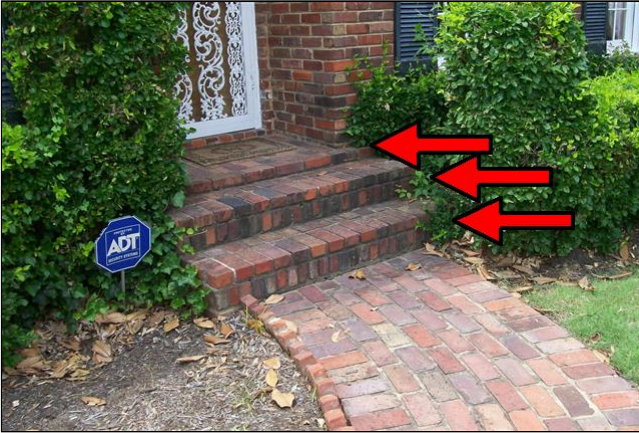
1.12 Item 1(Picture)

Stairs/steps at front of home are uneven. This is a possible safety concern. Recommend review by a qualified professional for repair or replacement as necessary.

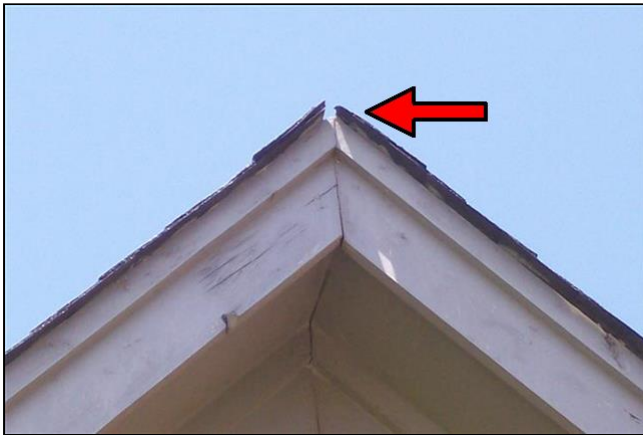
2.0 Item 1(Picture)

Cracked/damaged ridge cap shingle(s) observed. Repair/replace as needed to prevent water entry into soffit area.

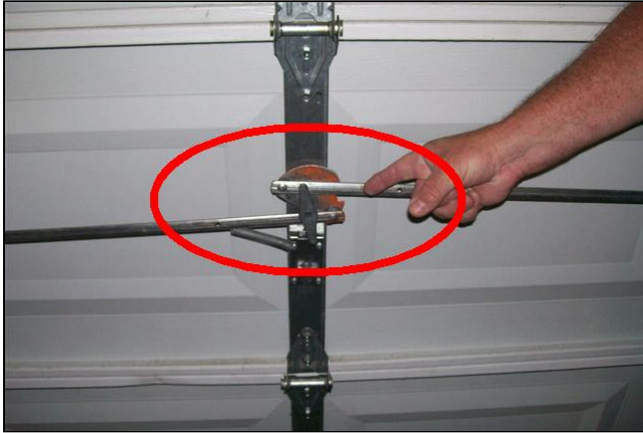
3.3 Item 1(Picture)

The manual locking device has not been removed or disabled. On any garage door that is equipped with an automatic operating device the manual locking device on the garage door must be disabled or removed. This prevents manually

locking the garage door and possibly damaging the operator or the door if locked and the operator is used. Recommend review by licensed garage door specialist for corrections.

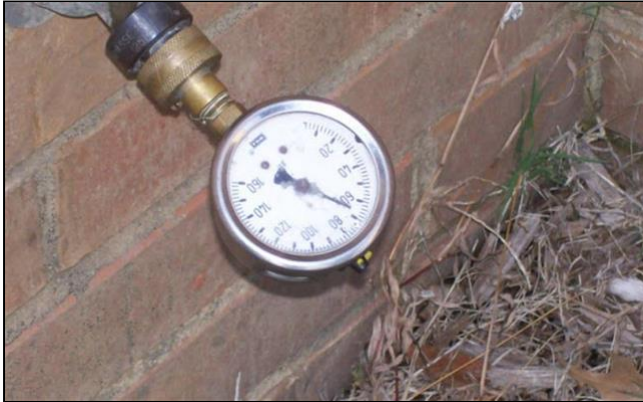
6.0 Item 1(Picture)

(1) Water pressure.

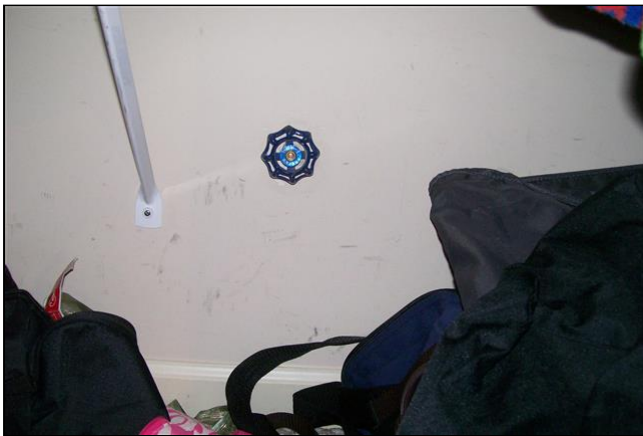
6.0 Item 2(Picture)

(2) Water Shut-off.

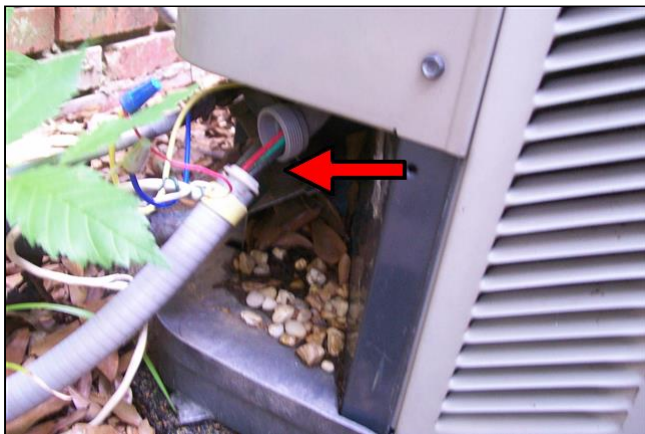
9.0 Item 1(Picture)

Improper or damaged wiring observed. Recommend review by a licensed heating contractor for repair or replacement, as necessary, prior to close.

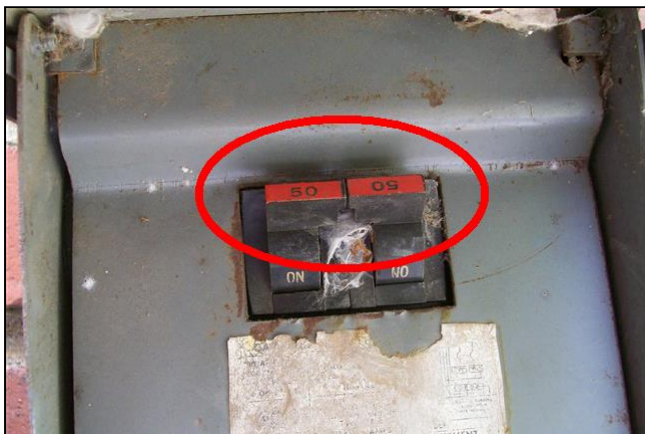
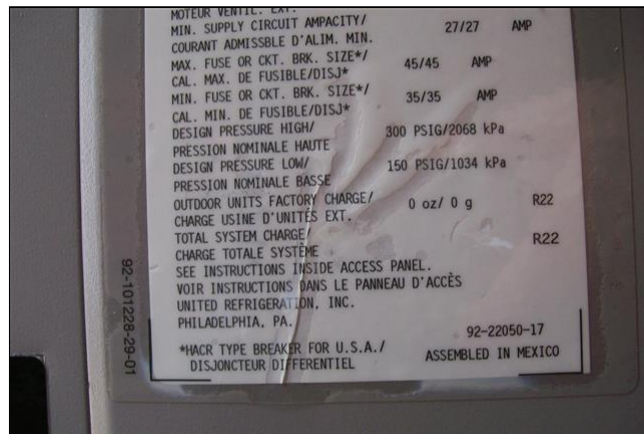
9.2 Item 1(Picture)

According to the air-conditioning units' specification label, the breaker protecting the condenser is not properly sized. A 50 amp breaker has been installed with a labeled demand that calls for a maximum breaker size of 45 amps. We recommend a licensed heating and air contractor perform any corrections necessary to assure proper protection.

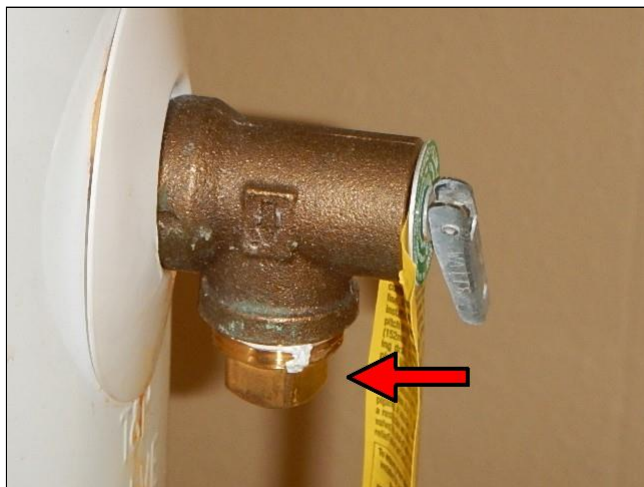
10.4 Item 1(Picture)

The temperature pressure relief (TPR) valve has been plugged. This is a serious safety concern. Recommend review by a qualified professional for repair or replacement, as necessary, prior to close.

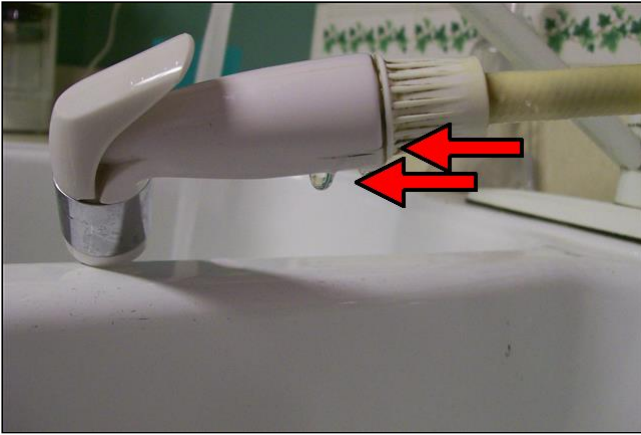
11.8 Item 1(Picture)

Sprayer leaks. Recommend review by a qualified professional for repair or replacement, as necessary.

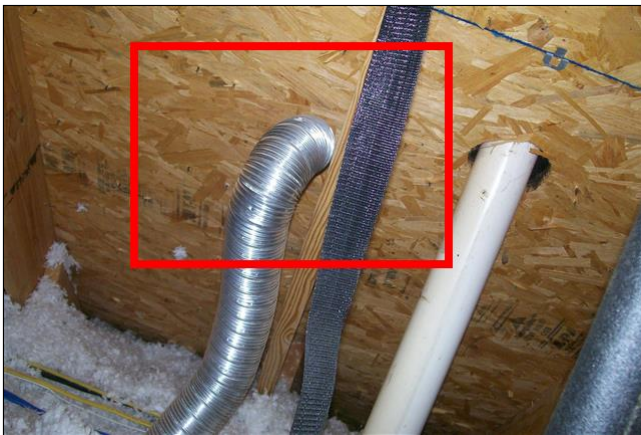
12.8 Item 1(Picture)

Fan located in the hall bathroom improperly venting into attic. Recommend extending the fans' exhaust to the exterior of attic to prevent damage/deterioration in the attic from moisture/condensation.

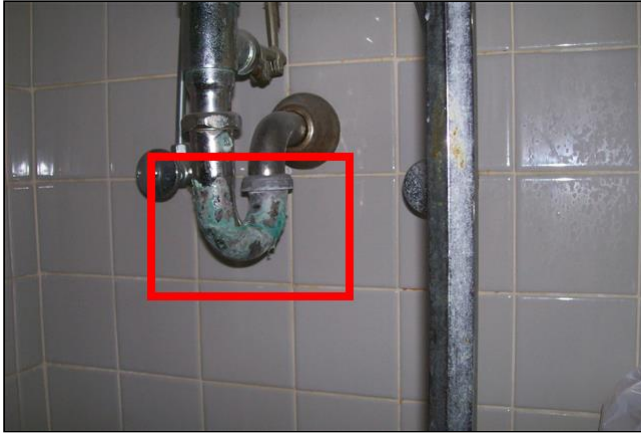
12.11 Item 1(Picture)

The plumbing waste line is rusted and deteriorated in the hall bathroom. A qualified licensed plumber should repair or correct as needed.

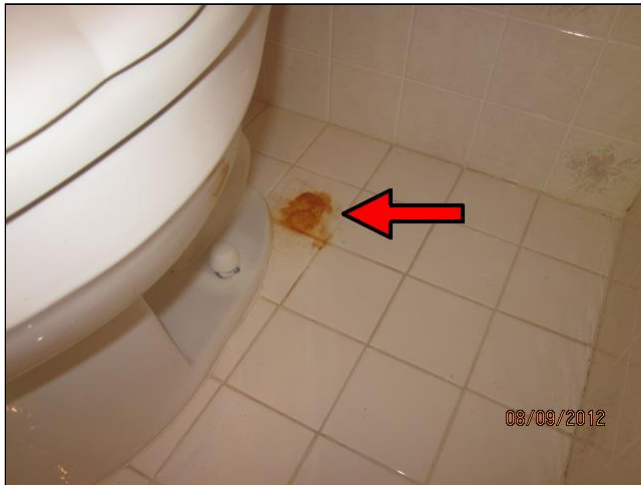
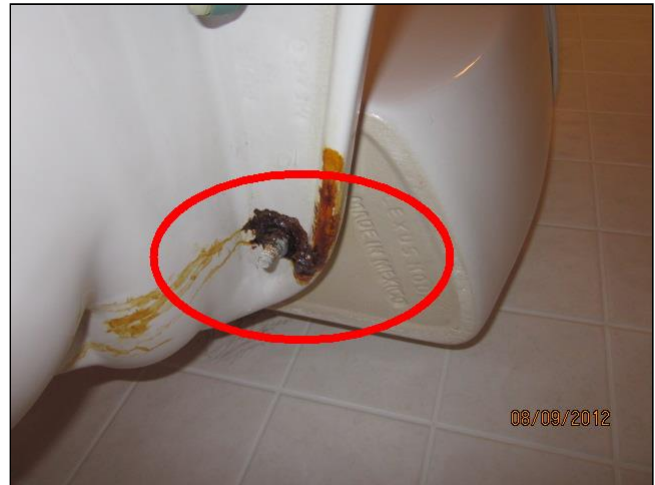
12.12 Item 1(Picture)

The toilet leaks at tank mount in the master bathroom. A qualified plumbing contractor is needed to make necessary repairs/corrections.

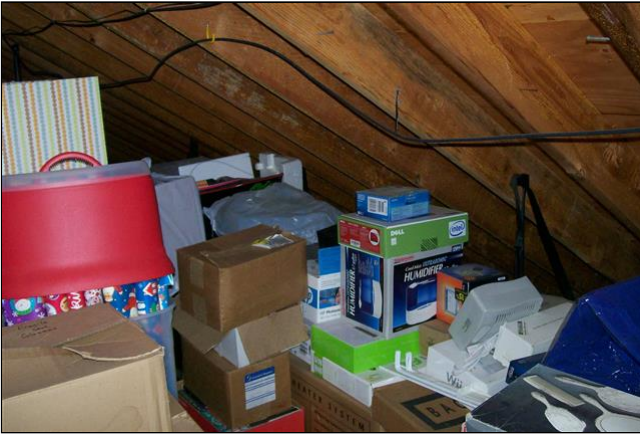
16.8 Item 1(Picture)

Limited access.
