TFHI RESIDENTIAL REPORT

1234 Main St. Union NJ 07083

Buyer Name
05/04/2020 9:00AM

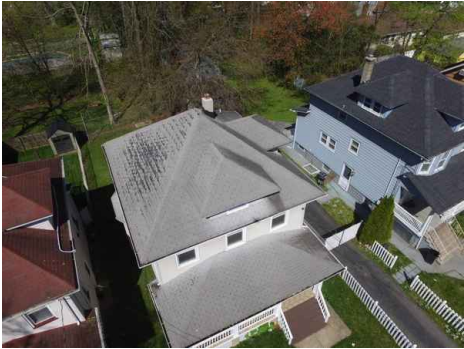
Coverings: Material

Asphalt

20+ years

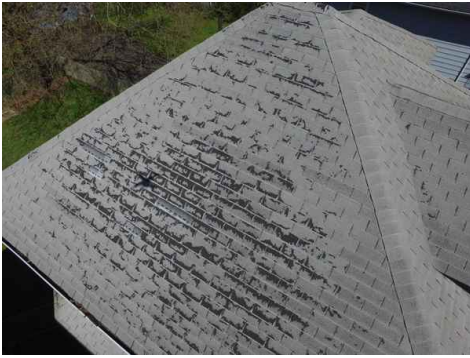
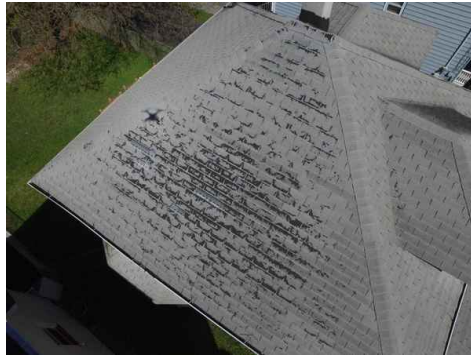
The asphalt shingle roof shows serious delamination. Delamination is separation of the surface layer of asphalt. This roof is beyond its life expectancy, and is in need of replacement. A qualified licensed roofing contractor should evaluate and repair as necessary to prevent further deterioration that results in leaking and moisture intrusion.

Contact a qualified roofing professional.

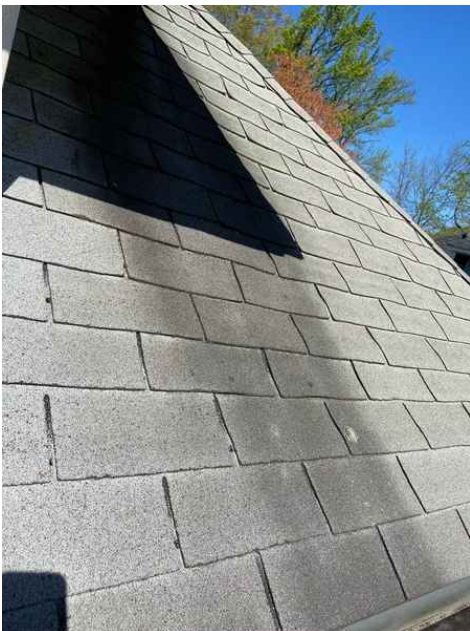
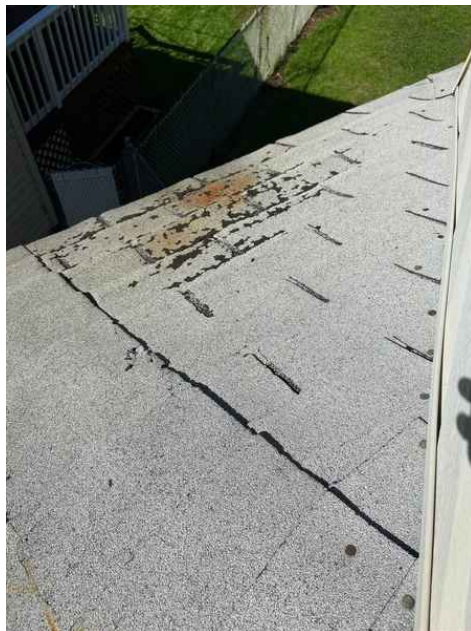
2.1.2 Coverings

DISCOLORATION

Roof shingles were discolored, which can be caused by moisture, rust or soot. A qualified licensed roofing contractor evaluate and remedy with a roof cleaning or repair as necessary.

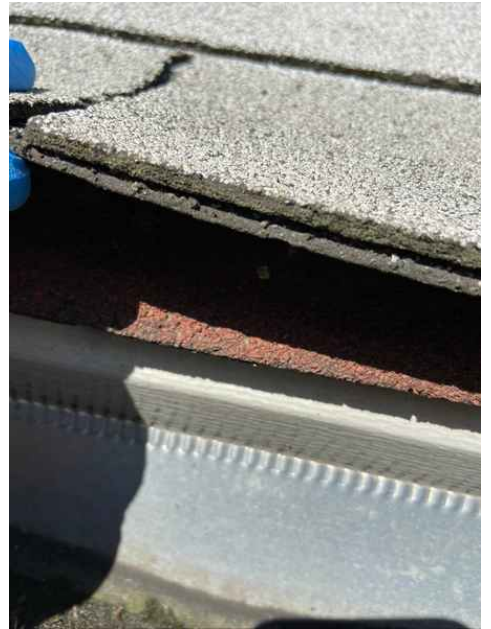
2.1.3 Coverings

MULTIPLE LAYERS

While it is common and permitted to have two layers of roofing, multiple layers of roofing can accelerate deterioration of the roofing materials, as well as add excess weight to the structure. The expected life expectancy for a roof is commonly 25 years, and a second layer can expect a 10-15 year additional life expectancy. The roof should be replaced at this stage of its condition and life expectancy by a qualified licensed roofer.

Contact a qualified roofing professional.

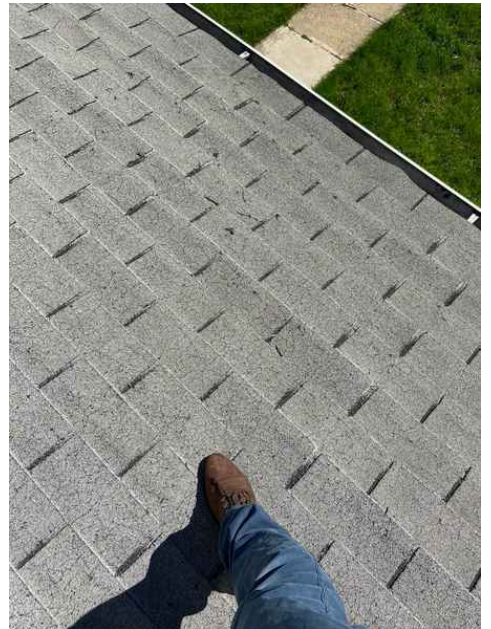
2.1.4 Coverings

SHEATHING POSSIBLY DAMAGED

The sheathing (wood covering) underneath the roofing material, was soft and spongy in an area above the front porch. This can be caused by a prior or current leak that is damaging the wood material. A qualified licensed professional should repair and replace as necessary.

Contact a qualified professional.

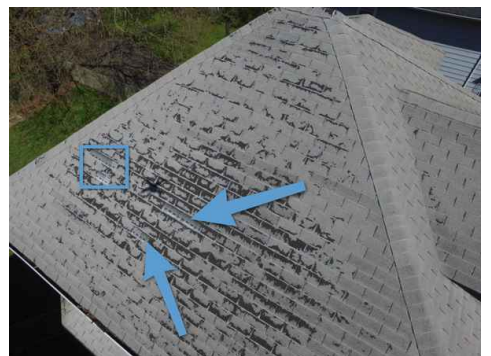
Observed areas that appeared to be missing sufficient coverings. This can allow moisture penetration into the substrate material. A qualified licensed roofing contractor should repair and replace as necessary.

Contact a qualified roofing professional.

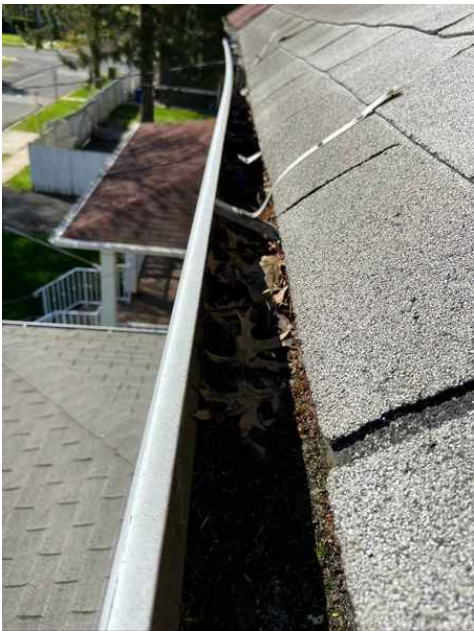
The gutters are full of debris in areas and need to be cleaned. The debris in gutters can also conceal rust, deterioration or leaks that are not visible until cleaned, and I am unable to determine if such conditions exist. A qualified licensed contractor should repair and replace as needed.

Recommendation
Contact a qualified professional.

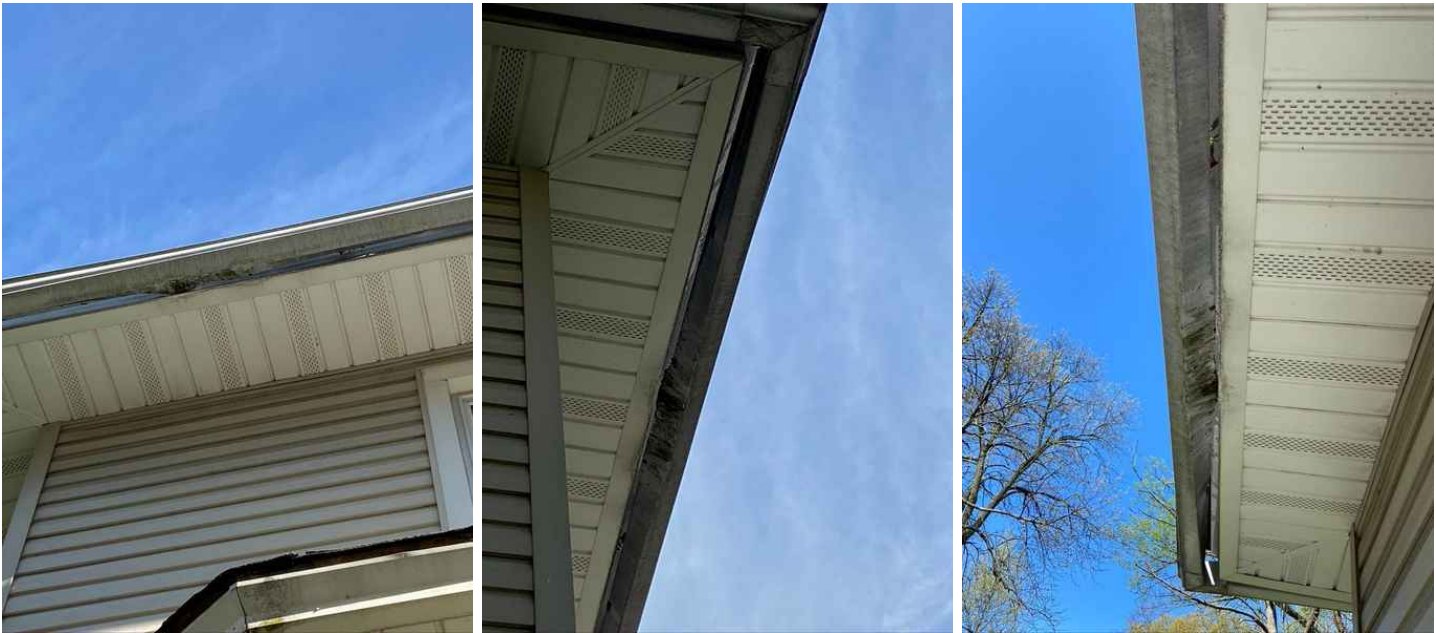
2.2.2 Roof Drainage Systems

GUTTER DAMAGED

The gutter on the left side of the home was damaged. This can result in excessive moisture in the soil at the foundation, which can lead to foundation/structural movement, and leaks in the basement, which is noted later in the report for this property. A qualified licensed contractor should repair and replace as necessary.

Recommendation
Contact a qualified gutter contractor

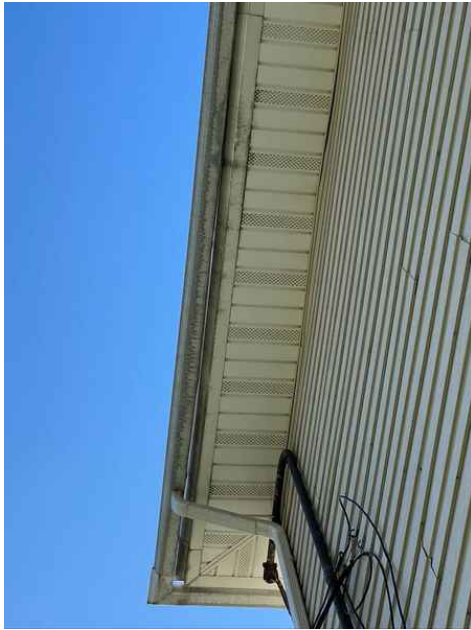
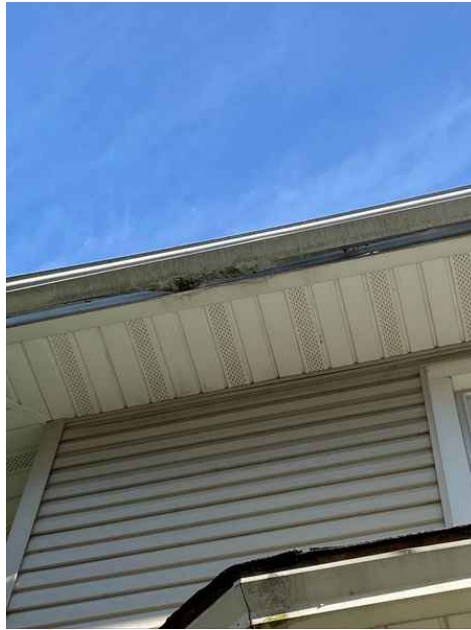
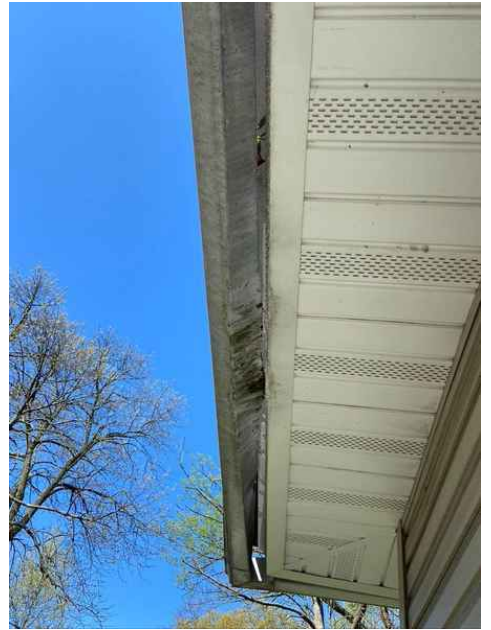
2.2.3 Roof Drainage Systems

WATER STAINS UNDER GUTTER

Water stains and high moisture levels were observed on the bottom side of the gutter/ underneath roof coverings. This could be due to the water overshooting the gutter from the gutter guards. Recommend monitoring the gutters during a rain storm for their performance.

Contact a qualified professional.

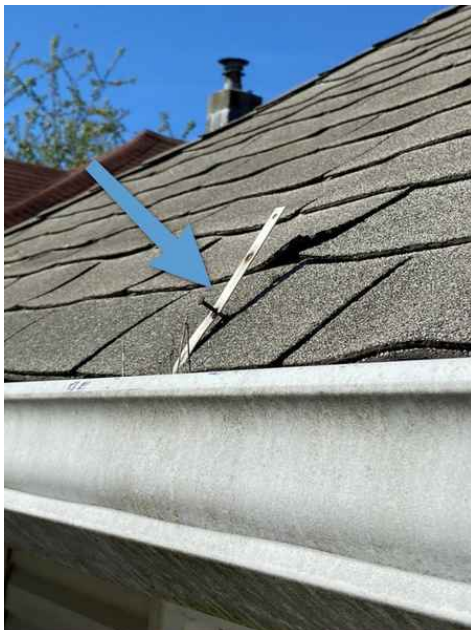
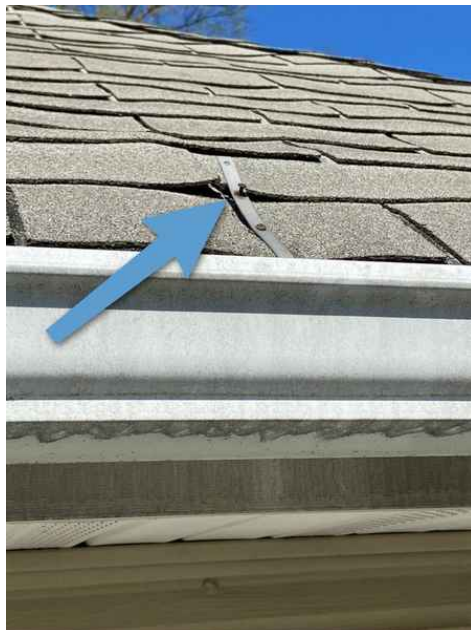
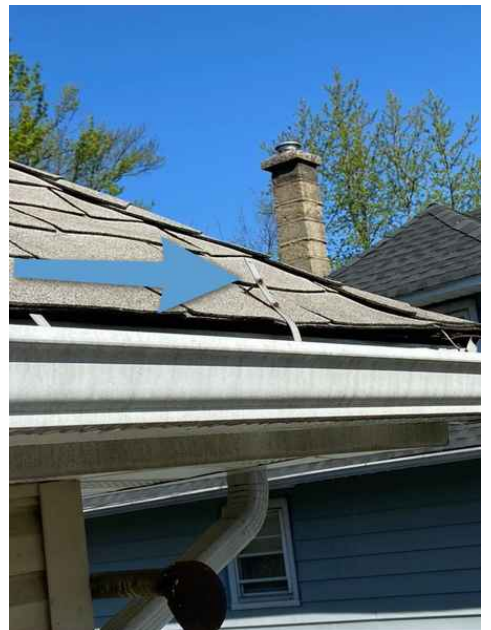
2.2.4 Roof Drainage Systems

GUTTER LOOSE

The gutter(s) is loose and needs to be re-fastened to fascia and pitched properly. This can lead to moisture penetrating the home as well as allowing excessive moisture in the soil at the base of the foundation. A qualified licensed contractor should repair and replace as necessary.

Contact a qualified gutter contractor

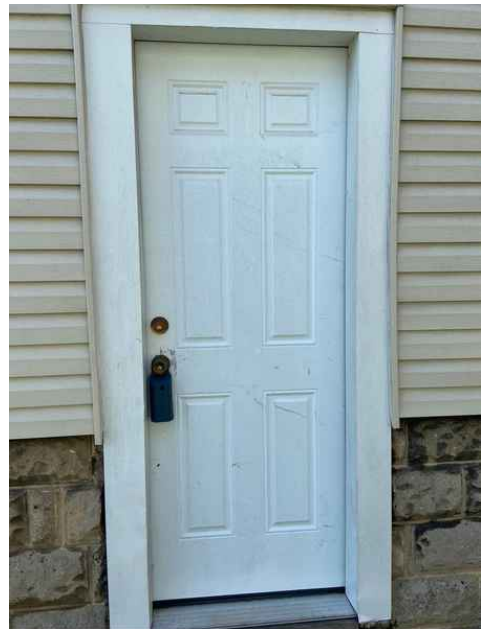
IMPROPER FLASHING BELOW DOOR

The side door has not been properly flashed at the bottom of door. This can lead to water intrusion and deterioration of door sill plate. A qualified licensed contractor should inspect and repair as needed.

Contact a qualified professional.

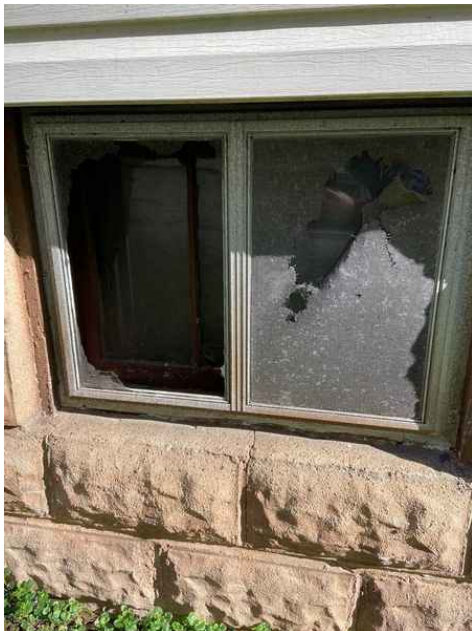
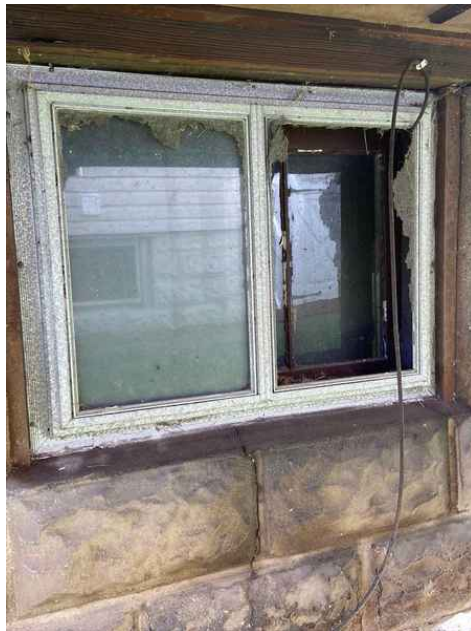
3.3.1 Exterior Windows

DAMAGED SCREENS/WINDOWS

The basement windows were observed to have damaged screens/window panes. This is a maintenance issue. A qualified licensed professional should repair and replace as necessary.

Contact a qualified professional.

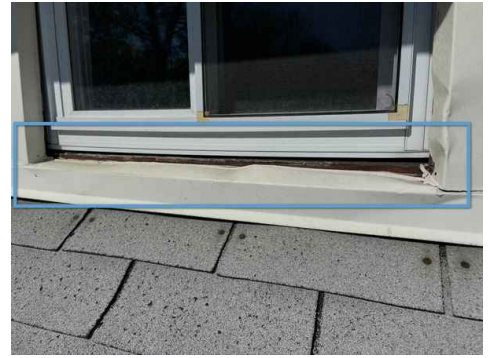
3.3.2 Exterior Windows

CAULKING/PAINTING

Exterior windows of the home would benefit from maintenance caulking and painting around the trim and window. This will prevent moisture from entering the materials of the home and causing damage. A qualified licensed professional should repair as necessary.

Contact a qualified professional.

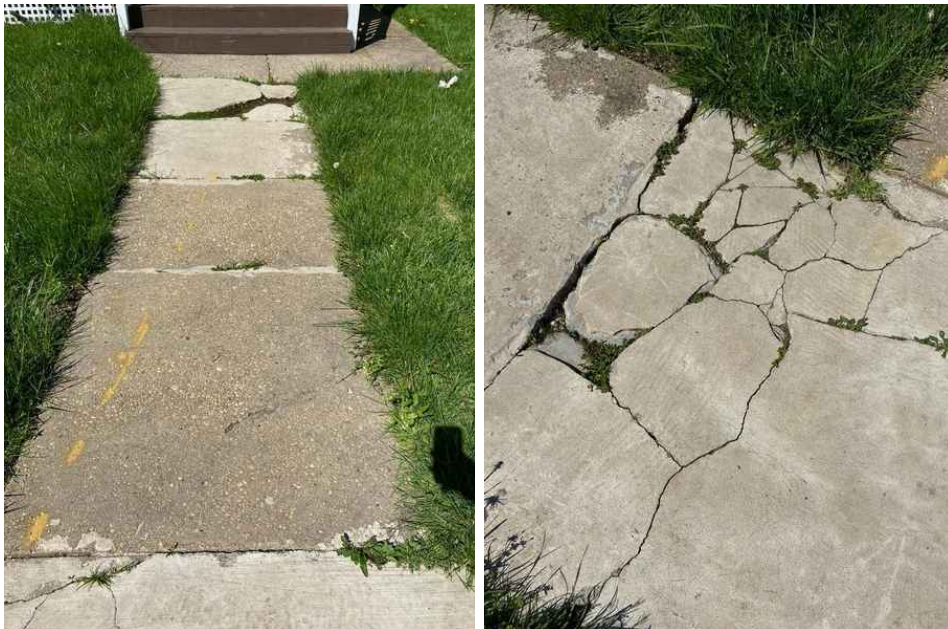
3.4.1 Walkways, Patios & Driveways

WALKWAY CRACKING

Cracking observed in the walkway leading to the home. This is a trip hazard. A qualified licensed contractor should repair and replace as necessary to prevent trip hazard.

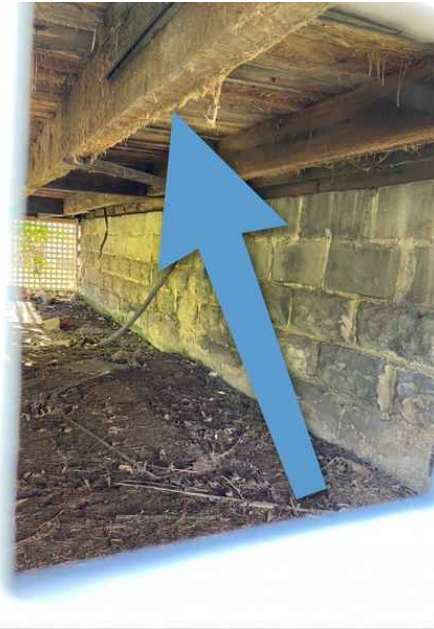
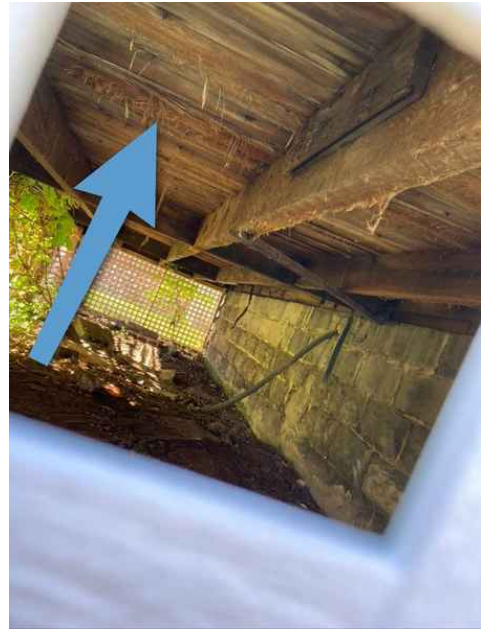
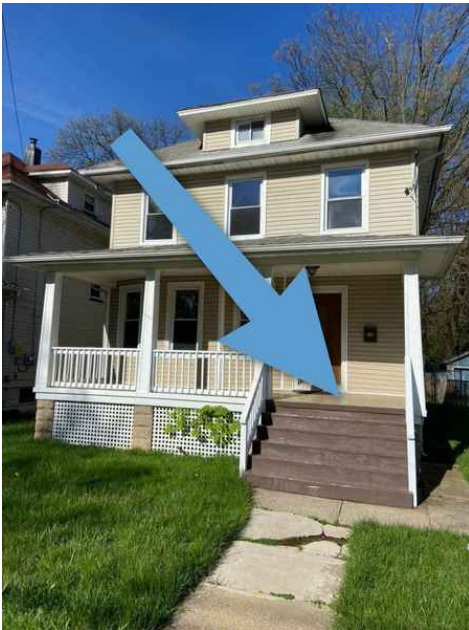
3.6.1 Decks, Balconies, Stoops, Porches, Railings & Steps

DECK - ROTTED BOARDS

One or more deck boards are showing signs of prolonged water damage, causing a portion of the porch to sag. Rot fungus is caused by water penetration into the material and will cause deterioration of the materials. A qualified licensed contractor should repair and replace as necessary.

Contact a qualified deck contractor.

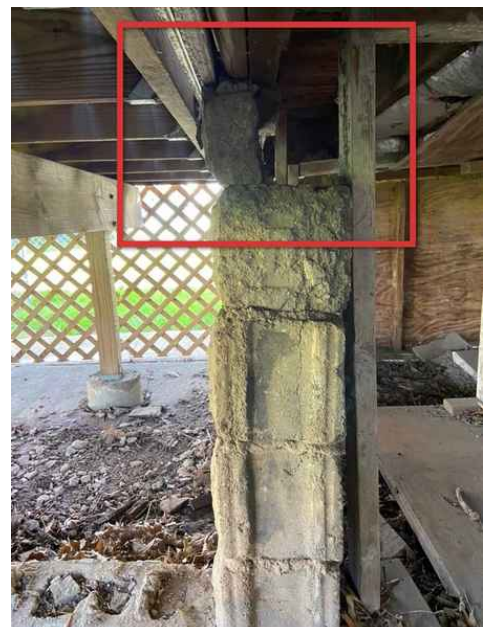
3.6.2 Decks, Balconies, Stoops, Porches, Railings & Steps

One of more areas of the rear deck/home support appears unstable. This could cause a safety hazard and further deterioration of the deck/home. A qualified licensed contractor should evaluate, advise, then repair and replace as necessary.

Contact a qualified professional.

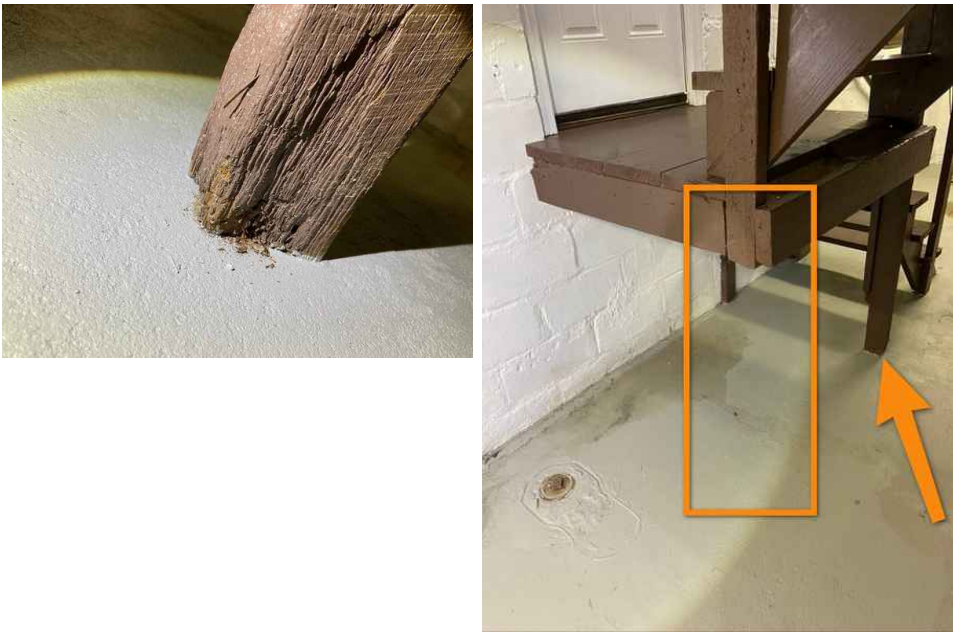
The basement steps possibly are in need of further support under the landing. The left side of the landing has no support. The other support column had some water damage at the bottom from the leaks in the basement. I recommend adding a support column under the landing for added stability.

Contact a qualified professional.

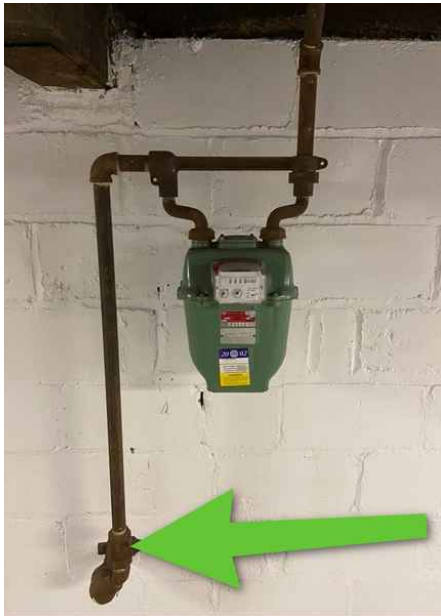
The main fuel shut off is at gas meter.

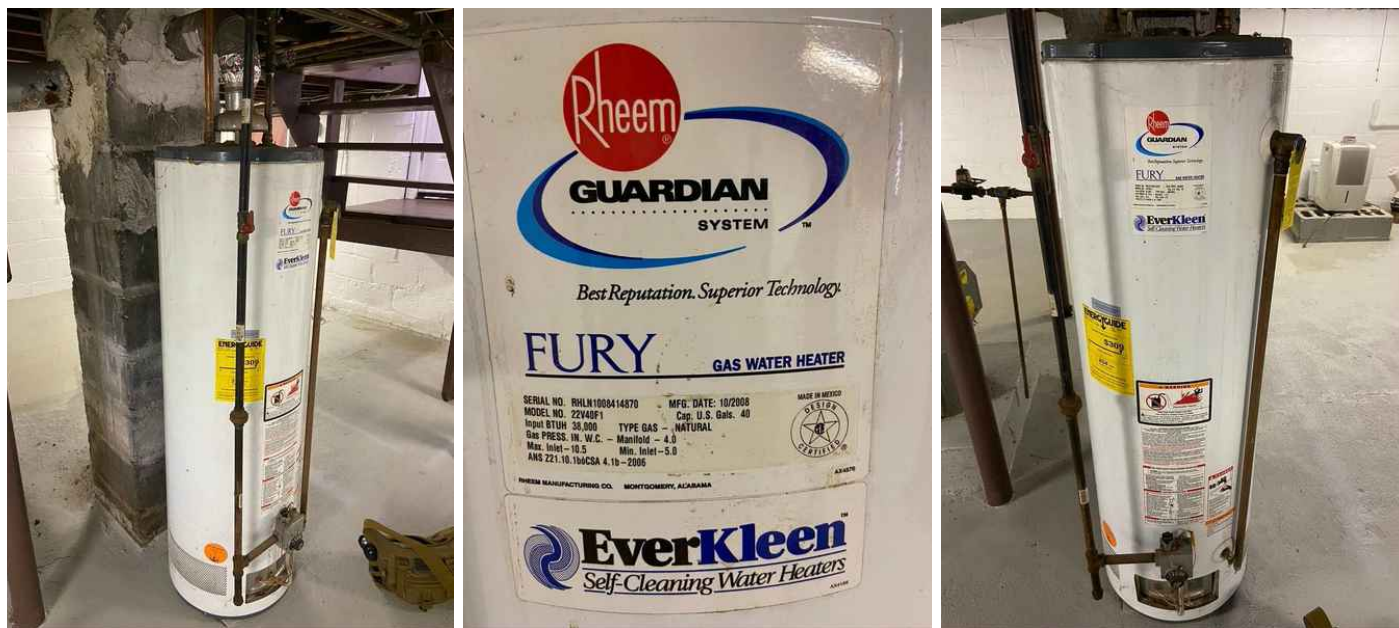
At this time, the water heater appears to be operating as expected. The Water heater (Rheem) Serial Number is (Please see image) and model number is (Please see image). The water heater was manufactured in 2008 and has a life expectancy of 7-12 years.

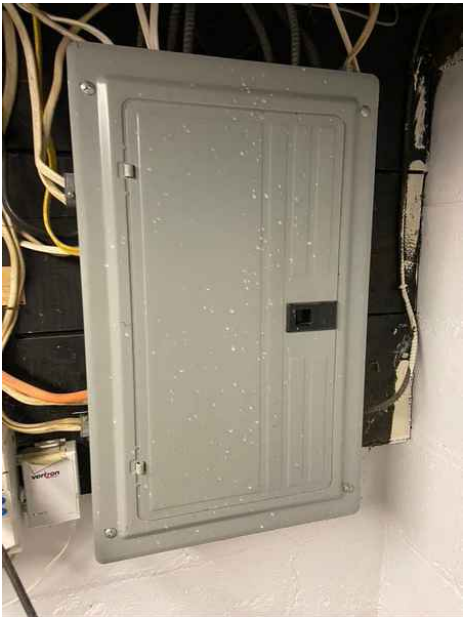
Main & Subpanels, Service & Grounding, Main Overcurrent Device: Main Panel Location
Basement

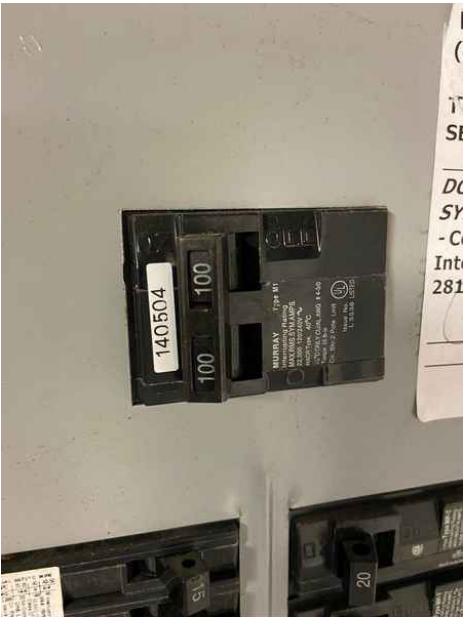
Main & Subpanels, Service & Grounding, Main Overcurrent Device: Main Service Disconnect
100 AMP

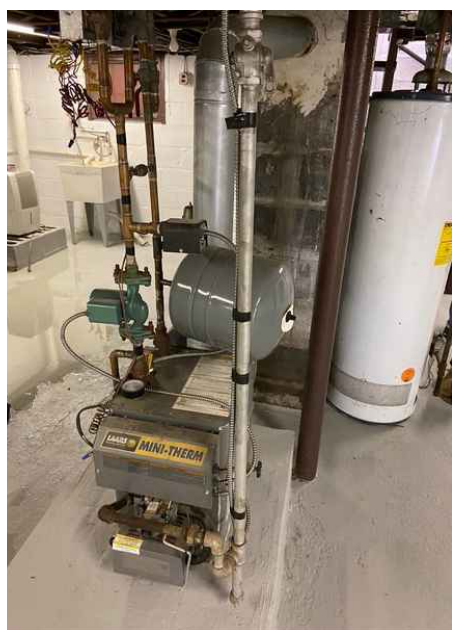
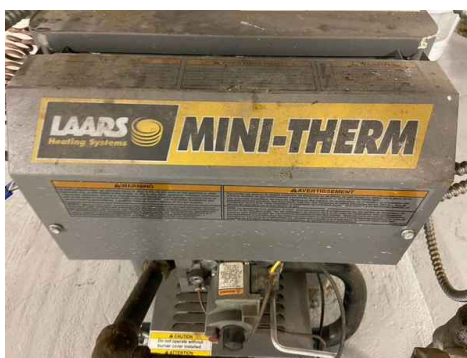
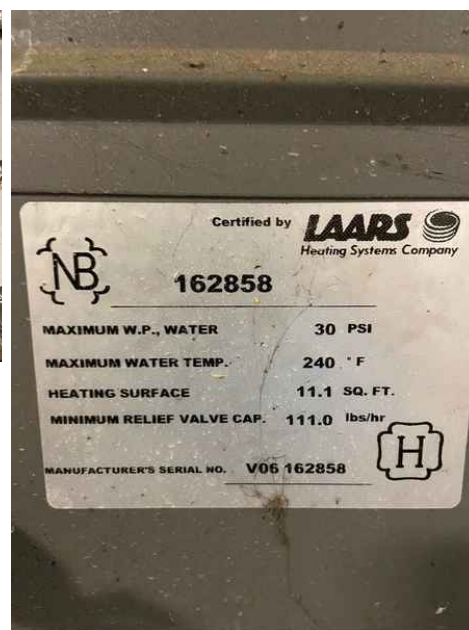
LAARS

The heating system (LAARS) was manufactured in 2006. The serial number is (Please see image) and model number is (Please see image) and has a 40 year life expectancy.

A qualified licensed HVAC/plumbing professional should clean, service and certify the system annually.

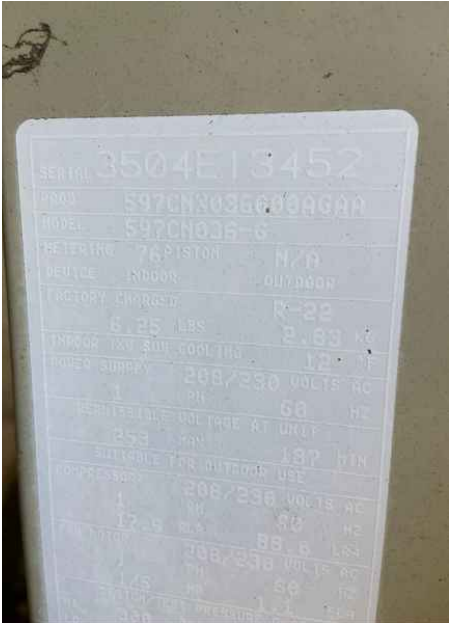
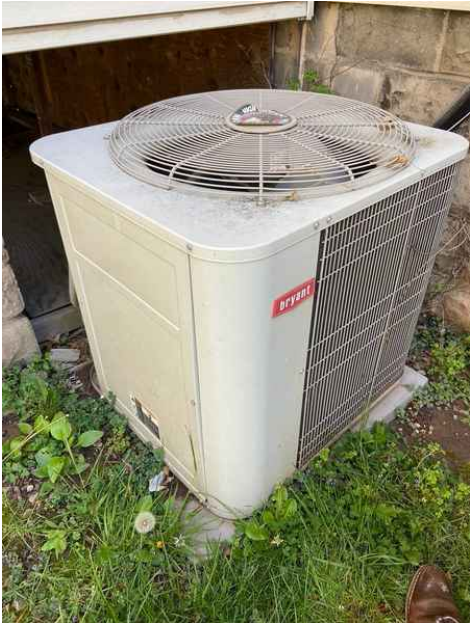
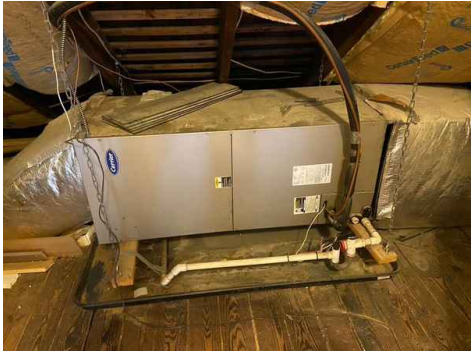
Equipment: Brand
Bryant, Carrier

The a/c system (Carrier) was manufactured in 2005. The serial number is (Please see image) and model number is (Please see image) and has a 15-20 year life expectancy. The condenser unit (Bryant) was manufactured in 2004. The serial number is (Please see image) and model number is (Please see image) and has a life expectancy of 7-15 years.

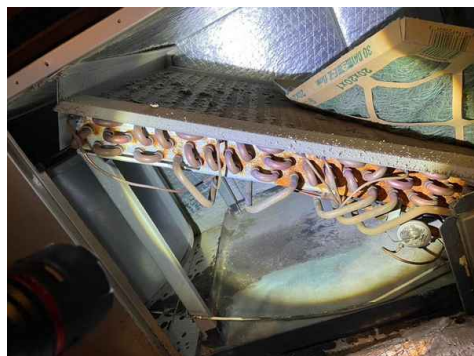
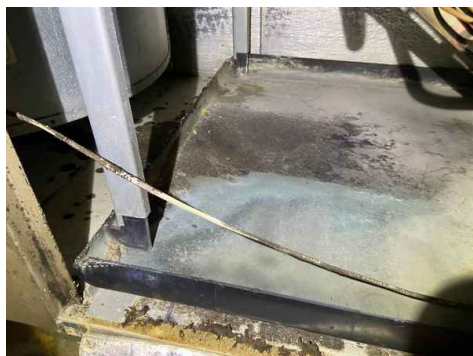
CORROSION

The evaporator coil was observed to be corroded. This is caused by moisture from condensation of the cold air, and humid conditions. This can accelerate aging of the unit. There was also excessive dust all over the coil from the issue with the air filter. A qualified licensed professional should evaluate, and advise as necessary.

Contact a qualified professional.

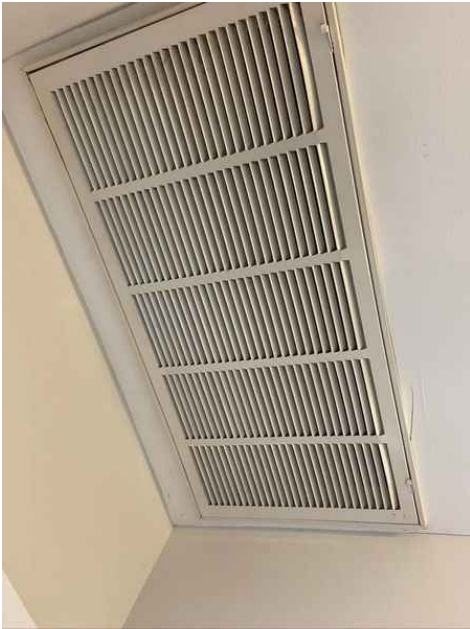
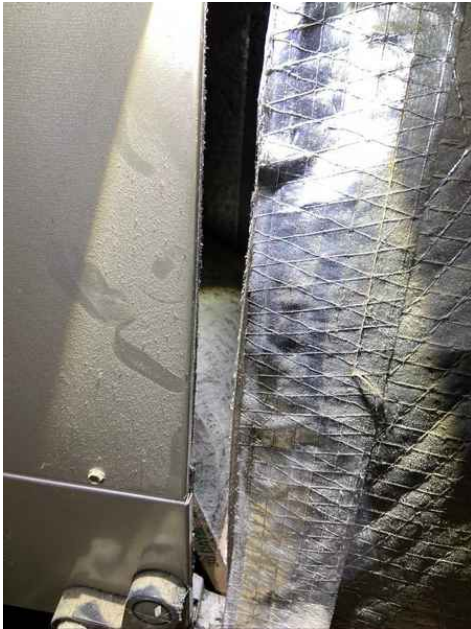
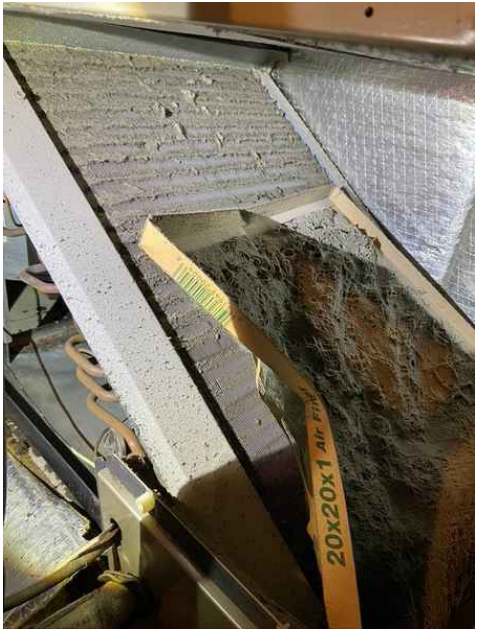
8.4.1 Distribution System

The filter going into the air handler is dirty, damaged, and has completely been compromised, leaving the system covered in dust. The filter should be installed in the overhead grill in the second floor hallway, and this penetration on the side of the unit should be sealed. It is undeterminable at the time of inspection what the correct sized filter should be used, but the correct size filter should be replaced every 1 to 3 months to maintain efficiency. A qualified licensed professional should evaluate the damage caused to the system, then repair and replace as necessary.

Contact a qualified professional.

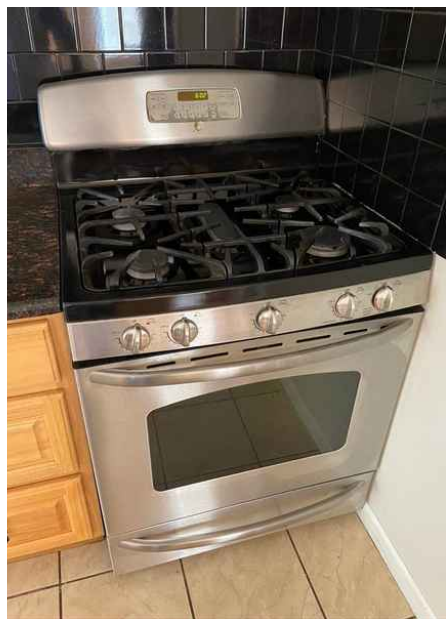
Range/Oven/Cooktop: Operational

The Oven and Stove Top were operational at the time of the inspection.

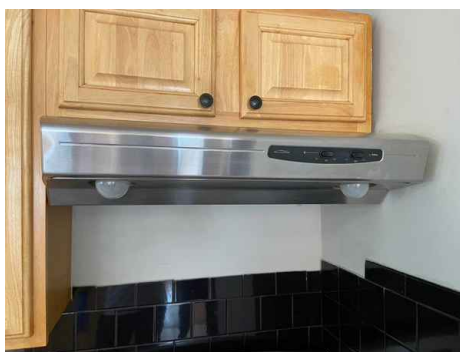
Exhaust Fan: Operational

The Vent Fan was operational at the time of the inspection.

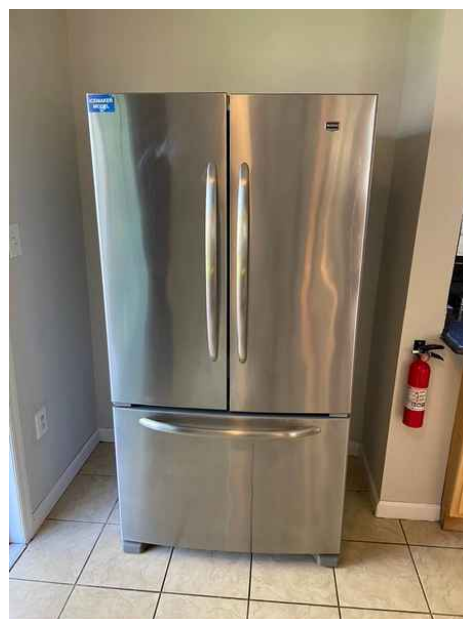
Refrigerator: Operational

The refrigerator was operational at the time of the inspection.

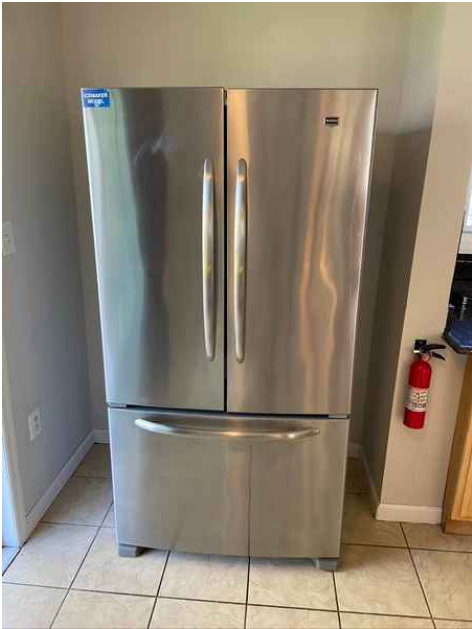
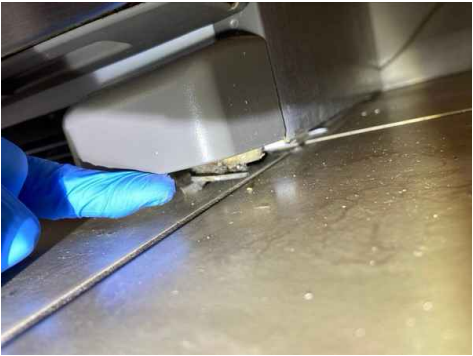
The refrigerator was observed to be wobbling. The leg stand that needs to be adjusted down to stabilize the refrigerator, appeared to be damaged underneath. A qualified licensed professional should repair.

Contact a qualified professional.

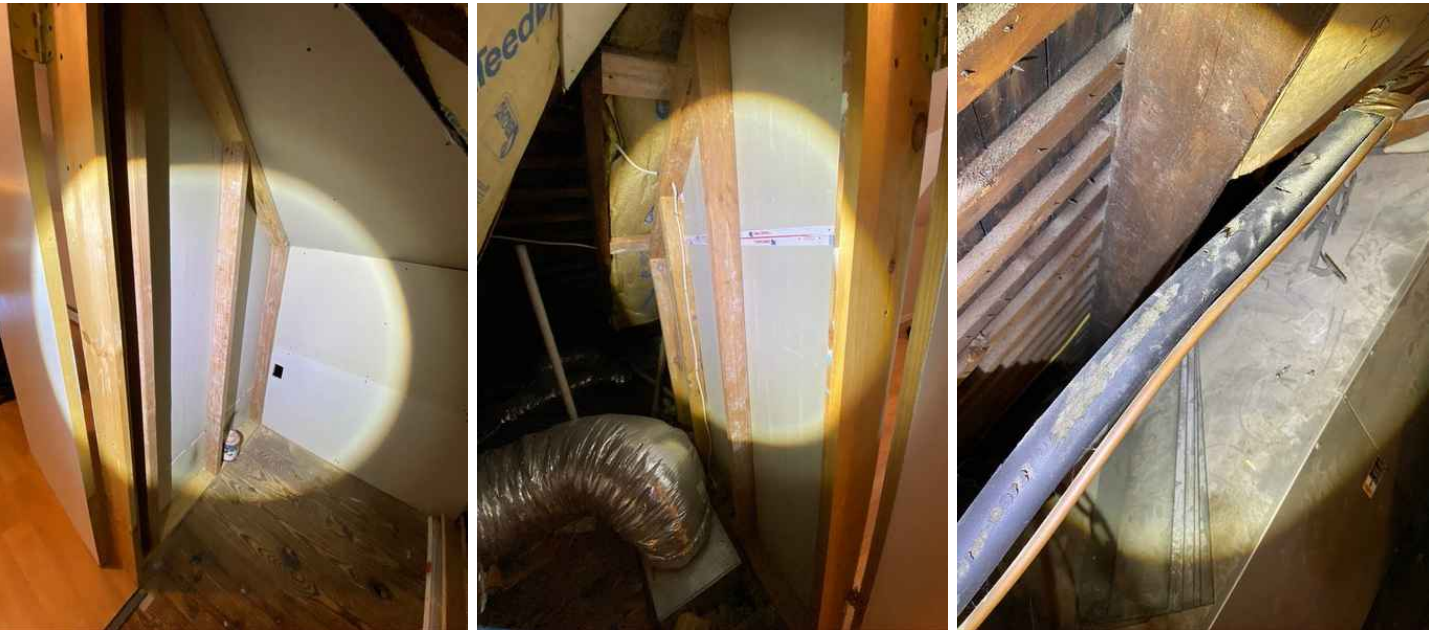
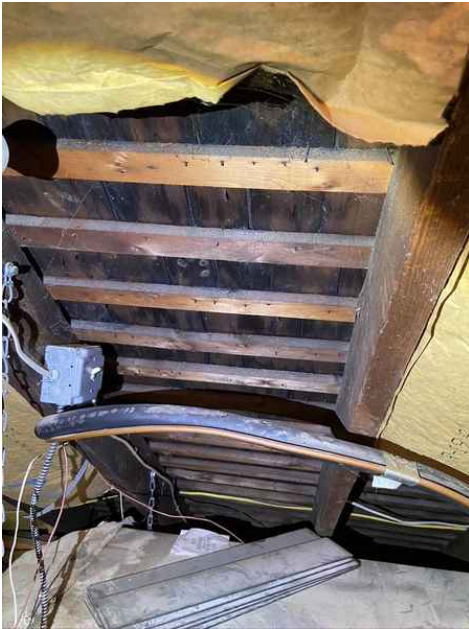
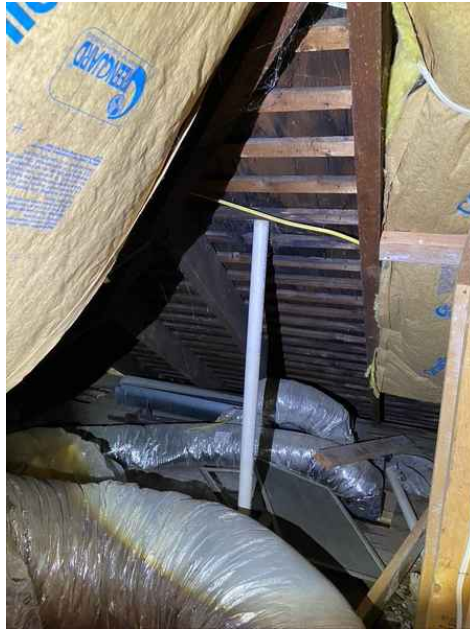
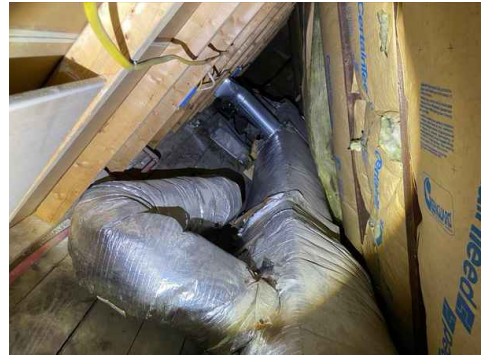
AREAS MISSING INSULATION

Fiberglass (Batts) insulation has been removed in areas of the attic. Heat loss can occur more on this home than one that is properly insulated. When installed, the insulation paper should face the interior of the house. I recommend all living space walls be insulated, rather than the roof structure insulating the attic space. A qualified licensed contractor should repair and replace as needed.

Contact a qualified professional.

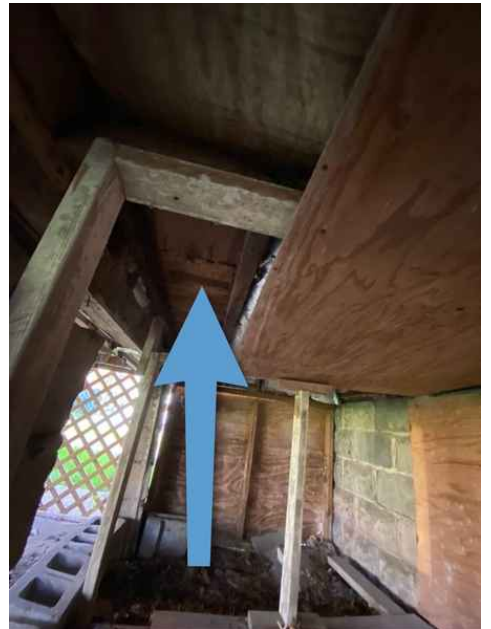
10.4.1 Insulation under floor system

The insulation has fallen in areas under the floor in the crawlspace. This is a maintenance issue. A qualified licensed contractor should repair and replace as necessary.

Contact a qualified professional.

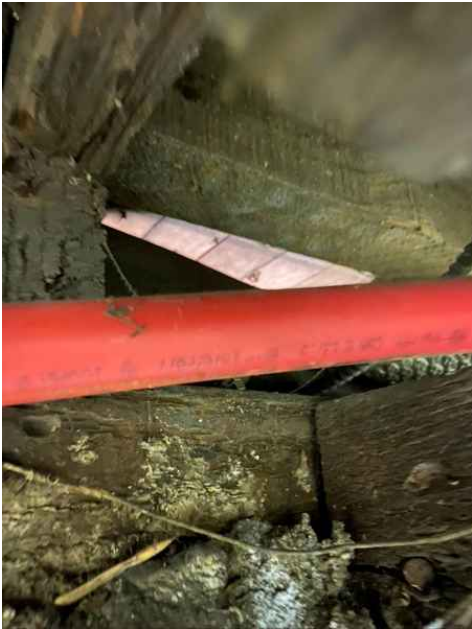
10.4.2 Insulation under floor system

The insulation was only present in a few areas of the basement between rim joists and floor joists. This is a maintenance issue. A qualified licensed contractor should repair and replace as necessary.

Contact a qualified professional.

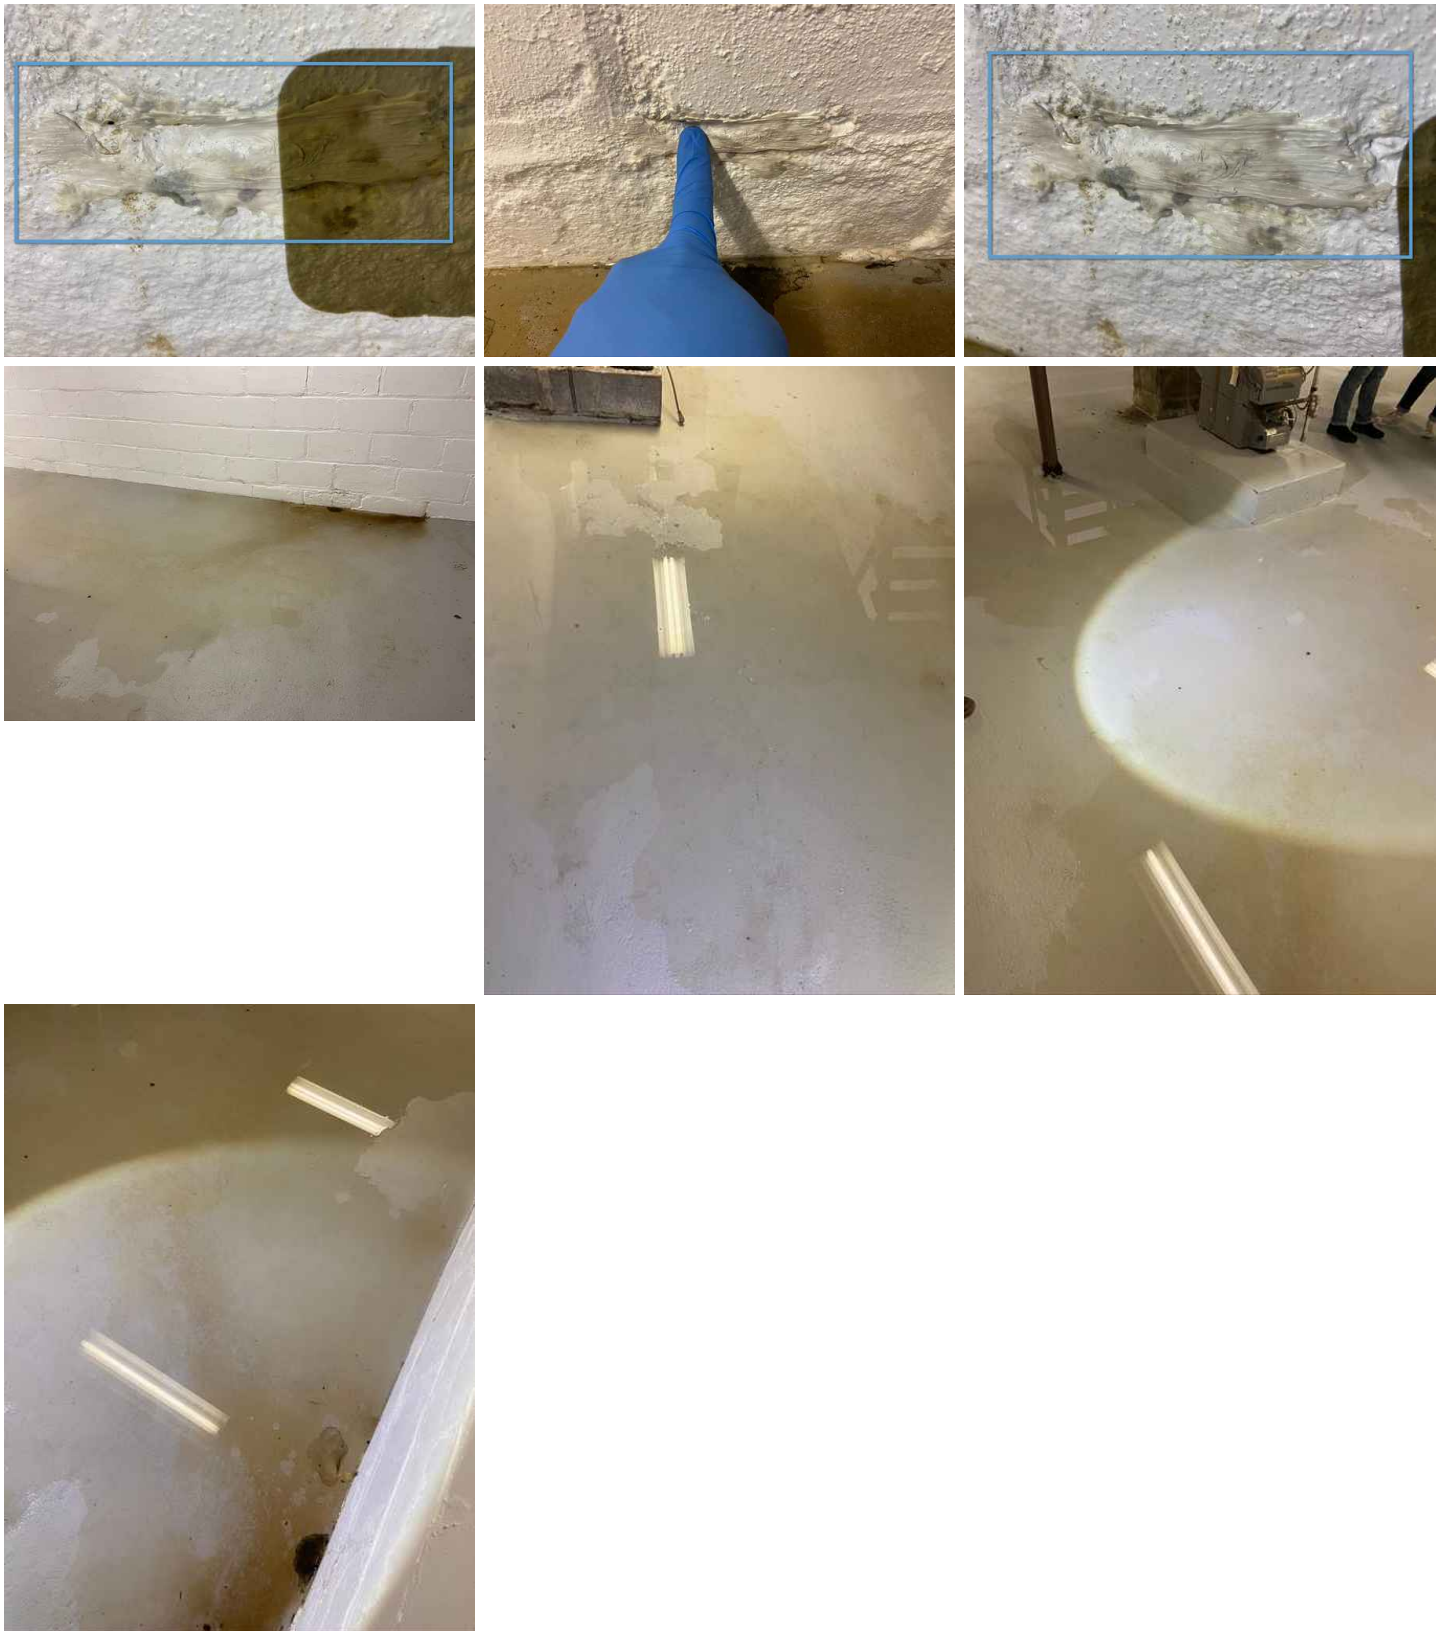
Water intrusion was evident through the foundation walls in the basement. Poor drainage, along with temporary patch work have all lead to moisture becoming an issue in the basement. Caulking is not a means of preventing moisture intrusion through masonry walls (see Clark Griswold at the Hoover Dam). The source of moisture must be corrected through proper gutter and drainage repairs, grading around the exterior foundation, and PROPERLY sealing all penetrations in foundation walls with appropriate materials. A qualified licensed professional should evaluate and provide a report on course of action and remedy.

Recommendation
Contact a qualified professional.
