TFHI RESIDENTIAL REPORT

1234 Main St. Union NJ 07083

Buyer Name
04/24/2020 9:00AM

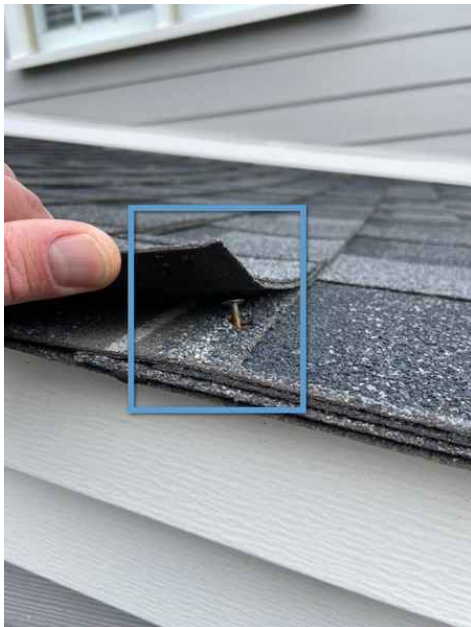
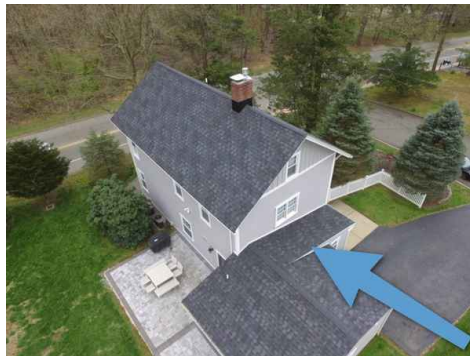
Observed one under-driven nails/fasteners. This can compromise the seal of the roofing materials, allowing moisture penetration. This was on the roof over the garage. A qualified licensed roofing contractor should repair and replace as necessary.

Contact a qualified roofing professional.

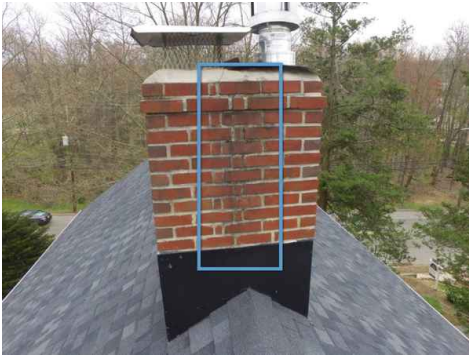
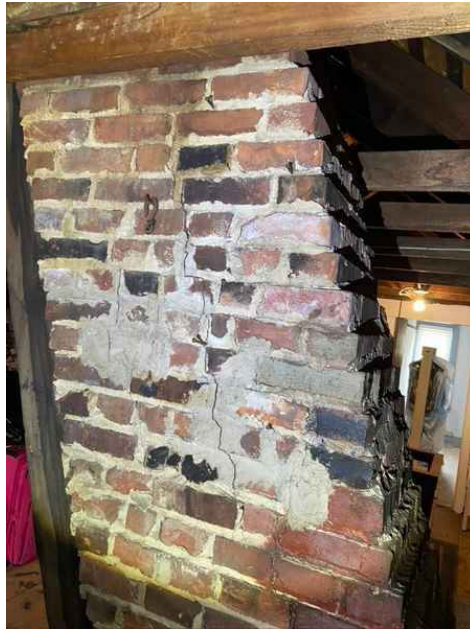
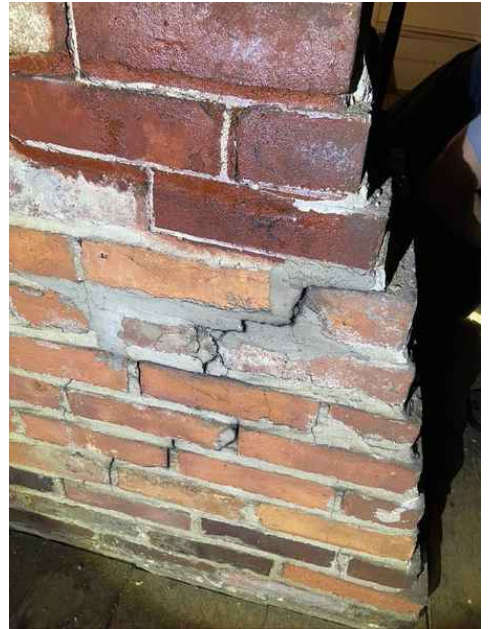
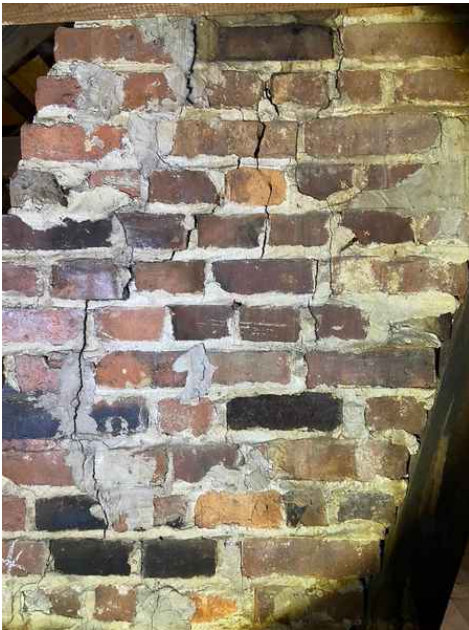
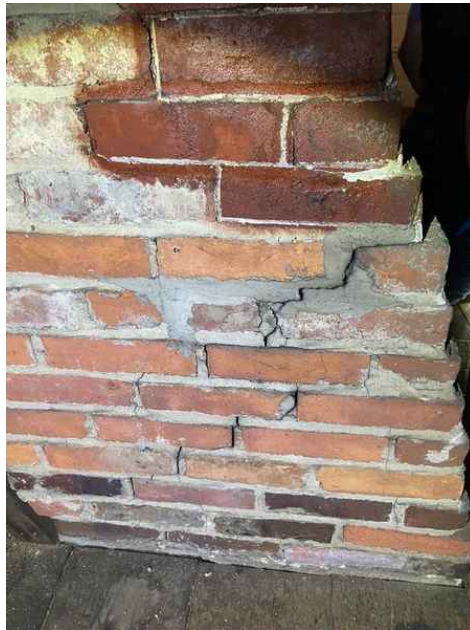
2.4.1 Skylights, Chimneys & Other Roof Penetrations

CHIMNEY MASONRY DAMAGED

One or more areas of the masonry chimney are damaged/cracked. This can be evidence of movement, or settlement, based on the design of the chimney. A qualified licensed structural engineer should evaluate and advise.

Contact a qualified professional.

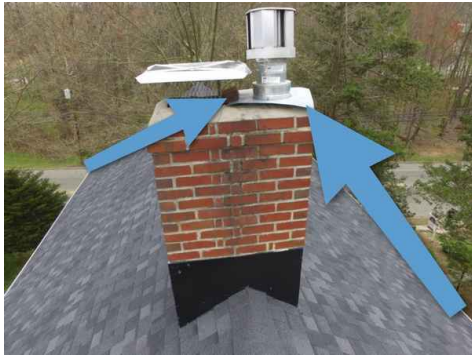
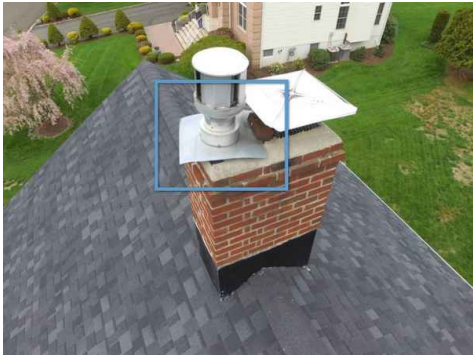
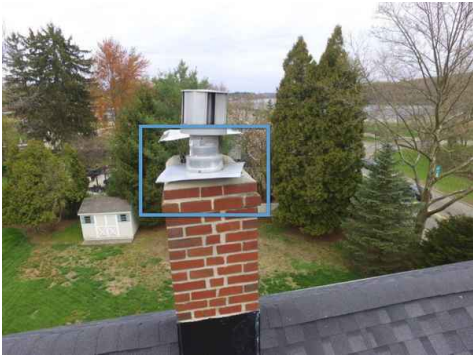
2.4.2 Skylights, Chimneys & Other Roof Penetrations

CHIMNEY FLUE CAP POSSIBLY LOOSE

The chimney flue cap at the top of the chimney was observed to be crooked, lifted, and possibly loose. There was also what appeared to be a loose brick lying between the two flues at the top of the chimney. A qualified licensed roofing professionally should evaluate, and repair and replace as necessary.

Contact a qualified professional.

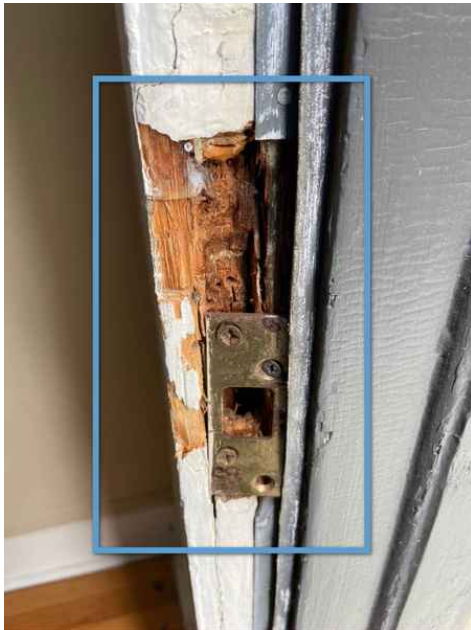
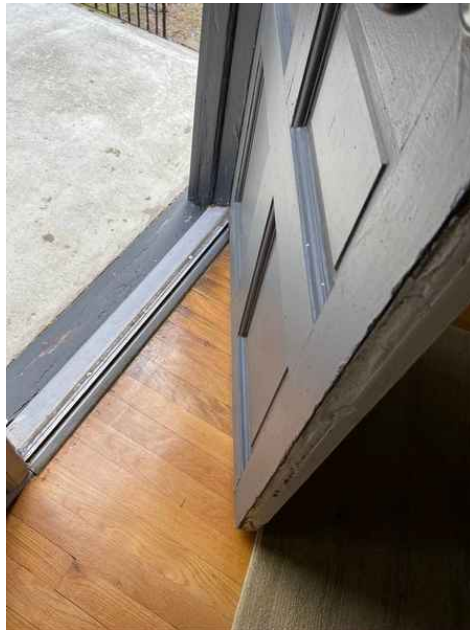
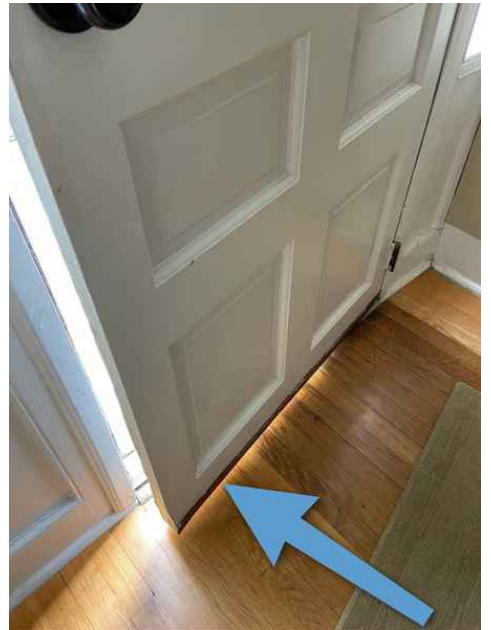
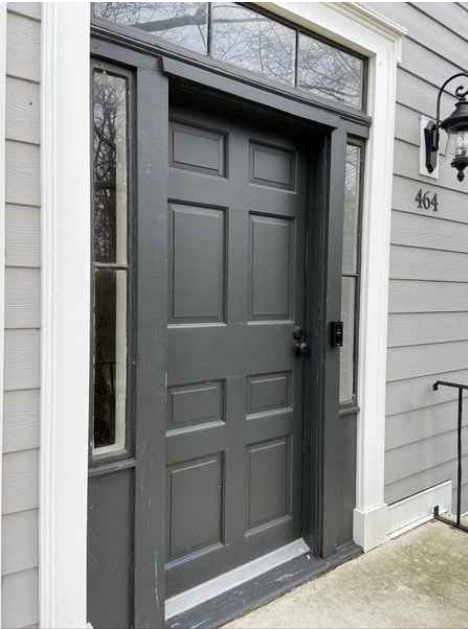
DAMAGED

The exterior front door showed signs of general damage, and was difficult to operate. This is a maintenance issue. A qualified licensed professional should repair and replace as necessary.

difficult to close

Contact a qualified professional.

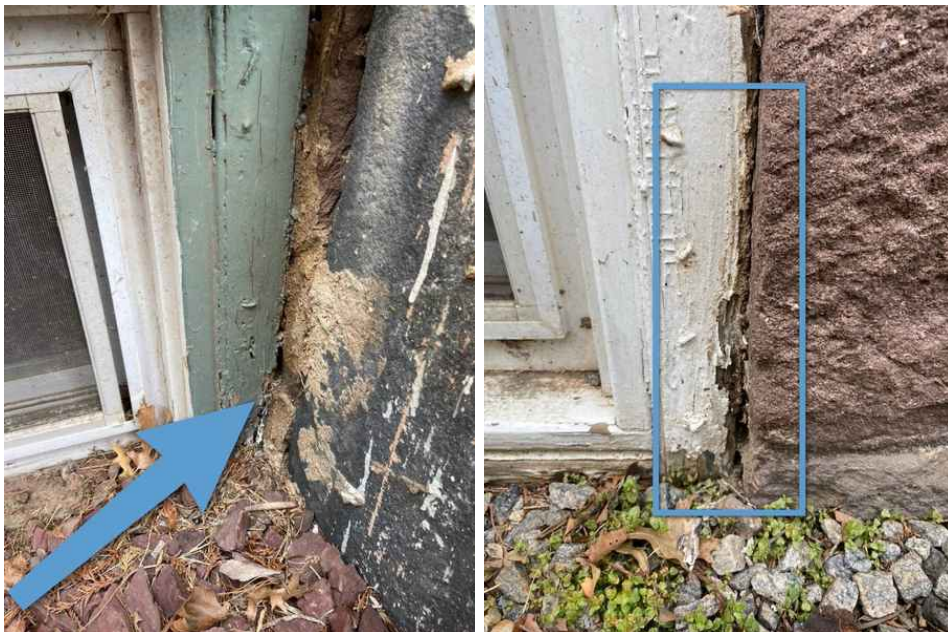
3.3.1 Exterior Windows

WINDOW TRIM TERMITE DAMAGE

The basement window trim was observed to show signs of termite damage. The window trim is in contact with the soil, which allows for termites and other wood destroying insects easy access. A qualified licensed pest control company should evaluate and advise as necessary for treatment.

Contact a qualified professional.

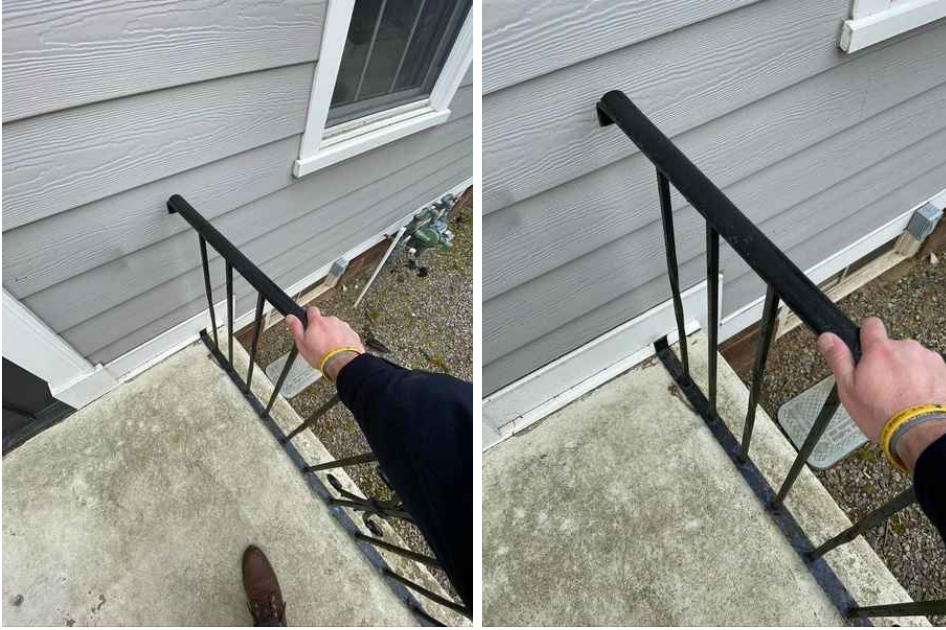
3.6.1 Decks, Balconies, Stoops, Porches, Railings & Steps

HANDRAIL/BALUSTER LOOSE

I observed that the handrail to the right of the front door was loose. This is a safety hazard. A licensed qualified professional should repair or replace as necessary.

Contact a qualified professional.

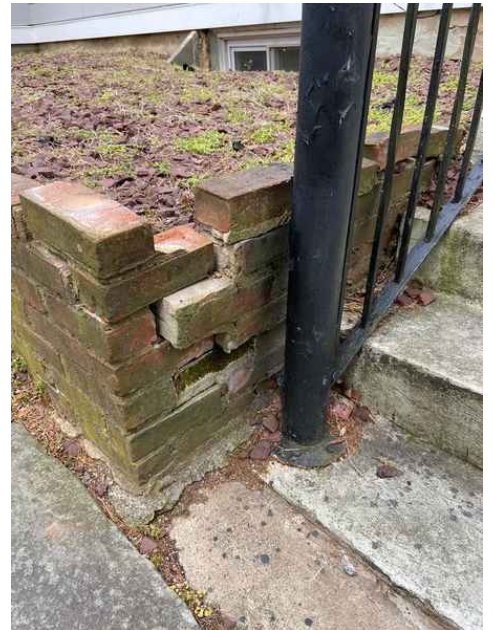
3.7.1 Vegetation, Grading, Drainage & Retaining
Walls

RETAINING WALL DAMAGED MASONRY/LOOSE CAPS

The retaining wall had damaged masonry. This is a maintenance issue. Please monitor and repair as needed.

Contact a qualified professional.

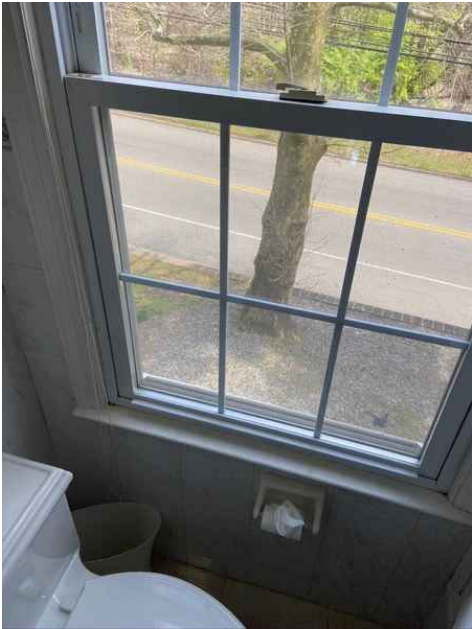
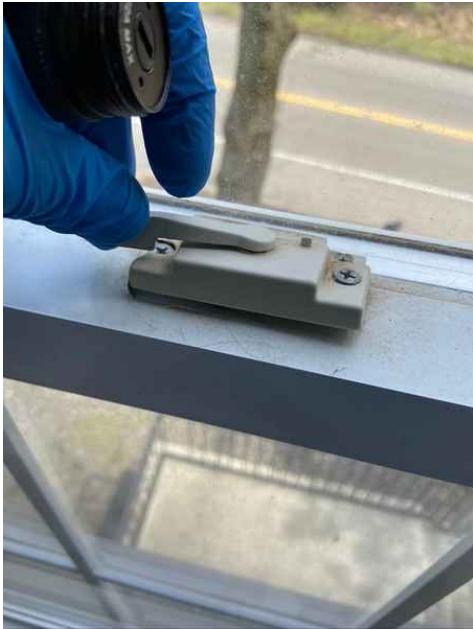
MISSING/DAMAGED WINDOW LOCKS

A couple upstairs windows (bathroom and bedroom) have damaged and/or missing locking mechanisms. This is a maintenance issue. A qualified licensed professional should repair and replace as necessary.

Contact a qualified professional.

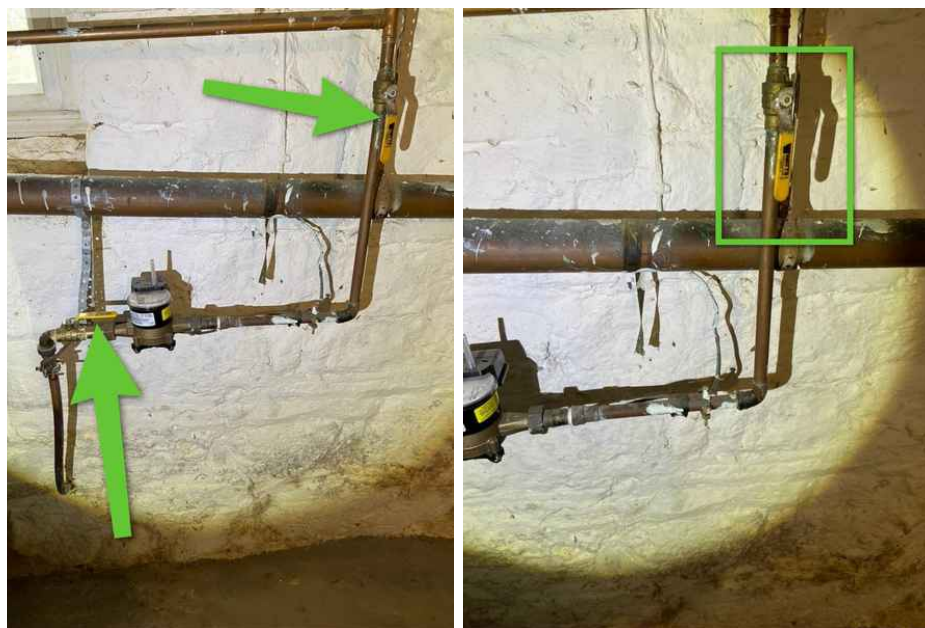
The main shut off is the yellow lever. This is for your information.

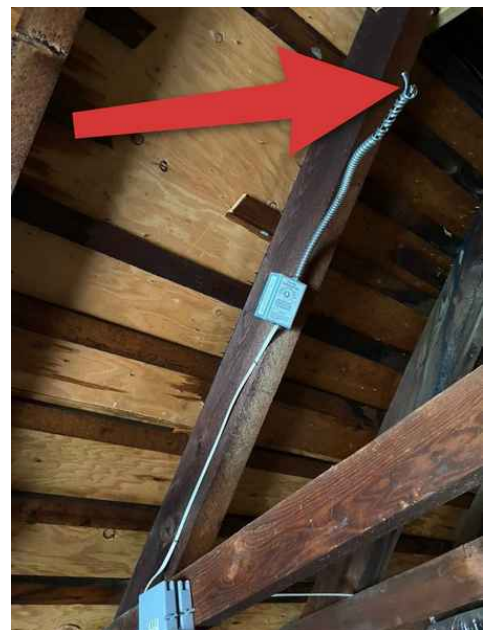
DAMAGED WIRE HAZARD

A previous attic fan wire appears to be damaged and exposed. This is a safety hazard. A qualified licensed professional should repair and replace as necessary.

Contact a qualified professional.

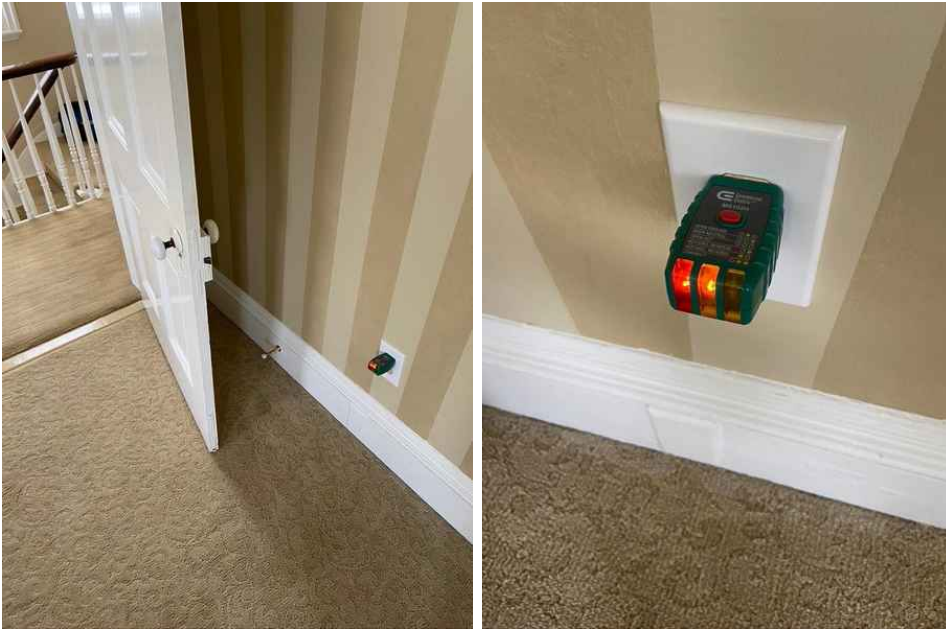
6.4.2 Lighting Fixtures, Switches, Wiring & Receptacles

One master bedroom receptacle has been wired with reverse polarity. This can create a shock hazard. A qualified licensed electrician should repair and replace as necessary.

Contact a qualified electrical contractor.

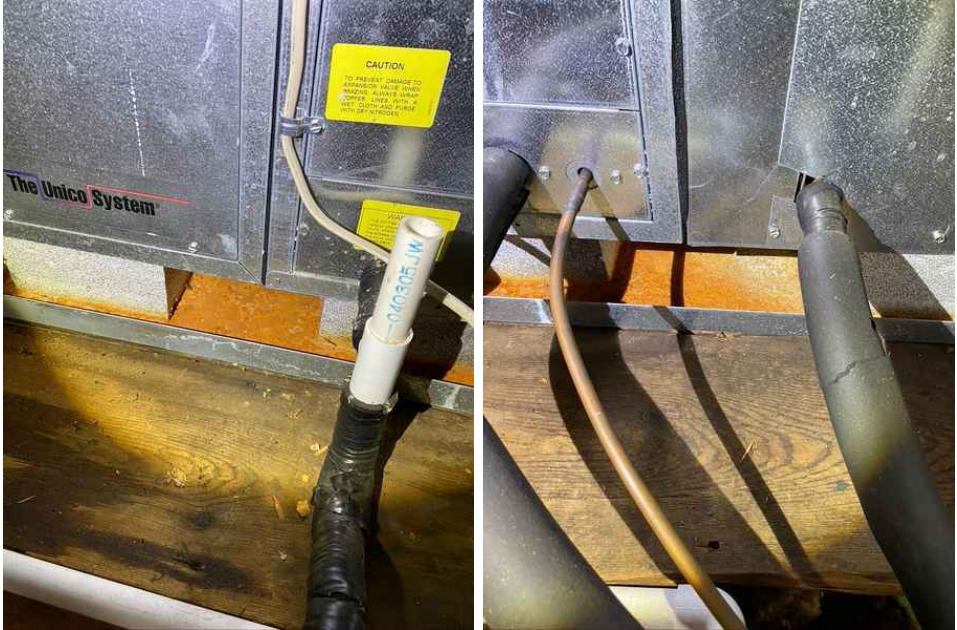
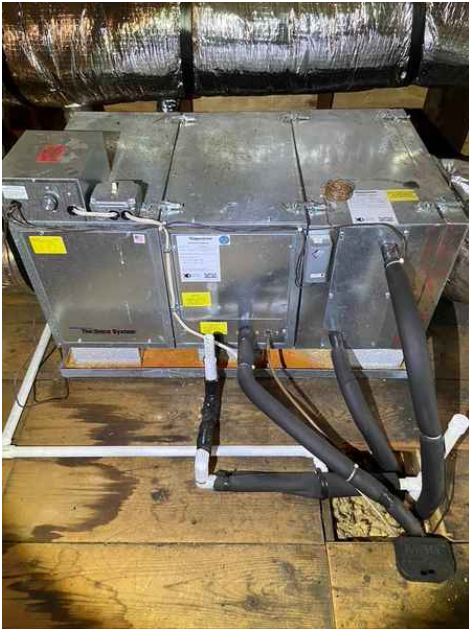
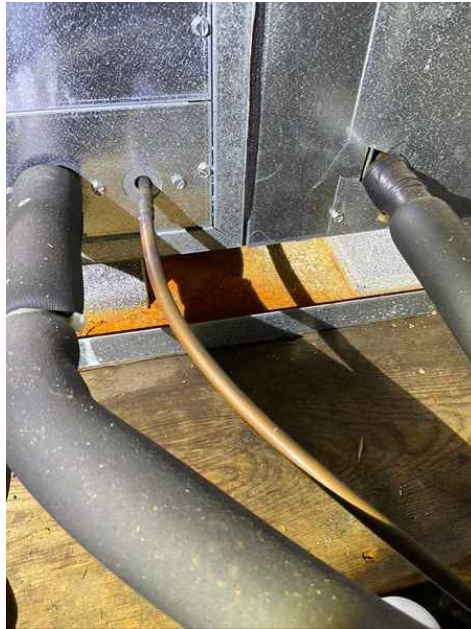
7.2.2 Equipment

LEAKING CONDENSATE TRAY

Contact a qualified HVAC professional.

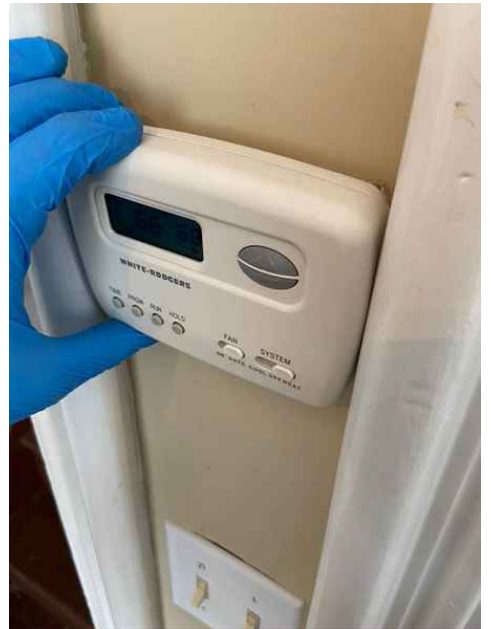
7.3.1 Normal Operating Controls

LOOSE THERMOSTAT

Contact a qualified HVAC professional.

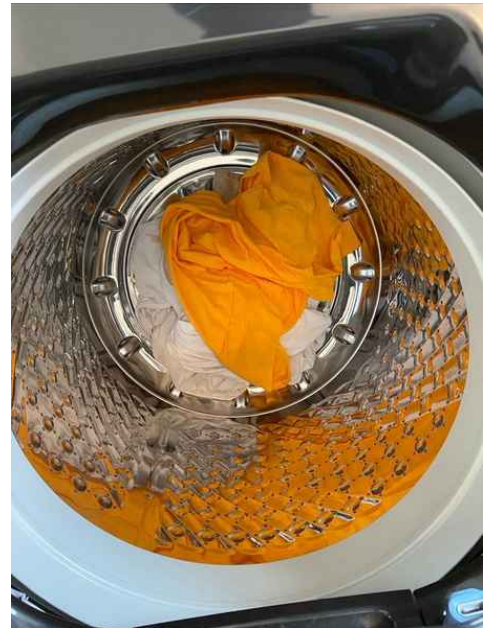
STORED PERSONAL ITEMS

Stored personal items inside the washer limited my ability to run the washing machine.

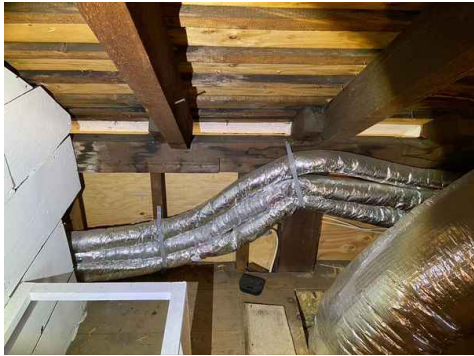
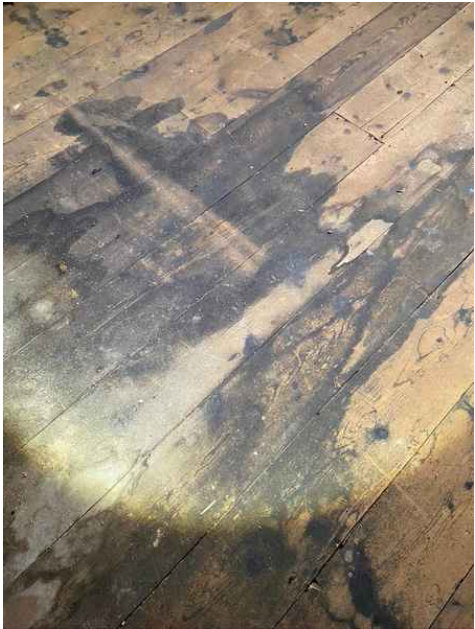
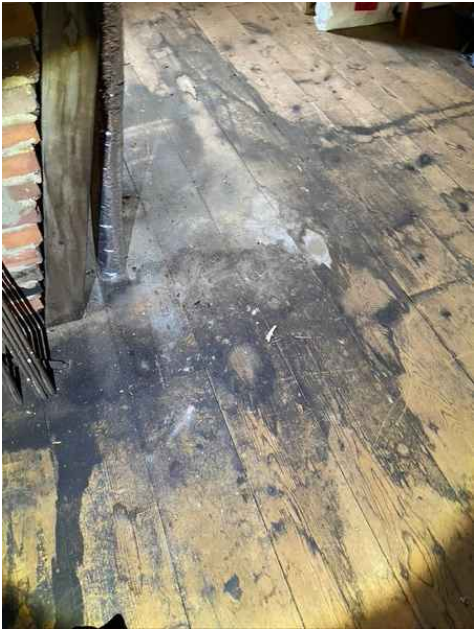
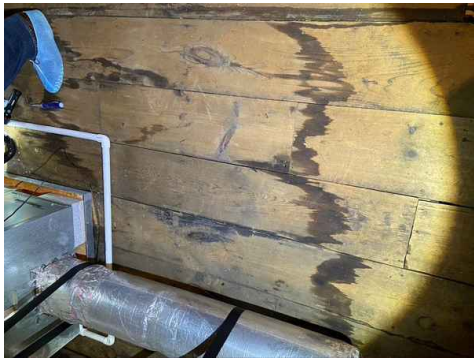
10.7.1 Roof Structure & Attic

MILDEW STAINS IN ATTIC

Contact a qualified roofing professional.
