TF HOME INSPECTION

## TFHI RESIDENTIAL REPORT

1234 Main St. Union NJ 07083

04/24/2020 9:00AM

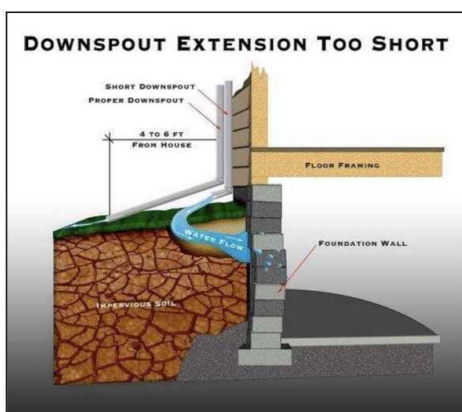
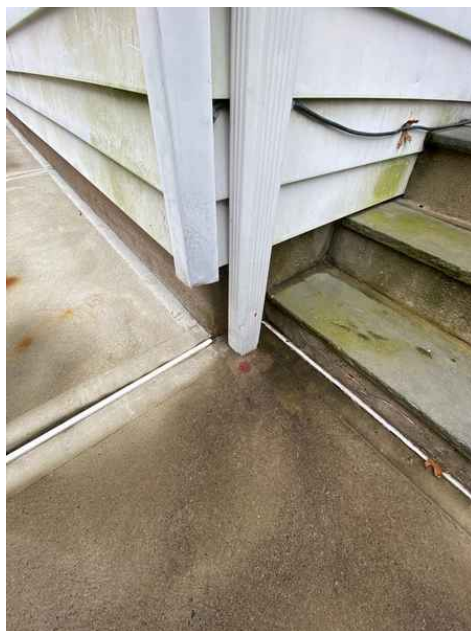
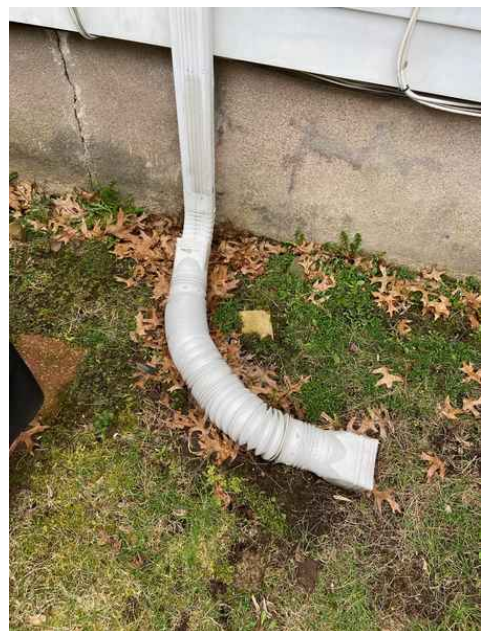
The downspout needs an extension and or a buried drain line to carry water away from the home at the front, rear and sides of home. Having the downspouts terminate at such a short distance can allow for water to penetrate the basement during heavy rain. This can cause damage to the interior finishes of the basement and the foundation. I recommend a qualified licensed contractor repair or replace as needed.

Contact a qualified gutter contractor

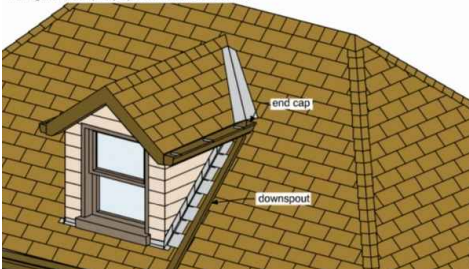
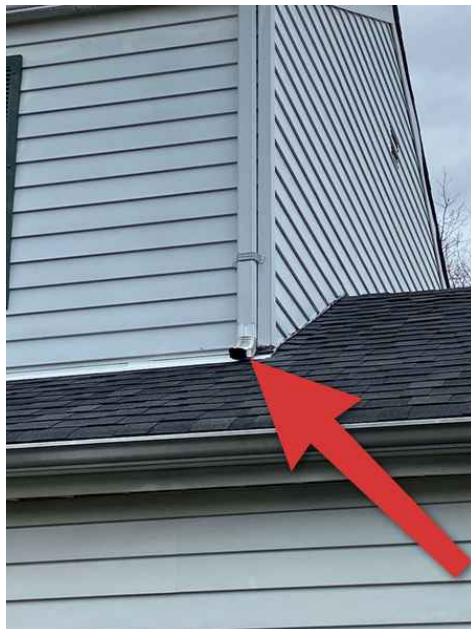
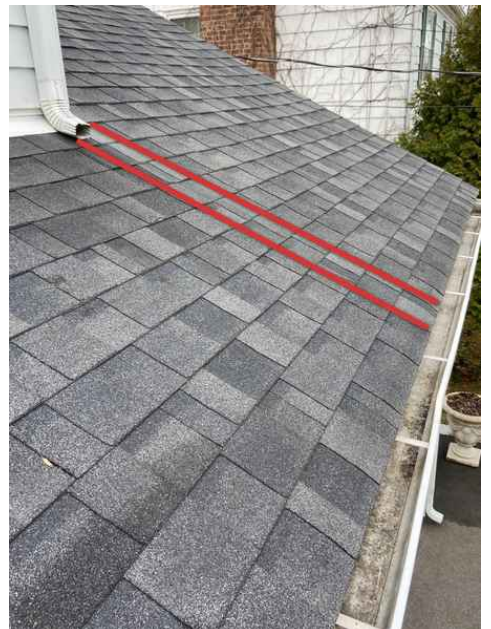
### 2.2.2 Roof Drainage Systems

I recommend continuing the downspout into the lower gutter. Always try to alleviate discharge onto lower roof when possible. Without these extensions, excess water can damage the roofing materials, causing penetration of water, and damage to the home. A qualified licensed professional should install an extension to the lower gutter.

**Downspout running across roof**  
installing a downspout (from the secondary roof to the main gutter below) helps prevent localized roof wear

Contact a qualified gutter contractor

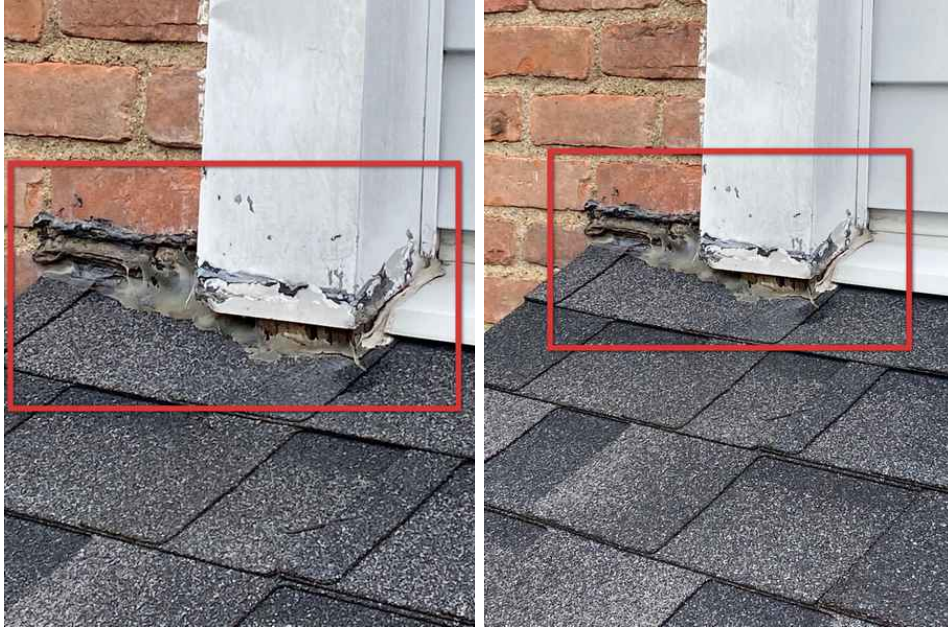
### 2.3.1 Flashings

I observed areas where the cap flashing was missing and the area was caulked, but the caulk has deteriorated and worn. These areas of missing flashing are prone to water penetration and have contributed to the deterioration of the wood member behind it. This specific area is above the front door. Flashing is installed to provide protection against roof leaks and to divert water away from certain areas. A licensed qualified roofer should repair or replace as necessary.

Contact a qualified roofing professional.

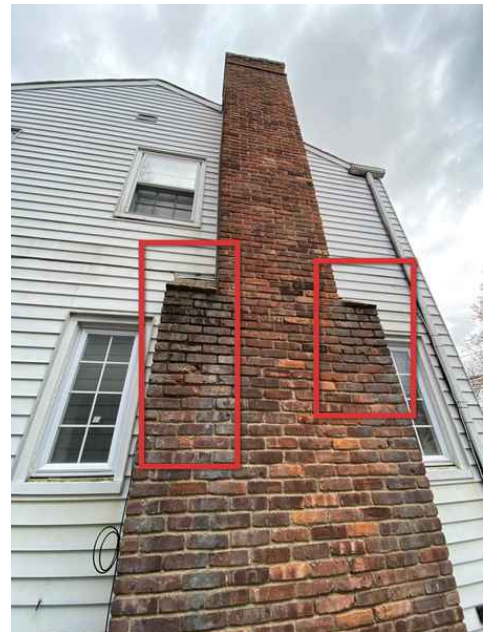
#### 2.4.1 Skylights, Chimneys & Other Roof Penetrations

Joints in the masonry have deteriorated and should be repointed. Repointing is the restoration of the mortar joints in the masonry. A qualified licensed contractor should repair and replace as necessary.

Contact a qualified chimney contractor.

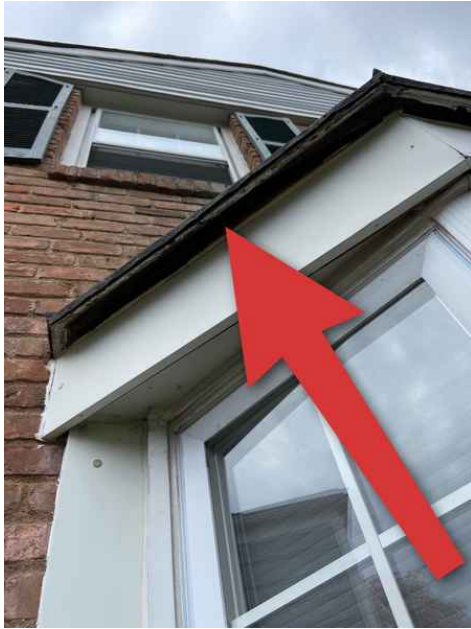
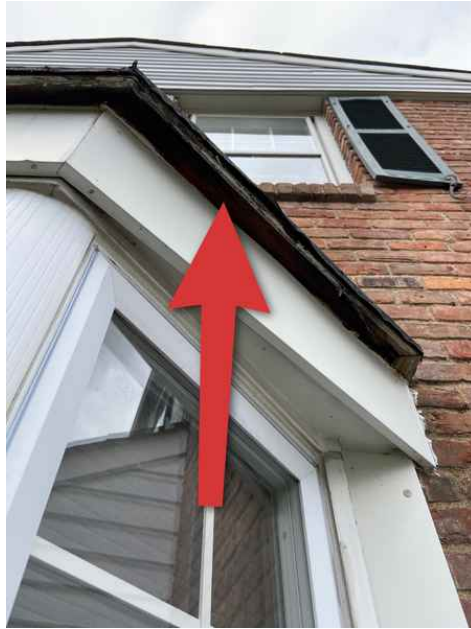
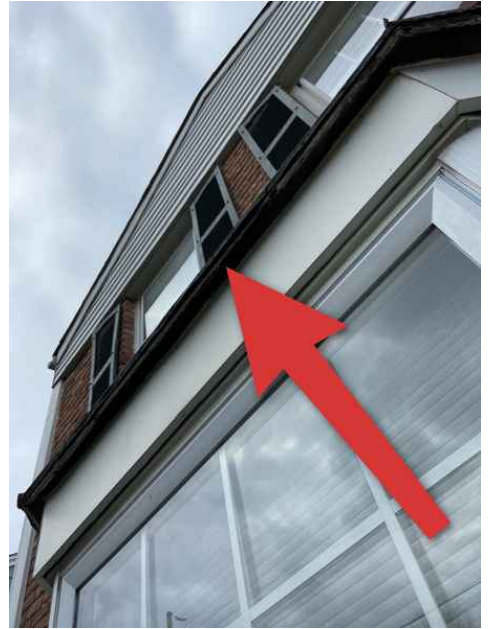
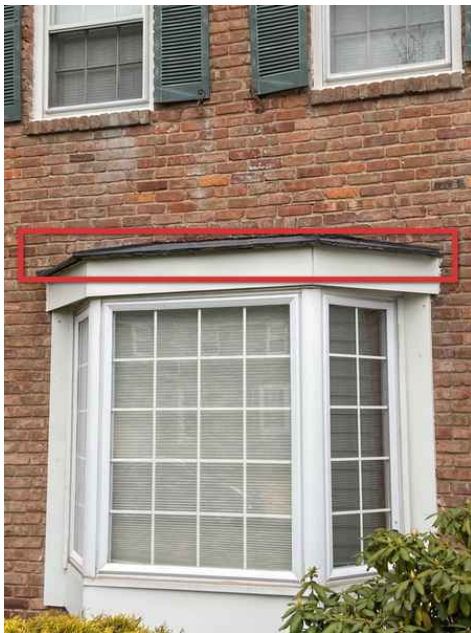
The trim above the window is showing signs of rot and deterioration. This can allow moisture to penetrate behind the covering and into the structure. A qualified licensed professional should paint the wood to protect it from rot and deterioration.

Contact a qualified professional.

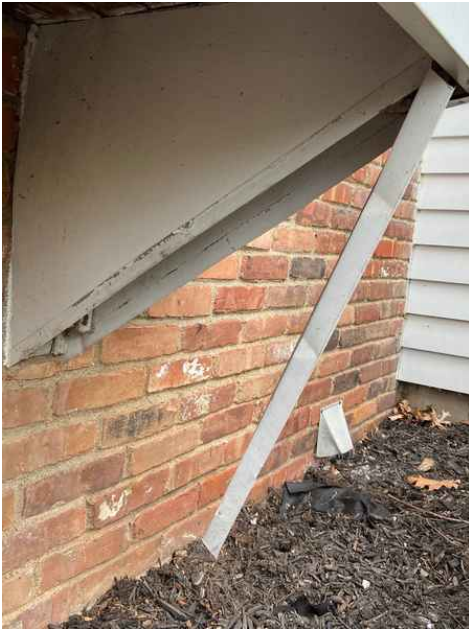
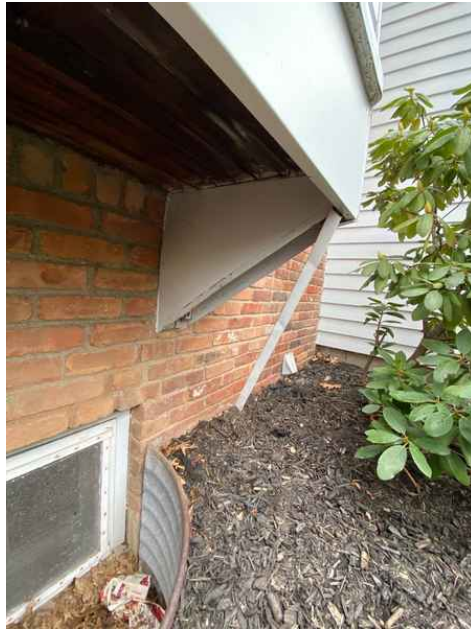
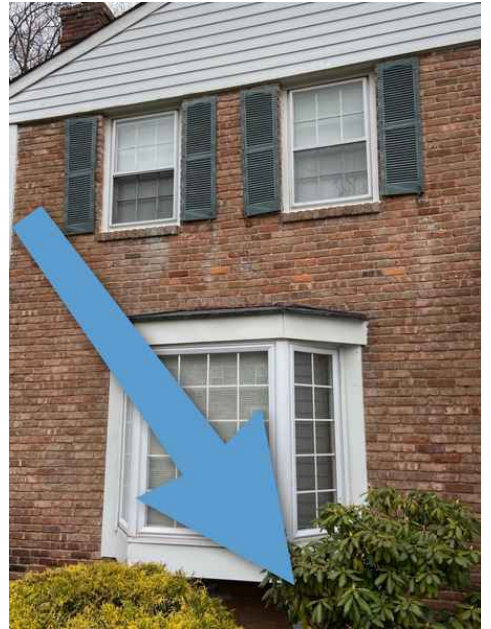
## 3.1.2 Wall Covering, Flashing &amp; Trim

A board/flashing strip under the front bay window was noted to be loose. This can result in moisture intrusion into the structure and interior finishes of the home. A qualified licensed siding contractor should repair and replace as necessary.

Contact a qualified siding specialist.

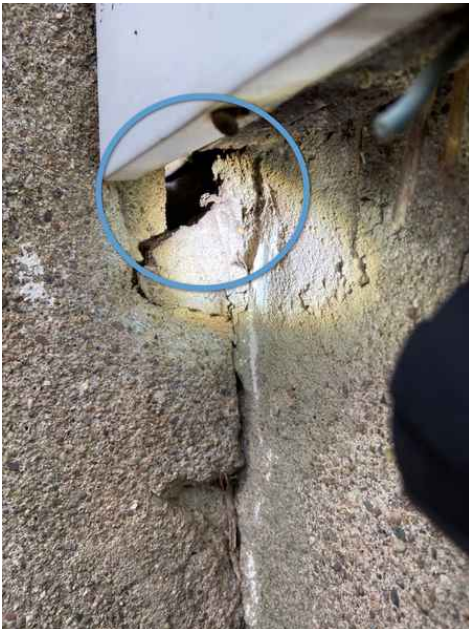
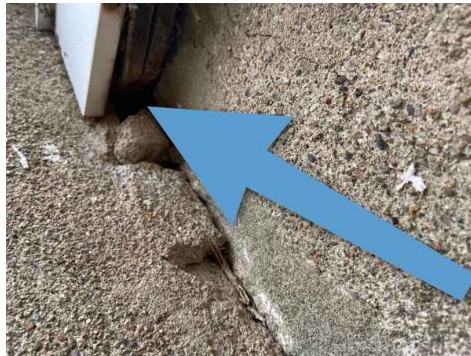
### 3.1.3 Wall Covering, Flashing & Trim

In the rear of the home, I witnessed a chipmunk, crawl in through a penetration behind the siding, through the foundation, into the crawl area under the addition. A qualified licensed pest control professional should evaluate and advise, and a qualified licensed professional should then seal the areas properly as necessary.

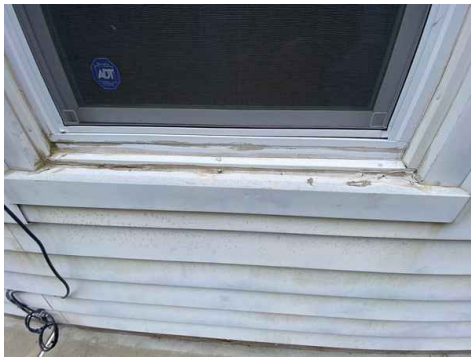
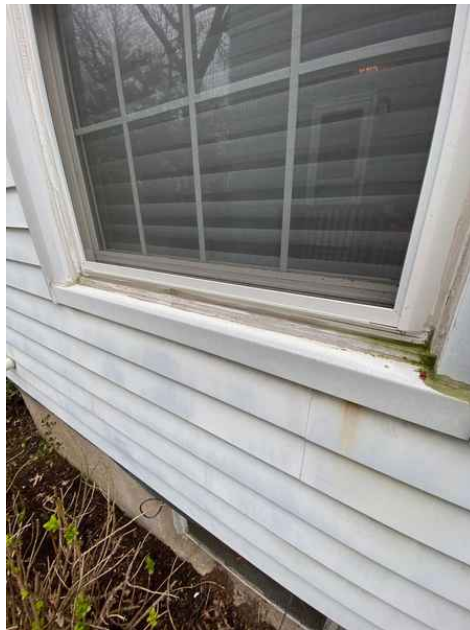
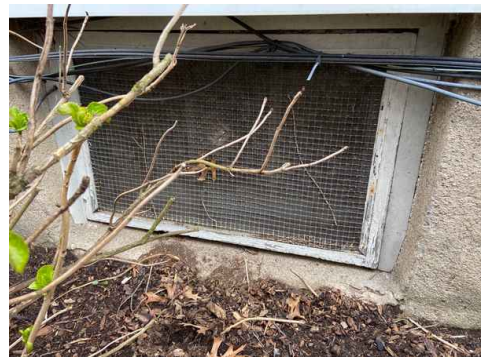
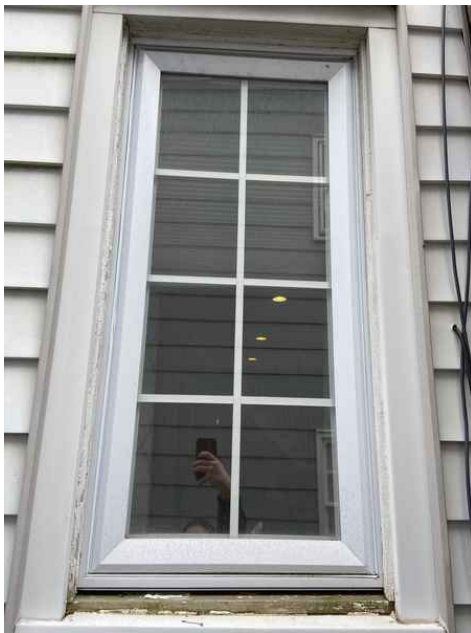
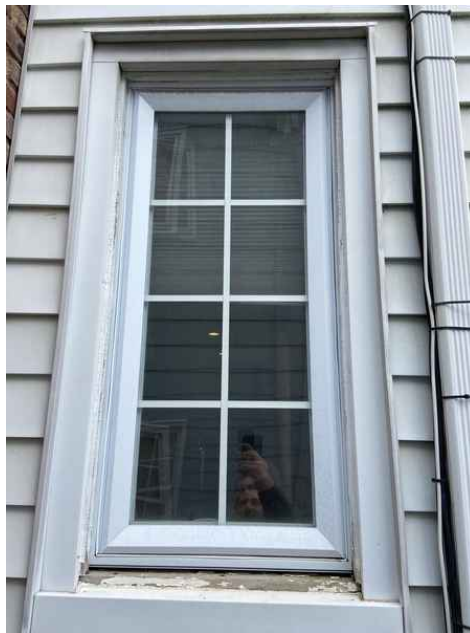
### 3.3.1 Exterior Windows

Exterior windows of the home would benefit from maintenance caulking and painting around the trim and window. This will prevent moisture from entering the materials of the home and causing damage. A qualified licensed professional should repair as necessary.

Contact a qualified professional.

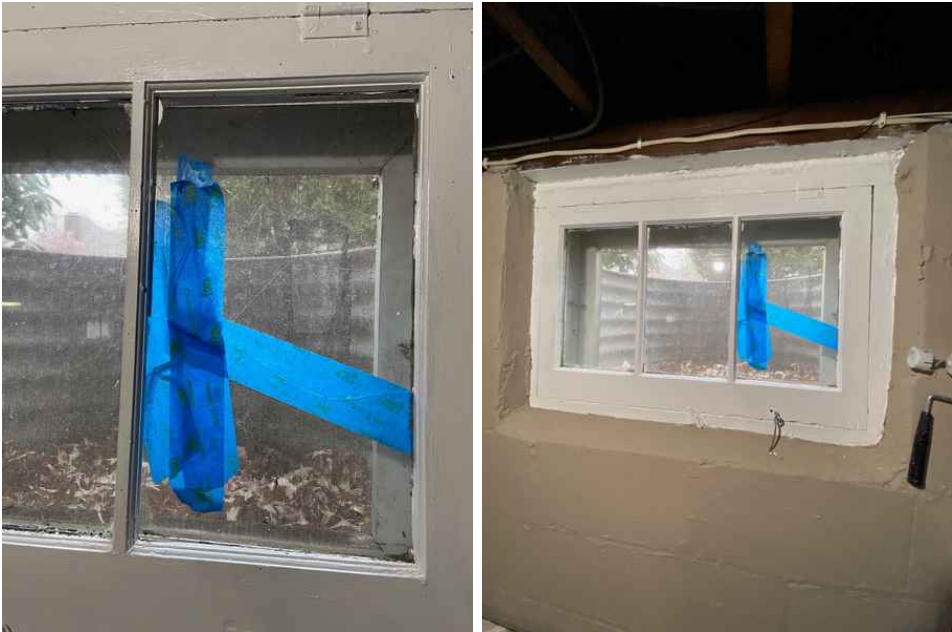
4.5.1 Windows (representative number)

The basement window facing the front of the home is cracked and taped over. This is a maintenance item. A qualified licensed professional should repair and replace as necessary.

Contact a qualified window repair/installation contractor.

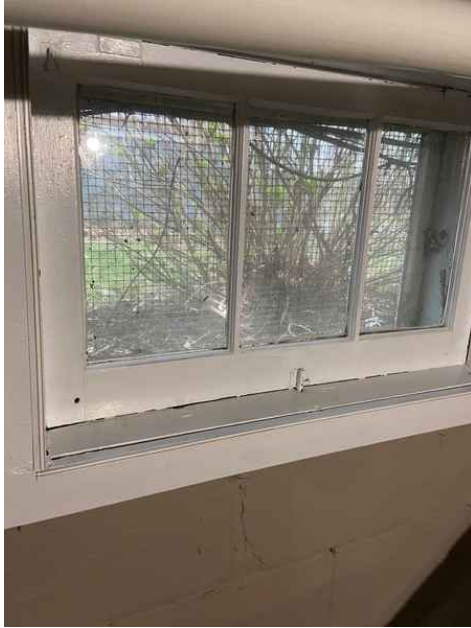
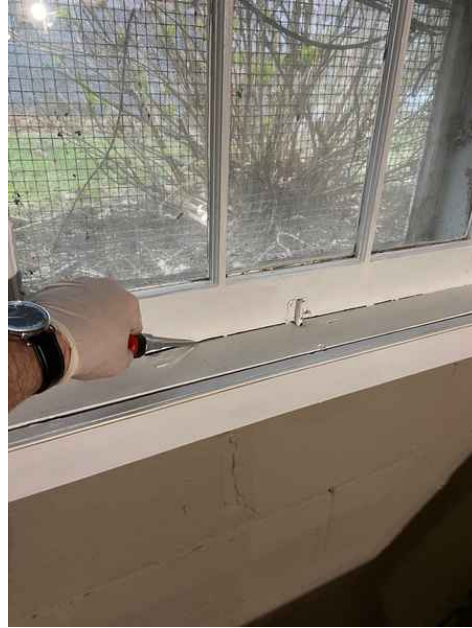
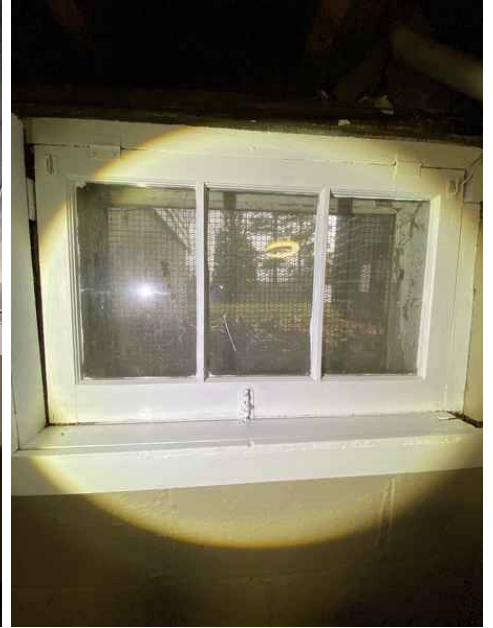
4.5.2 Windows (representative number)

One or more windows are painted shut in the basement. This is a safety hazard. A qualified licensed window contractor should evaluate, repair and replace as necessary.

Contact a qualified window repair/installation contractor.

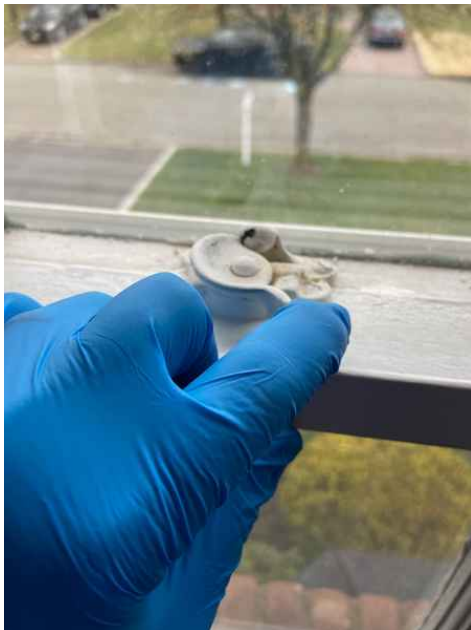
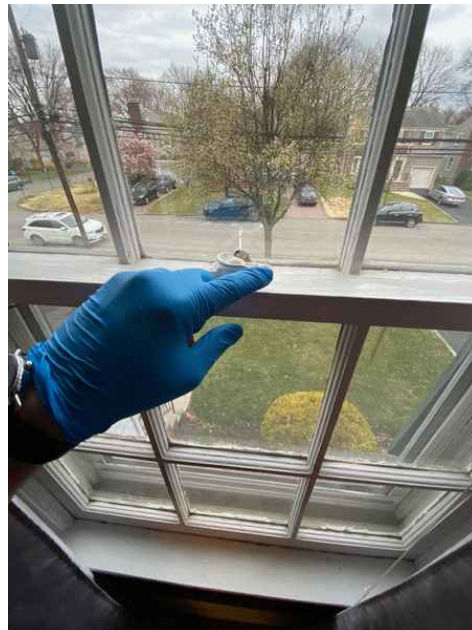
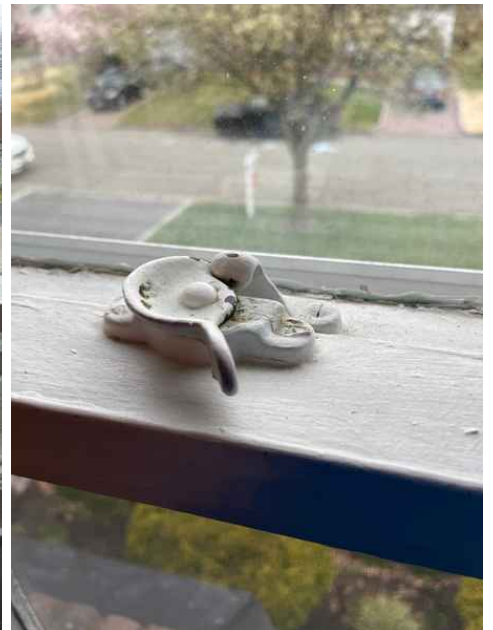
## 4.5.3 Windows (representative number)

Window locking mechanisms for the windows on the top floor need adjustment to line up properly for the window to lock shut. This is a maintenance item. A qualified licensed professional should repair and replace as necessary.

Contact a qualified professional.

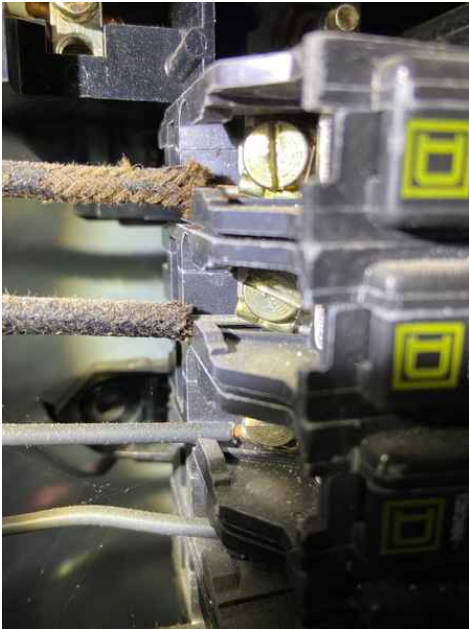
Branch wiring at the circuit breaker was observed to have a poor/loose connection. This is a safety hazard. A qualified licensed electrician should repair and replace as necessary.

Contact a qualified professional.

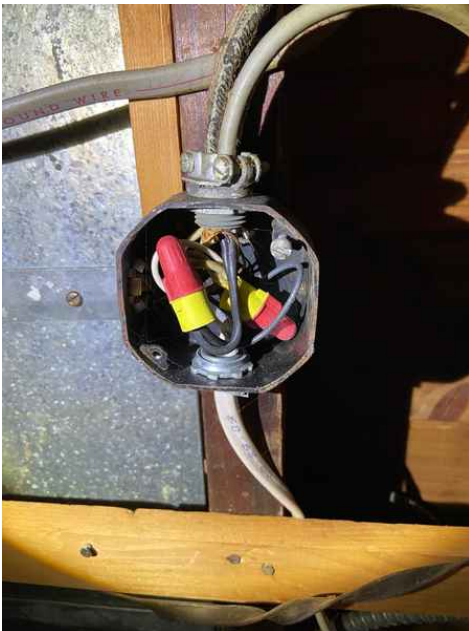
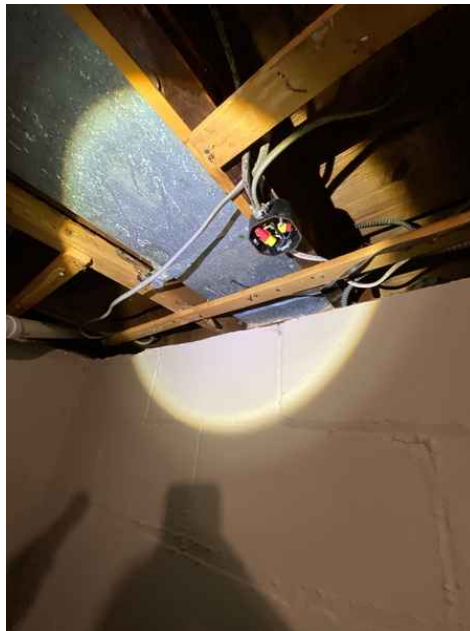
#### 6.4.1 Lighting Fixtures, Switches, Wiring & Receptacles

This junction box in the basement is missing a cover plate. This is a safety issue that poses a short and shock risk. A qualified licensed electrician should repair and replace as necessary.

Contact a qualified electrical contractor.

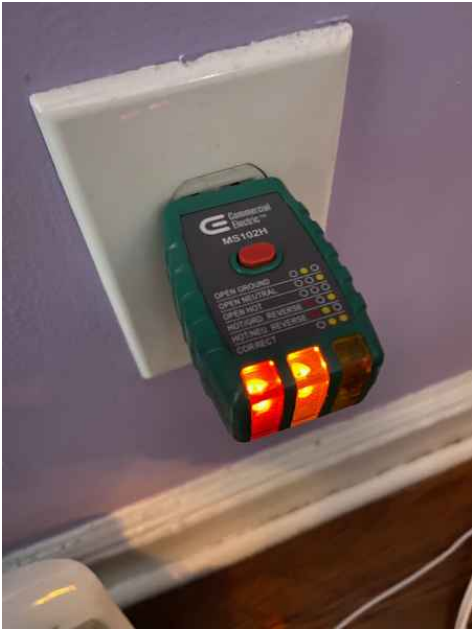
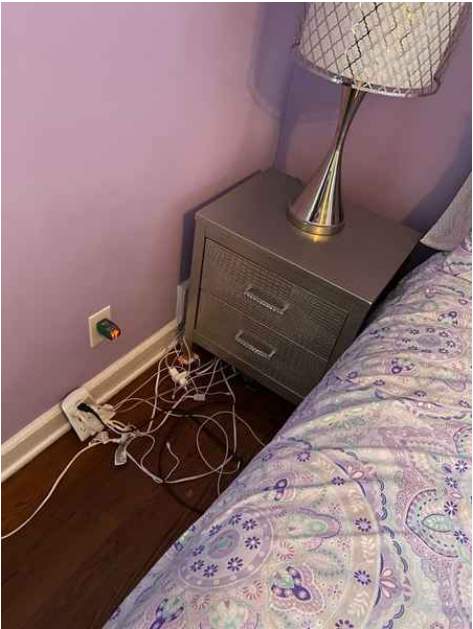
#### 6.4.2 Lighting Fixtures, Switches, Wiring & Receptacles

On receptacle in the pink bedroom has been wired with reverse polarity. This can create a shock hazard. A qualified licensed electrician should repair and replace as necessary.

Contact a qualified electrical contractor.

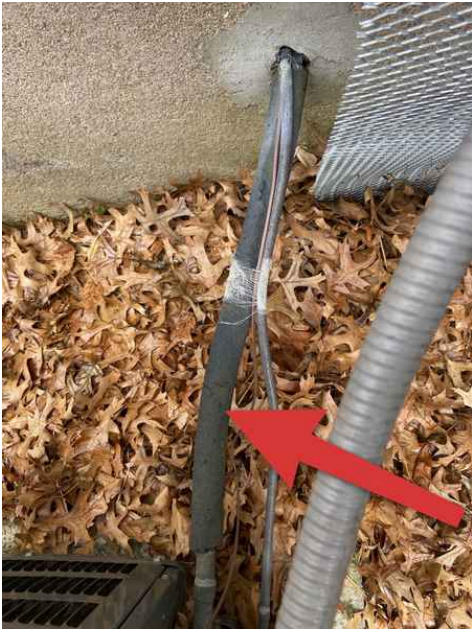
INSULATION ON CONDENSATE LINE DAMAGED/MISSING

Contact a qualified HVAC professional.

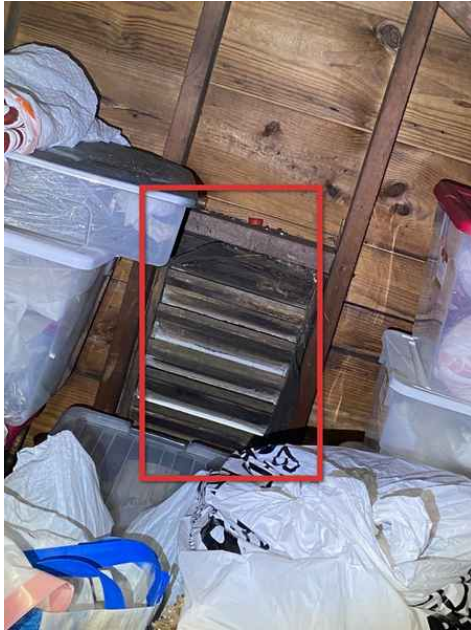
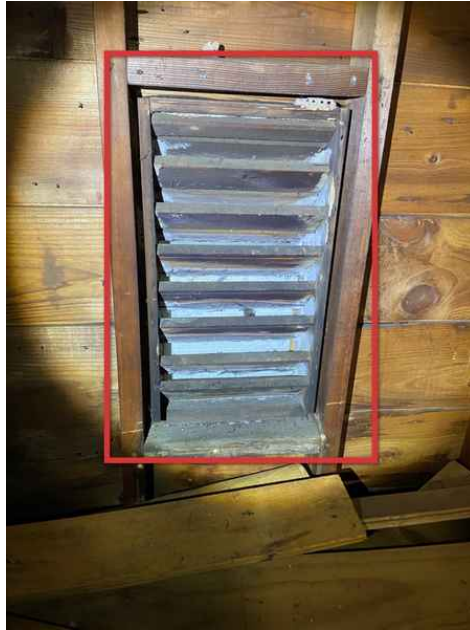
## 9.6.1 Ventilation (Attic and Foundation Areas)

**GABLE VENT SCREEN DAMAGED**

Contact a qualified professional.

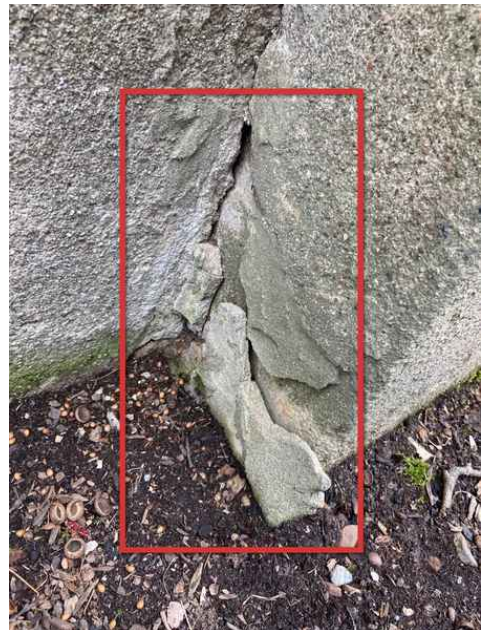
#### 10.1.2 Foundation

### FOUNDATION COVERING DETERIORATED/MISSING

Contact a qualified professional.

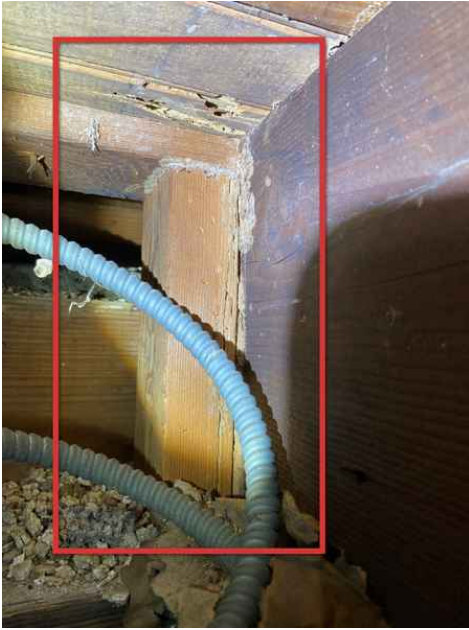
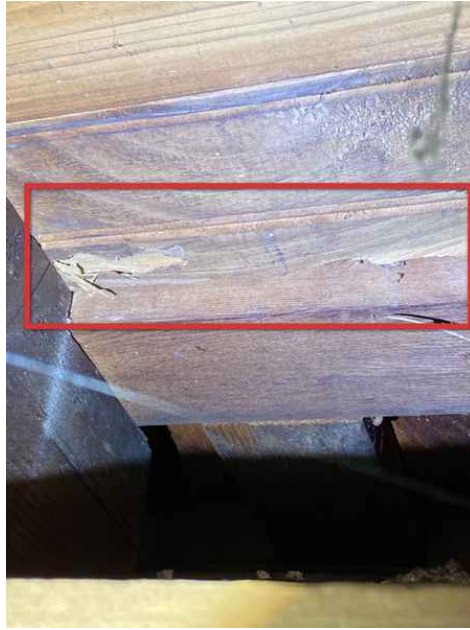
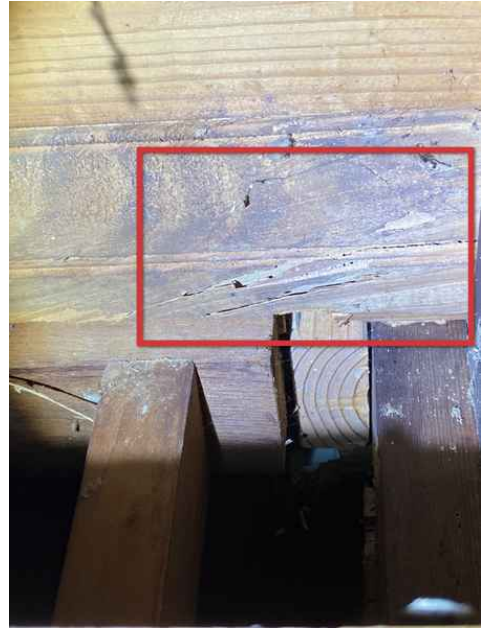
#### 10.3.1 Floor Structure

### TERMITE DAMAGE

Contact a qualified professional.

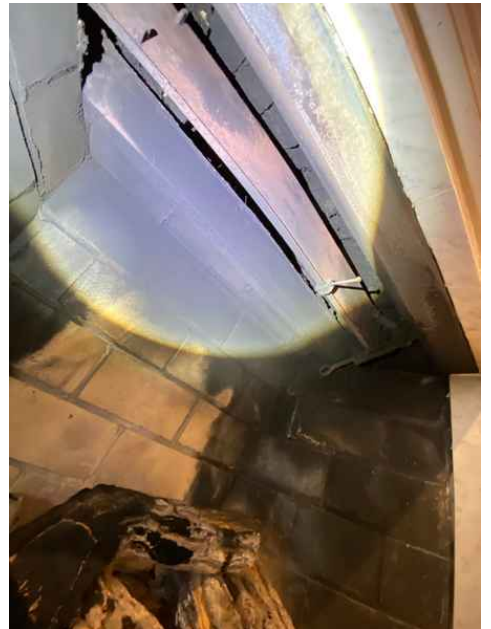
#### 12.4.1 Damper Doors

### **GAS FIREPLACE DAMPER SHOULD BE PINNED OPEN**

Contact a qualified professional.
